A Type Overdrive, Part IV Final Assembly & Testing

By Nelson Riedel, nriedel@nextek.net

Initial 8-01, last revised 2-04-02

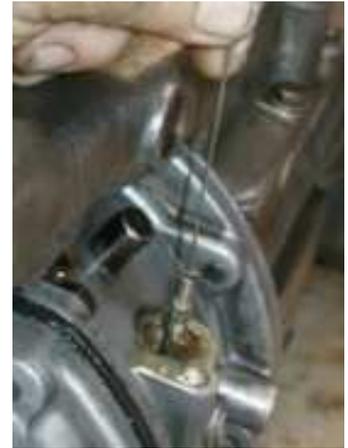
Time to go get a snack while the pressure bled off. Came back a little later ---- no change in pressure. I then loosened the adaptor with gauge carefully. The plan was to loosen it enough so that it would leak and bleed off the pressure that way. It worked and not too much oil escaped, there was still a lot of air mixed in

--- the oil was frothy. (The oil was observed to be nearly free of air after more operation indicating that most the air worked out of the fluid). The plug, spring & plunger were then removed. The ball was easily picked out with a magnetic pickup tool. The end of a length of ~19 gauge soft steel wire was bent slightly and then pushed into the end of the valve spindle then pulled up --- the spindle come out easily (photo on right). The top of the spindle was cleaned and blown into --- no air passage. --- it was plugged. A suitable drill bit was slid down the inside of the spindle and turned a few times then removed and wiped on a clean paper towel. Didn't see anything in the fluid but it had a lot of air mixed in it and not sure if I would have been able to see anything anyway. This time when the top was blown into, the passage was clear. (This left an after taste nearly as bad as beets.) The spindle was then cleaned thoroughly and reinstalled: everything worked fine then.

So, where did the dirt come from? It was probably in some of the internal passages in the main casting. Recall that this OD had a major internal failure and it is quite possible part of the debris got in the passages during the cleaning process. It appeared that little made it pass the screen, so if it was exercised a bit, hopefully anything else will work itself through the system, and no problems will be encountered in the future.

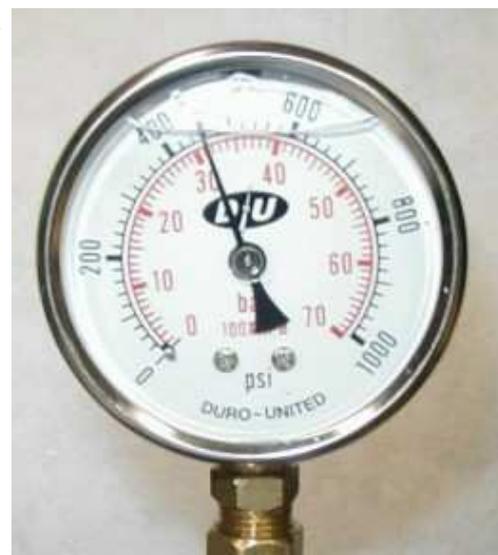
New Gauge: Unfortunately, the cheap gauge had become erratic, the no pressure reading had increased to about 40 psi; hours of 50 psi fluctuations 1300 times per minute must have been too hard on it. A liquid (glycerin) filled gauge was found at McMaster Carr via the internet (www.mcmaster.com/). It was ordered at midnight and they sent an email the next morning saying they had shipped it UPS from Cleveland --- less than 200miles away. It arrived the following day. The gauge was what they call Grade A that is calibrated to within 1% around the middle of the scale. A 2 1/2 inch dial, 0 to 1000 psi gauge, part number 49053K79 had been selected. The cost was \$21.34 plus 1.28 sales tax plus \$3.15 shipping, \$25.77 total. This outfit doesn't seem to pad the shipping like some of the others and will get more of my business.

The new gauge is pictured on right. Notice the liquid level. The needle was steady on this one, what a difference!

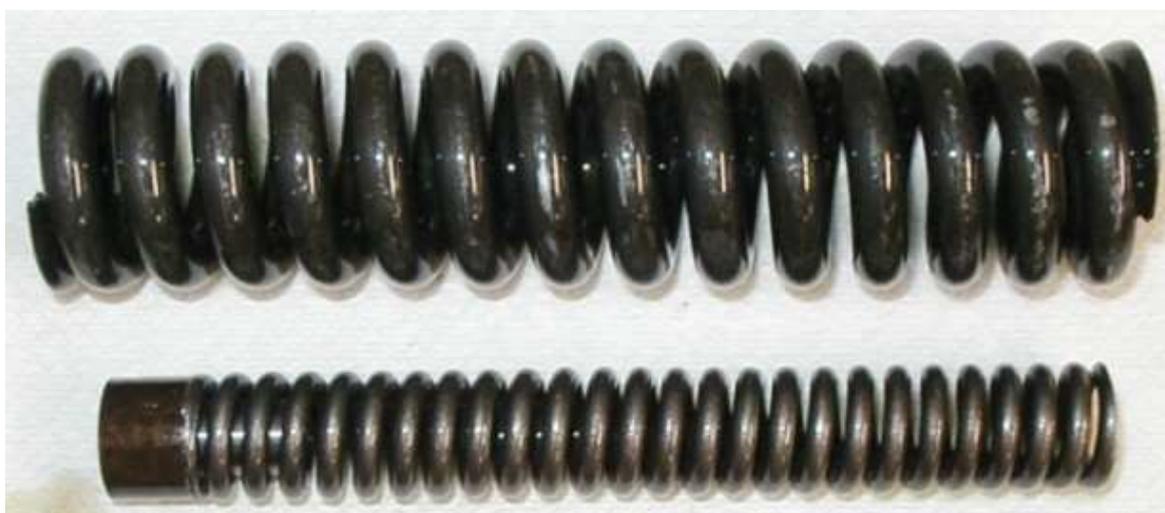
At this point the setup of test 9, the 0.9 inch plug and the 3 washers looked like the best choice. It did seem a shame to have this thing all fixed up like new and use that many washers. An attempt was made to secure a replacement inner spring. Called Moss UK, they didn't have any and none were on order. Then called Overdrive Repair Services (011 114 248 2632) to see if they had one. The guy who answered the phone asked "why do you want one of those?" I explained that I had low pressure and since I had a new outer spring, figured we should get a new inner spring to increase the pressure. He said that the inner spring has little effect on the pressure (I noticed that), it is there to support the outer spring --- help keep it straight. I said that the pressure was only about 350 psi. He said that was what it's supposed to be, 350 to 370 psi. He then explained the 350 psi and the big accumulator provided near instant engagement that tore up the axels in the later IRS cars so easily that the design was changed to the smaller accumulator on the later units to make the OD engagement softer. That made sense since Ronnie Babbitt's data showed that the pressure drops when engaged much more in the later units, and then built up in a second or so. Further, the later J type has no accumulator and has a much softer engagement. After the call I got to thinking ----- what pressure should the later A type unit be? Called the guy back and he said about 450 psi for the later units with the smaller accumulator pistons. The smaller accumulator makes for slower engagement but the higher pressure holds it in OD harder and should allow for higher torque without slipping. The later engines were 6 cylinders that had greater power and torque so it all fits together.

After considerable thought and consultation with a fortune teller, I flipped a coin and decided to make a small plug for the inner spring to compensate for any loss of strength due to old age. I also thought it would give a little margin. This combination is test 11 in the following chart and shown in the photo after the chart.

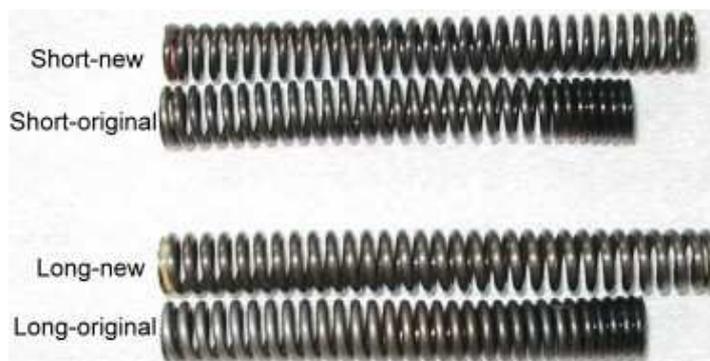
After the previous bout with the springs it was decided to investigate the clutch release springs more carefully. There were clearly two different types, four had a smaller spring wire diameter. Both the free length and compressed length of all eight were measured. That old thrust ring was used to hold the spring straight in the hydraulic press to measure the compressed length. The four in each group were very similar. The average measurement for the springs in each group is in the table below. It became clear that the short springs on the center 4 rods couldn't be compressed as much as the longer four springs on the outer four rods.

The longer springs (smaller wire) had the shorter compressed length and probably originally had the shorter length. The springs were put back in, this time with the springs made from the smaller wire on the inner rods. (The base for the outer rods is about 1/4 inch toward the rear than the base for the inner rods, hence the outer rods can accommodate a longer compressed length spring). While attaching the OD to the gearbox the springs seemed pretty weak. (The OD had been taken off and on so many times at this point that wing nuts were under consideration.) The OD engaged perfectly but the springs in this position were too weak, it was very slow to release from OD and finally stuck in OD. Time to order new clutch release spring!. TRF & Victoria British wanted \$40 for a set and Moss (US) wanted \$70. TRF was out and no idea when they would get any. Victoria British had them in stock and got the order. They arrived two days later via Priority Mail.

The photo above shows the original and new springs together. The ends of the new springs are painted, red on the short ones and yellow on the long ones. All the springs had about 31.5 turns. Note that the new short springs were wound in the opposite direction from the others --- doubt that the winding direction was part of the original specification. The right 3/4 inch or so of the original springs were clearly collapsed. All of them were that way and they were pretty uniform, so much so that I thought they were manufactured that way. Recall that the release bearing had failed on this unit and these springs pressed the thrust ring into the rotating clutch sliding member. The thrust ring and sliding member got very hot. It was then concluded that the ends of these springs also got very hot, hot enough to remove the temper and allow the springs to collapse. And here I was thinking the PO had substituted the wrong springs. Shame!

Before the new springs were installed the pressure required to operate the clutch using the original springs installed in the correct positions was measured; it took 80 to 85psi. This measurement was repeated using the new springs found to be 140 to 160 psi. This time the OD couldn't be pushed onto the gearbox far enough for the mainshaft splines to engage the planet carrier splines as with the original springs; the nuts on the long studs had to be used to draw it to that position. The mainshaft was rotated back and forth a few degrees each side of the center mark as the OD was drawn onto the gearbox and no difficulty was encountered and a minimal force was required on the long studs. The OD engaged without difficulty and released quickly with the new springs.

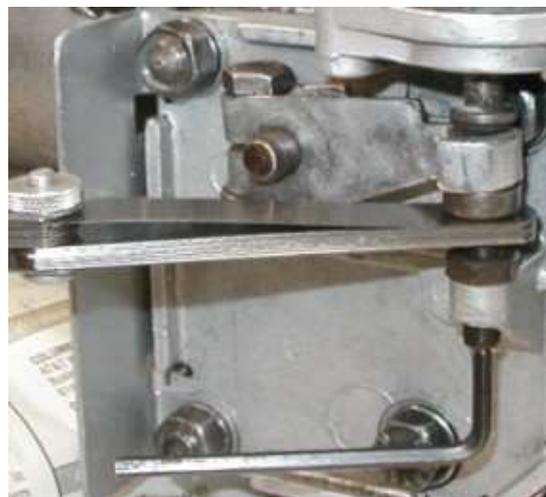
Actuating Lever Stop: I noticed that there was no adjustment screw in the stop below the solenoid plunger like on the later A type ODs on my TR250 and TR6. The hole in the stop was not threaded either. One of the catalogues indicated that a rubber stop (NA) was used on the early models. The plunger was pushed down as far as it would go and then the solenoid was powered ---- it wouldn't operate. This must not be allowed to happen. The OD will fail to engage and worse, the high operating current will quickly burn up the solenoid winding (~\$100). The hole was drilled and tapped 1/4-28 to match the later models and the 3/4 long set screw and jam nut from a later unit was installed since the hardware store wasn't open at that time of the night. The Haynes TR250-TR6 manual says the gap between the top of the screw and the bottom of the operated plunger should be 0.150 - 0.155 inch, see photo on right. The solenoid then operated reliability. Note that too small a gap may cause the OD to not disengage when the solenoid releases. Fred Thomas said an insufficient gap caused him to remove the interior of his TR3 eight times this past spring. Fortunately, his OD was not damaged.

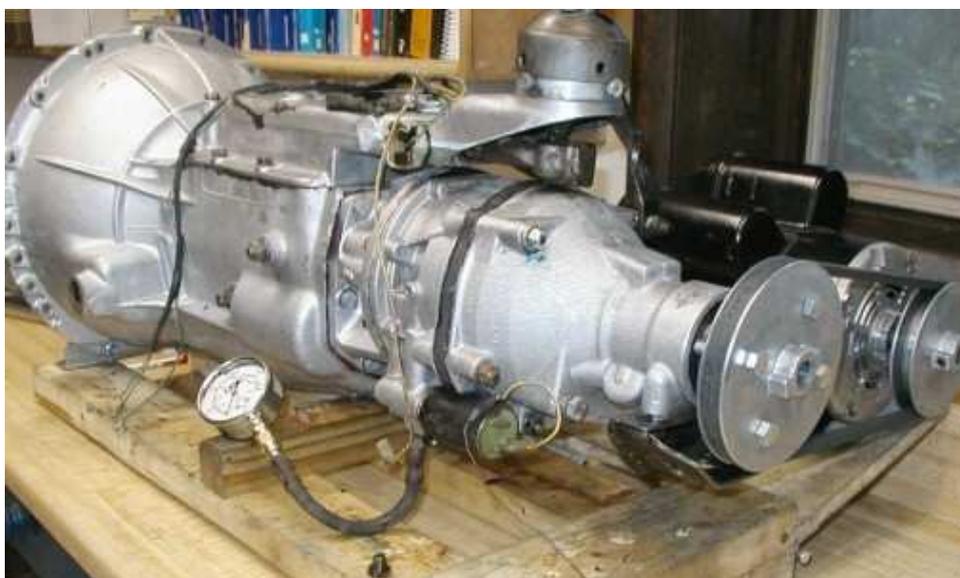
J Type OD: The J type OD from my '76TR6 was put in the test stand to find a small leak. Before firing it up, a small leak from the countershaft cover plate in the front was noted, but it hadn't yet made it to the drain hole; the cover plate was bowed so it was reversed. The rear seal was replaced (again) because there was a one drop drip on the bottom. The motor was then run for an hour. There was a stream of oil from one of the studs near the top that hold the front and rear casting on each side of the brake ring. There is a copper washer then lock washer and then nut on the stud. The lock washer had distorted the copper washer,. The fix was to replace the copper washers on the two top studs and then add a flat washer between copper washer and lock washer. Joint sealer was also used around the stud.
