## Overdrive Throttle Switch Disassembly – Removing the Camshaft

By John Spaur  
1962 MKII BT7  
August 23, 2010  
REV 1

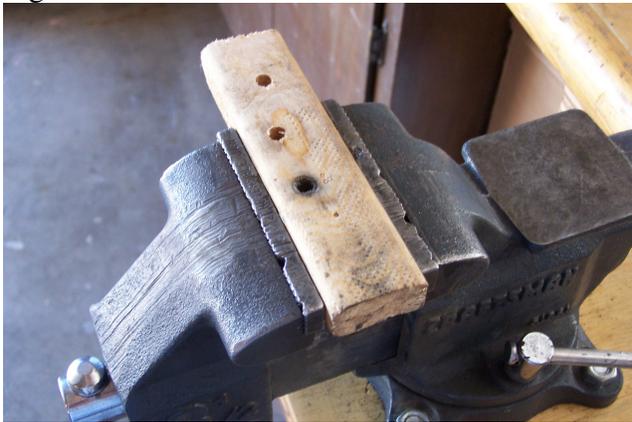
Figure 1

The key to separating the cam from the shaft is having the right setup and tools. If you are restoring your car you know doubt have the tools and the setup is easy and quick to fabricate. You will need a small piece of 1x2 soft wood. It is important to use soft wood as this will minimize flattening of the brass rivet bearing. Drill a 17/64” hole in the wood such that the shaft can be inserted in the hole with the side of the case bearing fully on the wood. The hole should be off-center so the formed case edge will set below the flat of the wood. In addition, the wood should have a radiuses edge on the side nearest the black hole; shape it with sandpaper if needed. See the black hole in figure 1.

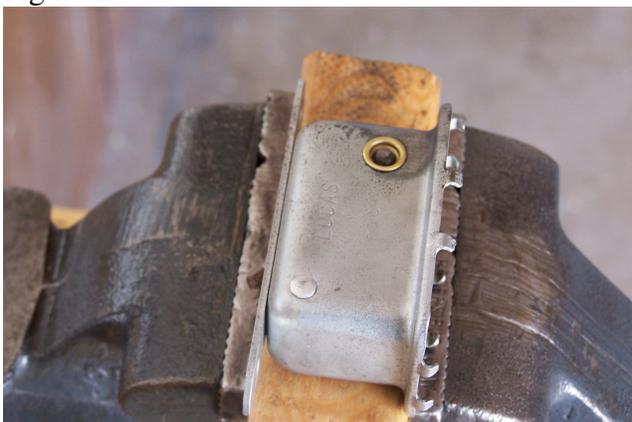
Figure 2

Fix the 1x2 in a vice and set the case shaft, with the base removed, into the hole. See figure 2.

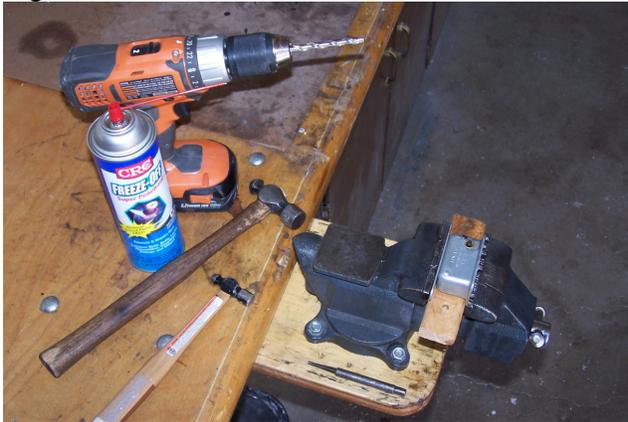
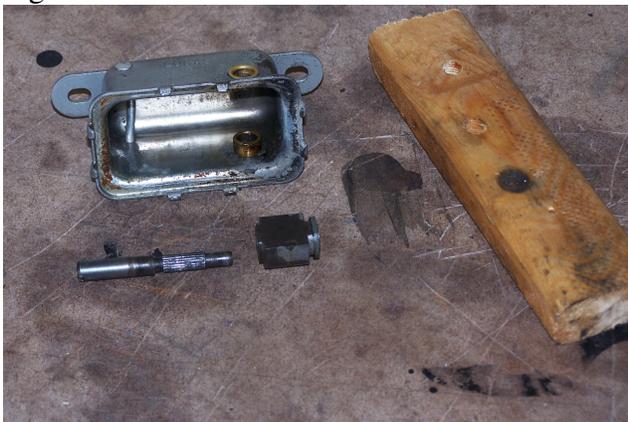
With this setup, a wood nail punch was used as a drift pin to hammer the shaft out. At first, several raps with a small, light ball-peen hammer did not produce the desired results. Being somewhat impatient, a larger ball-peen was employed. The shaft came free quite easily. See Figures 3 and 4.

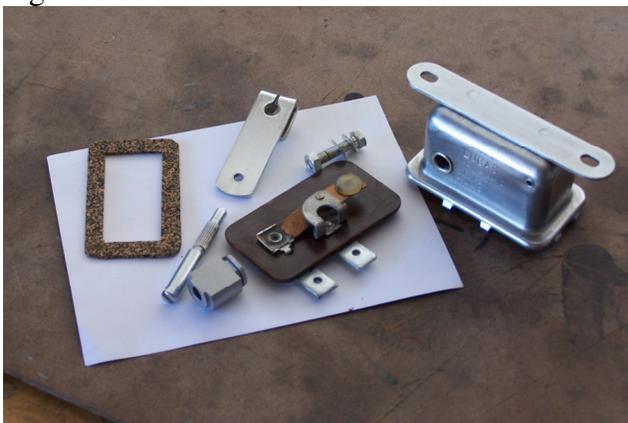
Figure 5

When you reassemble the OD throttle switch be sure to have some cork gasket material on-hand because you will most likely need to replace the gasket. The spring lever is not in the picture for some reason. Be sure to note its orientation when removing the lever and to reinstall it. See figure 5.

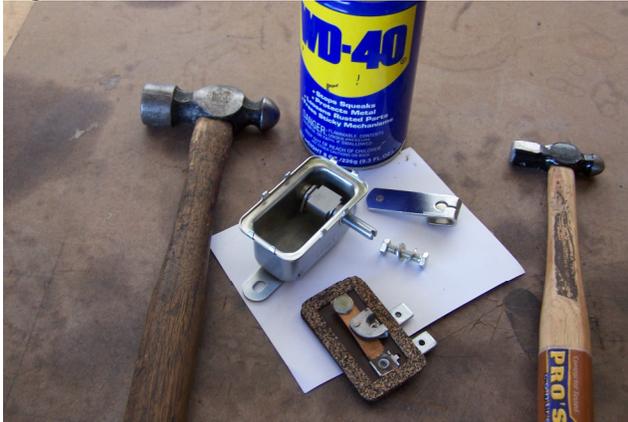
Figure 6

As they say in the instruction book; assembly is the reverse of disassembly. Use a little WD 40 as a lubricant (lets not debate this). Note the orientation of the cam, figure 6 (do this before removing it)!

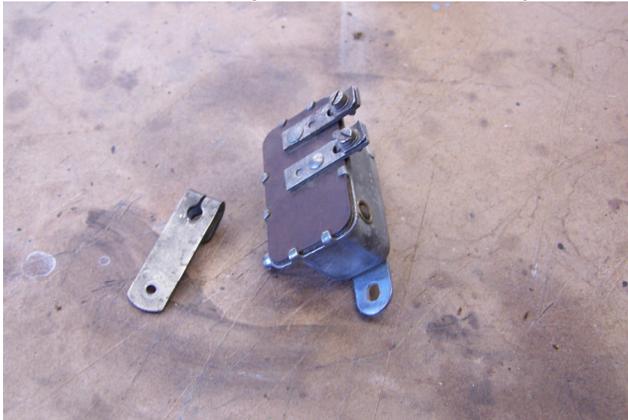
Before (note that my case was not heavily rusted)

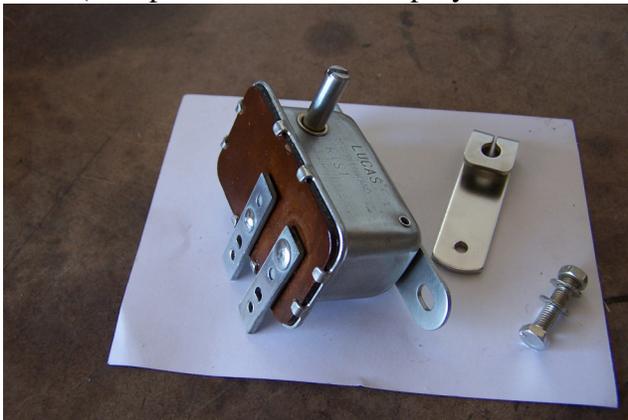
After (zinc plated at home and sprayed with clear coat)
