## Restoration Methods

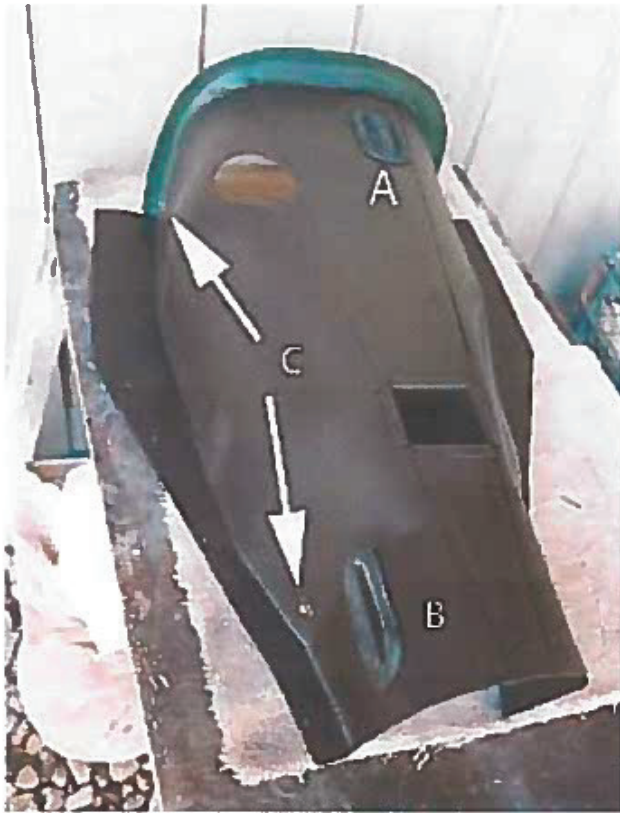
**Photo 14:** This is the style of gearbox cover used on all 100-Six and 3000 roadsters (up to the center-change gearbox). The 6-cylinder roadster cover had two longitudinal seams, as compared to the single seam on the BN2 cover. The front flange was wider (shown here) on 3000s than on 100-Sixes. On cars with grey interior trim, carpet binding around the gear lever and handbrake was done in grey vinyl, as was the piece glued behind the brake handle and the front flange was trimmed in either green (shown here) or red to blend with the carpet. On all other trim colors (black, red, or blue), the front flange trim as well as all carpet trim and binding was the same vinyl color used throughout the interior. The rubber gear lever gaiter is shaped on the underside to fit snugly over the metal gear lever retaining cup on the transmission (see also Photo 10). Rectangular ports with rubber plugs provided access for filling the gearbox (A) or lubricating the forward driveline grease fittings (B). As with the BN2, the gearbox carpet was attached using snaps (C).

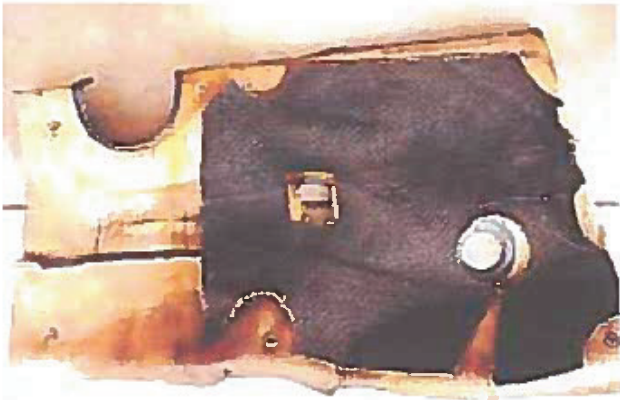
**Photo 15:** This photo shows the jute pad glued to the underside of an original BN6 gearbox carpet. The carpet extends all the way back to the rear bulkhead and now has a wrapped vinyl binding around the opening to clear the hand brake.

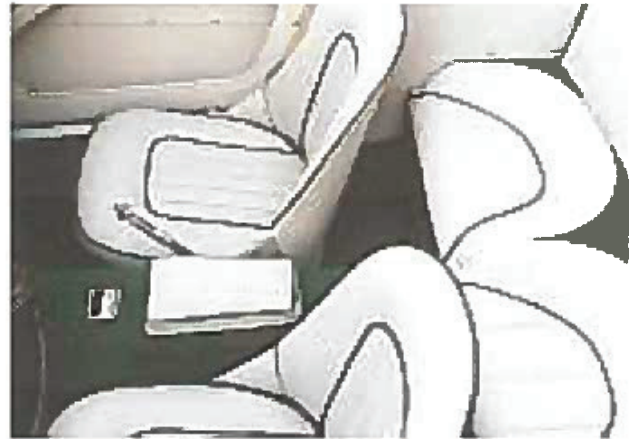
**Photo 16:** With the one-piece gearbox-drive shaft carpet, the arm rest pad was now sewn to it, starting with BN6 C. 744 and continuing from BN4 C. 68960 through 3000s, up to the BJ8s. Note that the pad is not rectangular, but rather noticeably wider at the front than the rear. This photo is of a 3000 Mk I with grey-green interior. Original seat cushions were a bit more squared-off at the front.

One significant change was made when the one-piece carpet cover was introduced. From that point onward, the armrest pad was sewn directly to the carpet. This pad had vinyl sides and leather for the three pleats on top. It is noticeably wider at the front than the rear, and had a molded foam rubber pad inside, of the same type of foam used in original seat cushions.

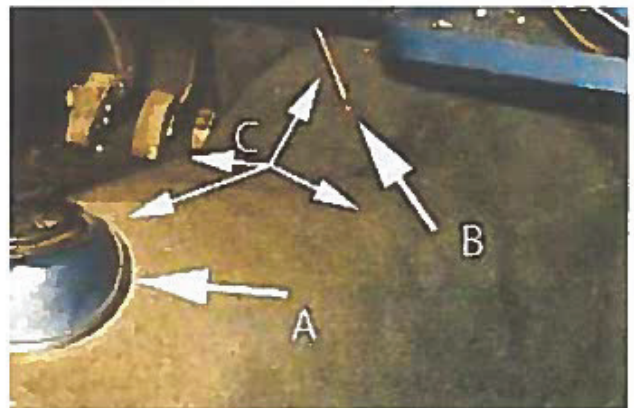
**Photo 17:** Original carpet in a center-shift BT7. The raised part of the fiberglass around the gear lever is covered in vinyl and the carpet edge is finish with a rolled vinyl binding (A). The speedometer cable passes through a hole in the carpet (B). On Mk II roadsters, a rather limited jute pad was glued to the underside of the carpet only over the top horizontal area and extending from the gear lever forward and up the sloped front (range C in the photo). This padding has not been observed on very original BJ7s or BJ8s. The carpet must be pulled back quite a bit to gain access to the gearbox for filling (see hole and plug [25] in Photo 18). The armrest pad continued to be sewn to the carpet up to the BJ8. (Photo courtesy of Peter Svilans)

and a vinyl piece glued to the tunnel behind the handbrake were continued. All vinyl pieces and binding were of the same color as used elsewhere in the cockpit. The only exception was on cars with grey interiors, where the piece of vinyl glued over the front edge of the gearbox cover was in a color to blend with the carpet.

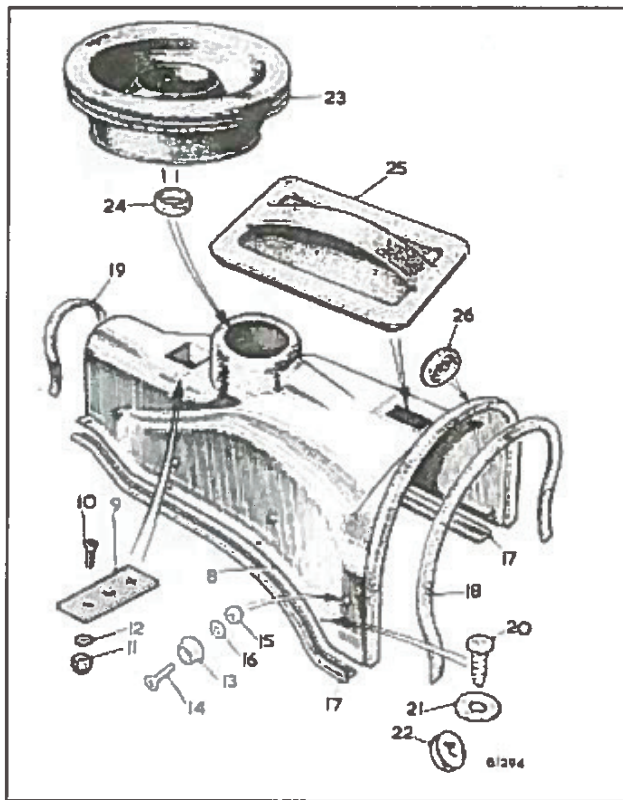
**Photo 18.** An illustration of the fiberglass gearbox cover used for cars with center-shift transmissions. Item #17 is the rubber seal to the chassis, BUT I believe its placement is incorrectly pictured for a number of reasons. First, a mechanic who owned a Healey repair shop for about 30 years from the late 1960s and worked on many relatively new Healeys, remembers only seeing this seal mounted over the raised metal flange that was welded to the floor. Second, the inverted "U" channel on the inside of the cover is quite wide and fits perfectly over the metal flange with the seal attached to it. And third, rubber grommets (#22) are inserted into the fiberglass flange for mounting to the floor. The face of these grommets, projecting on the flange underside, would interfere with a good seal, even if the surface was a compressible rubber strip.

**Center-shift Healeys, 3000 Mk IIs and Mk IIIs** – With introduction of the center-shift gearbox during BN7/BT7 Mk II roadster production, a number of changes were made to the gearbox cover and its trimming. The carpet remained one piece from the front back to the rear cockpit bulkhead. However the cover structure was now made out of fiberglass and incorporated formed inverted "U" channels running lengthwise on the inside just above the bottom edges. These channels nested over metal flanges that were welded to the floor. A J-shaped rubber seal was installed between the chassis and the gearbox cover. As noted in the caption for photo 18, I believe the seal should be attached to the raised metal flange welded to the floor.

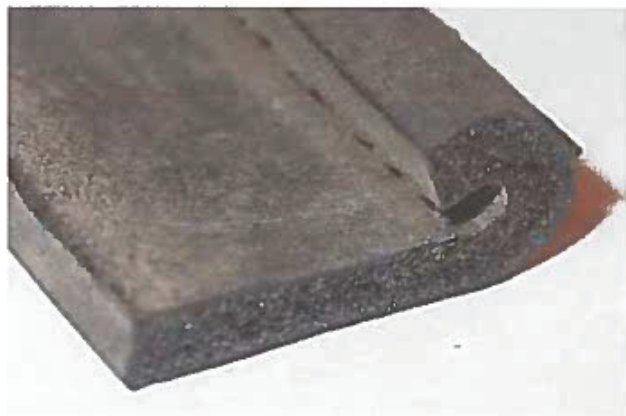
**Photo 19:** This is a close-up of the original gearbox cover seal. The material is mold-  
ed, skinned foam rubber approximately 1/8 inch thick. Measured from the top of the  
curve, the long leg is 7/8 inch and the short one about 1/4 inch.

There is no source that I know of for this "J" seal, but it is easy to make a fairly close replacement using skinned foam rubber 1.5 inches wide by 1/8 inch thick from Metro Molded Parts ([www.metromp.com](http://www.metromp.com) – their item #LP-58F).

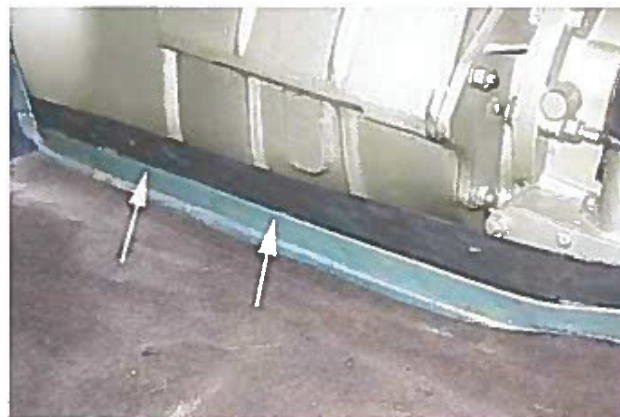
**Photo 20:** To replicate the original inverted "J" seal, first glue the 1/8 inch thick foam strip to the back side of the metal flange, leaving enough projecting up to reach down to the floor on the front face.

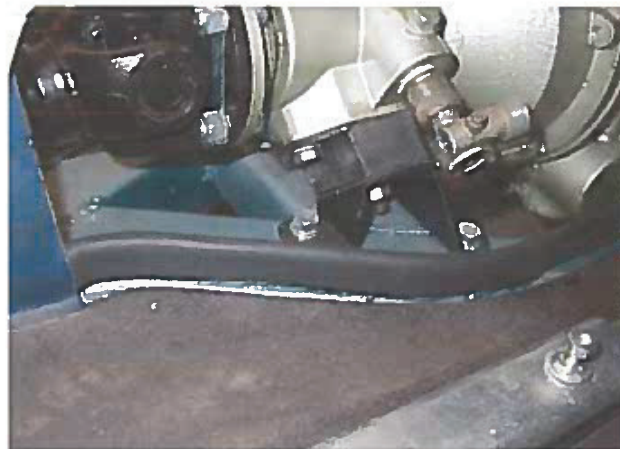
**Photo 21:** The second step is to use contact cement again to adhere the strip to the outer face of the metal flange. Make sure the rubber layer is tight to the metal to keep the overall thickness at the folded edge as thin as possible.
