A Type Overdrive, Part II - Disassembly

By Nelson Riedel, nriedel@nextek.net

Draft Updated 1-3-2002

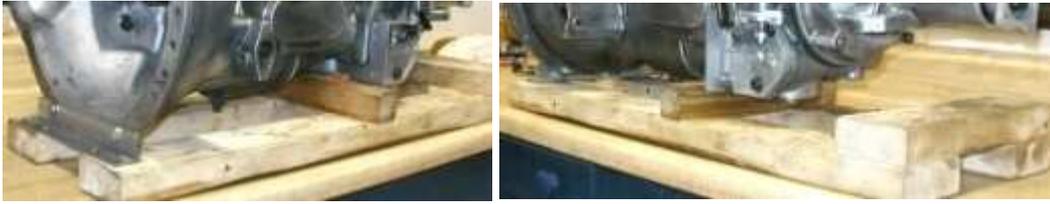
Gearbox Stand: I use a gearbox stand made from scrap pieces of 2X4, 2X2 and a short piece of steel angle as seen in the photos below. The gearbox bolts to the angle at the front. The 2X2 near the rear of the main gearbox casting has a shim tacked to the top to adjust the gearbox so that it is horizontal. The stand took about 30 minutes to make and proved its worth in about 15 minutes of use.

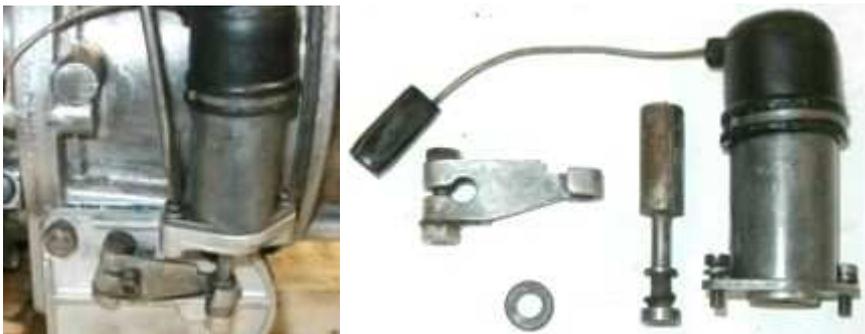
Remove the small parts: It's convenient to remove several small parts from the OD unit before detaching the OD from the gearbox, starting with the solenoid. The solenoid sticks up and makes a nice handle. Unfortunately, using it for a handle nearly always breaks the bracket to which it attaches. At ~ \$75 per bracket, an expensive handle. (That small aluminum casting is known both as the solenoid bracket and the cover plate. The term cover plate is used from here on.) It's best to get the solenoid off and in a protected place first thing. The following photos show the solenoid attachment screws being removed (left). The solenoid, plunger, actuating lever and collar are then removed. When new there was a rubber boot around the end of the solenoid to prevent debris from entering the cylinder in which the plunger slides. The boots have long since cracked and fell off on most these old units. Replacement boots are not available so we do without. I've operated several without boots for about 15 years with no problems.

As parts are removed they are thoroughly cleaned and inspected. To keep track of the parts, associated groups of parts are placed in small zip lock plastic bags. For example, the parts in the lower right photo were put in the same bag.

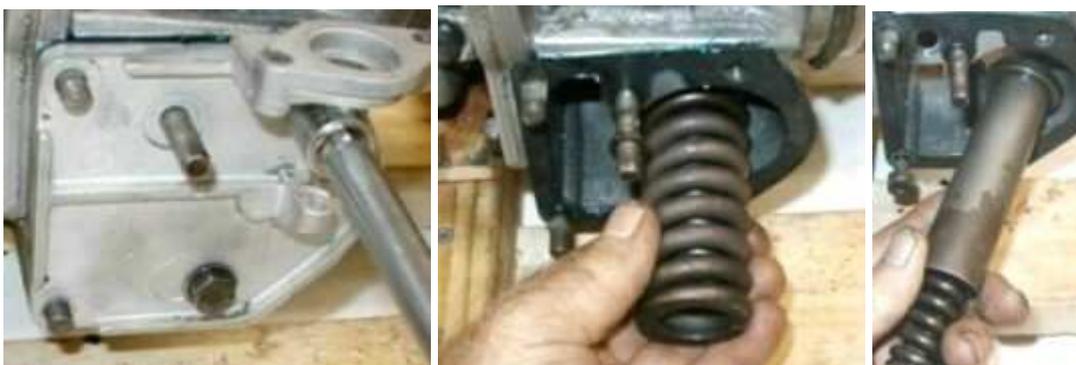
The cover that retains the humongous accumulator spring was removed next. It is secured by two bolts to the rear and two nuts on studs toward the front and must be removed properly so that it is not bent or distorted. **Caution, the operating valve must be operated and released a half dozen times using the lever or solenoid to relieve the pressure before removing the operating valve plug or the cover plate.** The nuts on the studs on the forward side of the bracket were removed first. Then the two bolts were unscrewed alternately a little at a time such that the plate comes off relatively straight (left photo below). The center photo shows the spring of the early style accumulator being removed. There was a bunch of metal parts in the sump under the accumulator, including several little ball bearings, an ominous sign. The right photo shows the removal of the spring and spring tube from a later style accumulator. (Another OD was setting nearby that is a future project. The accumulator was pulled from it from it to show a comparison. Later on you'll find we borrowed some parts from it.)

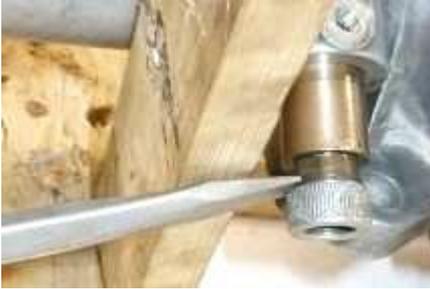
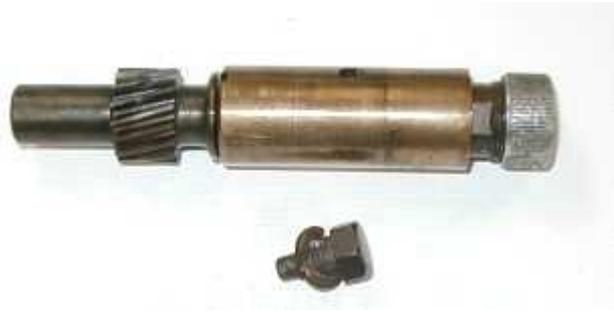
The speedometer bearing & pinion were removed next. This need be removed only if one plans to disassemble the rear casting to replace the two rear bearings. The retaining bolt was removed first, and then the nut from the end of an old speedometer cable was screwed onto the speedometer bearing and a large screwdriver was then used to pry against the lip of the speedometer nut to remove the bearing (left photo below). The parts in right photo were bagged together.

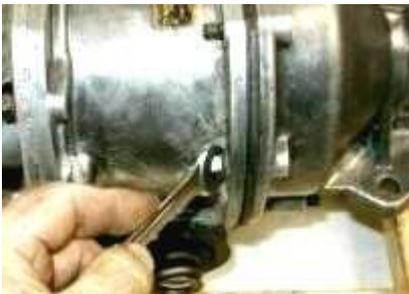
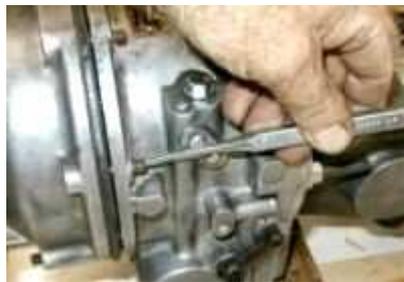
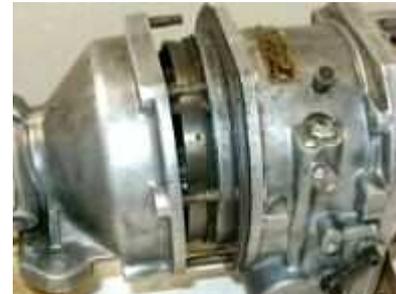
Removing the rear casting: I prefer to separate the rear casting from the main casting while the overdrive is still attached to the gearbox. Six studs hold the two castings together. The eight springs between the gearbox and the OD unit push against the annulus that helps separate the rear casting. This time, the castings didn't come apart when the nuts were removed. The ends of the studs were tapped with a punch to break the seal as shown in the middle photo below. The brake ring also came loose from the main casting so the hammer and punch were used to drive it back into the main casting. The brake ring can't be removed until the bridge pieces are removed from the thrust ring. The right photo shows the rear casting ready to slide off. Once the rear casting was off it was clear that the thrust bearing had failed --- more about that later.

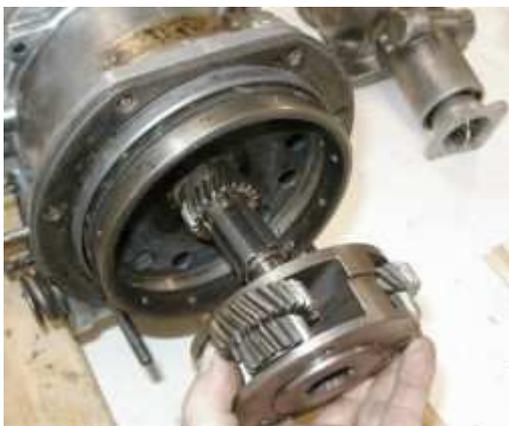
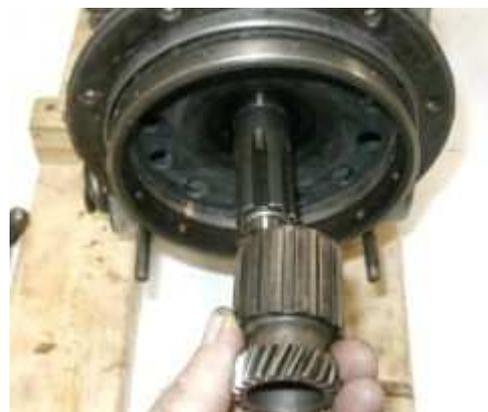
After the rear casting was removed, the planet carrier with planet gears and then the sun gear were removed as shown below. The planet carrier was cleaned and the bearings in each planet gear were tested by rotating the gears. All three gears rotated smoothly and there seemed to be no play in the bearings. It was decided that the planet bearings would not be replaced so it was not necessary to disassemble the planet carrier further.

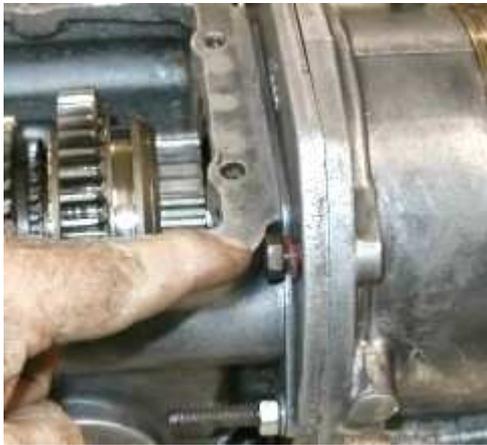
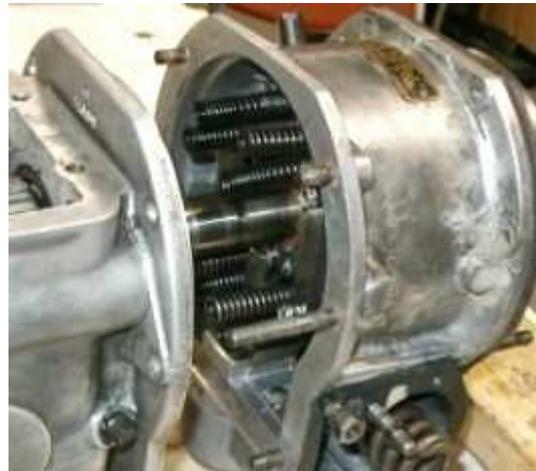
Removing Main Casting: The nuts and lock washers from the two bottom studs were removed first. Next, the nuts on the two top studs were loosened; these nuts can't be removed until the main casting is

separated from the OD adaptor plate (left photo below). The nuts on the two long studs were then backed off a quarter inch or so. The casting didn't separate so I tapped it with a hammer and wood block. Once the casting separated, there was sufficient clearance to remove the nuts from the two top studs. The nuts on the two long studs were then backed off together to keep the main casting straight as the springs pushed it toward the rear. After the nuts were removed the casting was slid off. The eight springs were pulled out and bagged.

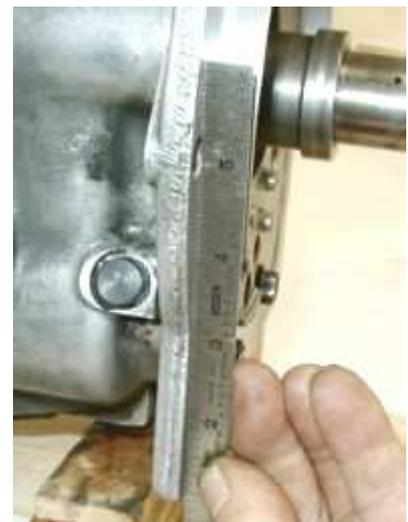
Adaptor: Before leaving the gearbox the adaptor plate surface that mates with the main casting was cleaned and a straightedge used to check to see if it was bent or bowed. If the OD had been previously forced onto the adaptor by tightening the nuts on the studs it is possible that the adaptor is distorted. This will lead to leaks. A severely bent or distorted adaptor can't be used. There have been reports of some success filling minor low spots with epoxy based fillers. The adaptor plate was OK.

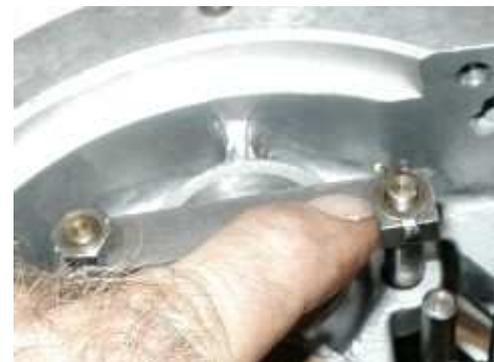
Removing Bridge Pieces: The nuts were removed from the bridge pieces next. These nuts were originally equipped with locking tabs. I prefer to not reuse these because the tabs usually break off after they have been bent once. These tabs are NA so both the tabs and nuts were discarded and replaced with 1/4-28 nyloc nuts. Once the four nuts were removed the bridge pieces were pulled off the thrust ring and the thrust ring was slid out the rear of the main casting. A bronze thrust washer and an adjustment washer were also removed from a recess behind the main shaft bushing in the main casting.

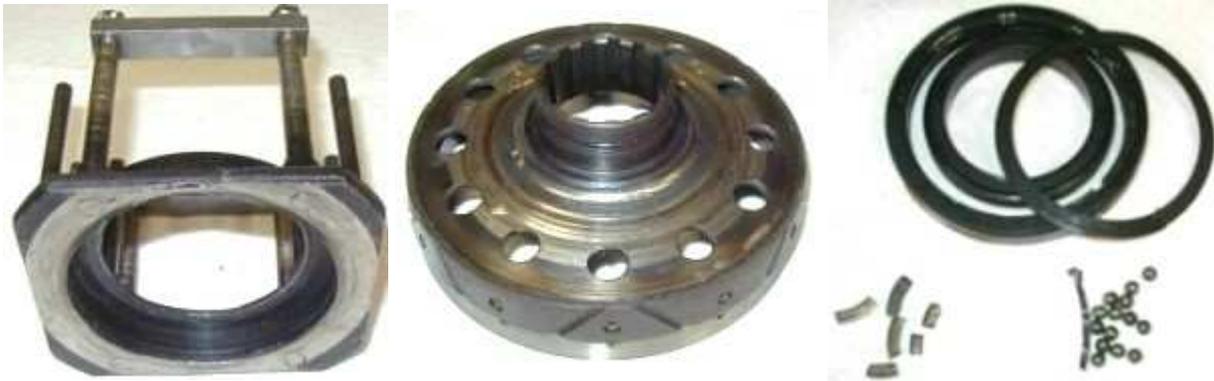
As mentioned earlier, a bit of a disaster was discovered when the OD was dismantled. The thrust bearing, that large bearing between the thrust ring and the clutch sliding member failed --- the balls fell out and the two parts separated. The eight springs then forced the thrust ring (doesn't rotate) into the rotating clutch sliding member. It must have made a hell of a racket. The left photo below shows the back side of the thrust ring where much of the metal has been worn off. The circlip retaining the bearing outer race was also damaged. The center photo shows the front side of the clutch sliding member where again, much of the metal has been worn off. The dark area indicates that it got very

hot. The right photo shows the remains of the bearing. The pieces in the lower left hand corner of the right photo are the remains of the thrust washer between the sun gear and the planet carrier. It was decided to reuse the clutch sliding member since the clutch surfaces, the splines and the collar that mates with the bearing inner race were not damaged. The thrust ring was so heavily worn that the lip retaining the bearing outer race circlip was missing in some places. The thrust ring and circlips in addition to the destroyed thrust washer and bearing were replaced. Because some of these metal pieces were floating around the OD it was decided to also replace the two annulus bearings in the rear case.

Because this unit had a failure that ground some parts into unrecognizable bits that were scattered throughout the unit, the unit was completely disassembled except for the planet carrier and everything was inspected. The large bearings were replaced as well as the broken parts.

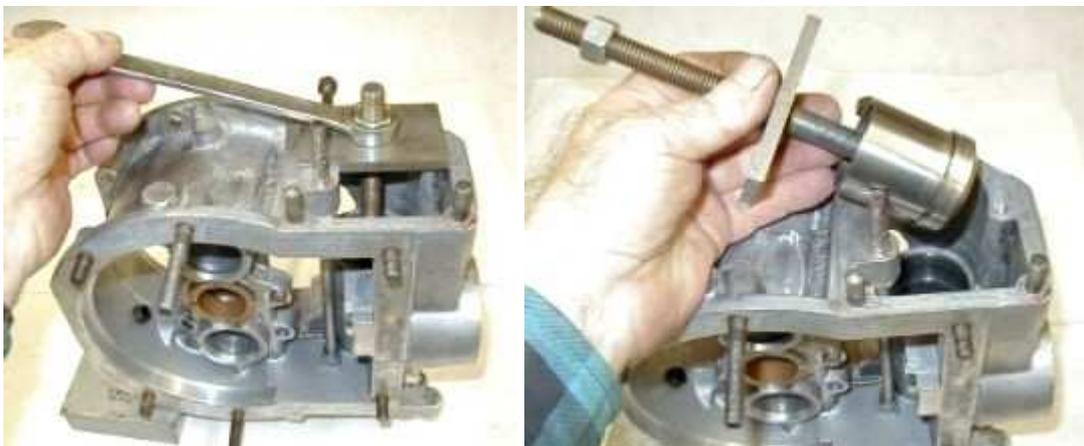
Removing Accumulator Piston: This OD was an early model with the Accumulator cylinder machined into the main casting. The center of the piston has a hole threaded 3/8-24 (this was previously reported as 5/16 -24 - thanks to Dan Shockey for the spotting the error). A puller was made by turning down the end of a 1/2 inch treaded rod (had a stack of these left over from a church project ten years ago) and then threading 3/8-24. A length of 3/8-24 threaded rod would have worked just as well. Not much force was required to remove the piston. The photos below show the puller in action. After the piston was removed, the rings and the cylinder walls were examined for defects. We were lucky; the metal pieces from the bearing failure didn't seem to have made it to the accumulator.

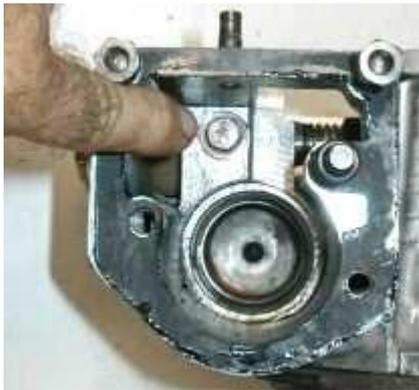
Removing Non-Return Valve: The pump non-return valve is located beside the accumulator cylinder as shown in the left photo below. After the plug was removed the spring, plunger washer, and ball were removed, cleaned, inspected and stored (right photo).

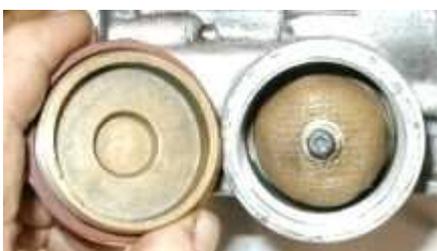
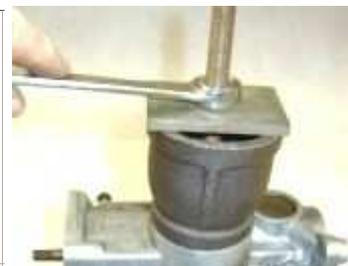
Removing Pump: The drain plug and screen filter must be removed to expose the pump.. The photos below were taken after the gearbox had been cleaned up. Much of the oil evaporated from the heat generated when the bearing failed. The outside of the screen was covered by black goo mixed with metal parts. (The later models use a larger plug and the screen is retained by the plug rather than the screw as shown in photos below.)

The pump is pressed into the case and requires quite a bit of force to remove. **Caution - the non-return valve must be removed before the pump body is extracted.** The two screws and plug shown in the middle photo below were removed first. A threaded rod screwed into plug hole was then used to pull the pump body. The threads are 7/16-20. The end of another one of those 1/2 threaded rods was turned down and threaded to make a puller --- right photo below. A length of 7/16-20 threaded rod would have worked just as well. A pipe fitting was used to provide a space to draw the pump into. The pump body came right out as the nut was tightened.

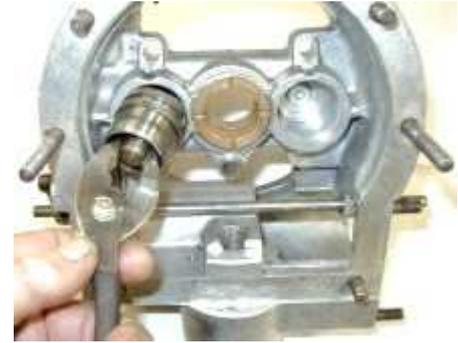
Removing Operating Pistons: The operating pistons were removed by grasping the ends with pliers and rotating the pistons back and forth while pulling out. Upon inspection one of the piston rings was found to be broken. Quite possibly it was broken when initially installed. These rings are no longer available so the new style piston with O ring seal had to be purchased.

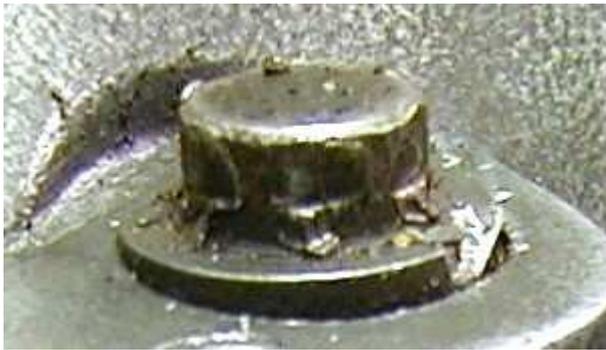
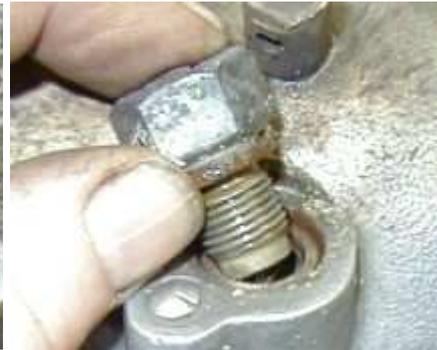
Removing Operating Valve: The last thing removed from the main casting was the operating valve. The valve plug is on the upper right-hand side of the casting. Unfortunately, the corners on the hex head of the plug had been rounded. A six point socket was tried first, and it slipped. There was no room to get another type of wrench on it. A 1/2 inch nut was driven over the top of the plug and welded. The nut and plug were then removed together. The plug with the large nut attached is shown at the right.

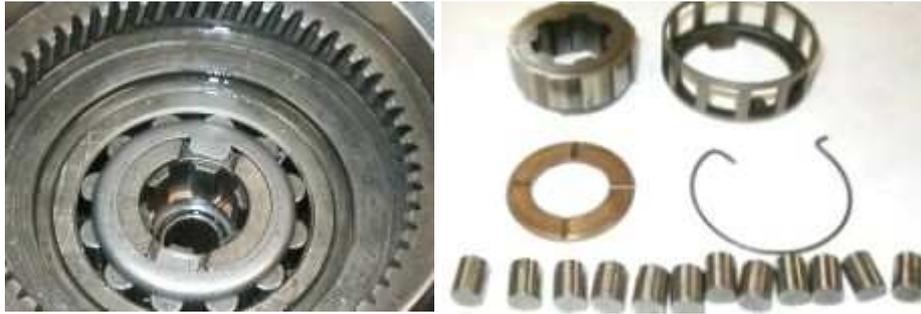
Removing Unidirectional Clutch: The unidirectional clutch sets in a recess in the large end of the annulus in the rear casting (left photo). It is removed by rotating the center part counterclockwise and

lifting up. The rollers came out of the cage so then we had a bunch of pieces as show in photo on right below. The bronze thrust washer is located behind the clutch.

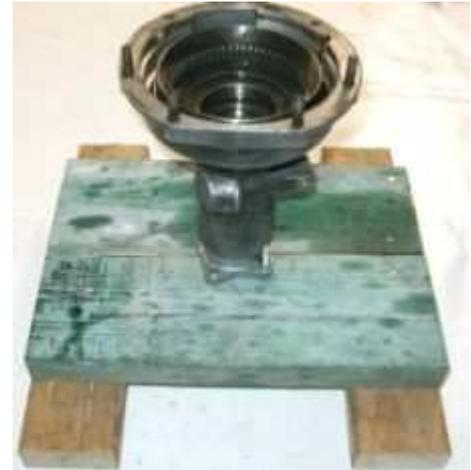
OD Stand: A stable base to hold the OD on end during reassembly is very useful. The old piece of 2X12 used previously had disappeared so the new stand shown on the right was made from scrap lumber. A 1 1/2 inch hole in the center provides clearance for the end of the annulus shaft and nut. Two 3/8 inch holes provide for bolts to hold the rear flange.

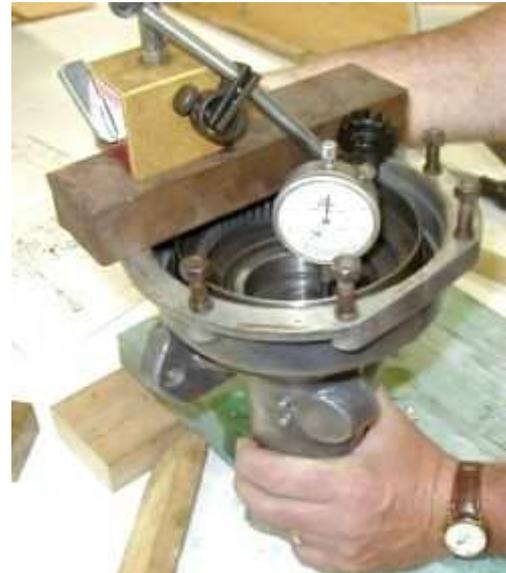
Annulus End Float: The annulus end float was measured before the rear casting was disassembled. The end float is adjusted by changing the adjusting washer between the rear bearing and a shoulder on the annulus shaft. If the end float is within spec before disassembly, then it should be within spec even if new bearings are installed because the bearings are made to a very close tolerance.

The rear casting was secured to the stand and a dial indicator was positioned as shown with the point against the annulus. The casting was then pushed down for the first reading. The second reading is taken after the casting has been pulled up by placing one hand on each side the top of the casting and pulling up while pushing down on thumbs pressing against the outside of the annulus. The required end float is .005 to .010 inches. If the end float is out of spec, refer to the discussion near the beginning of Part III. This end float was right on .005 inches.

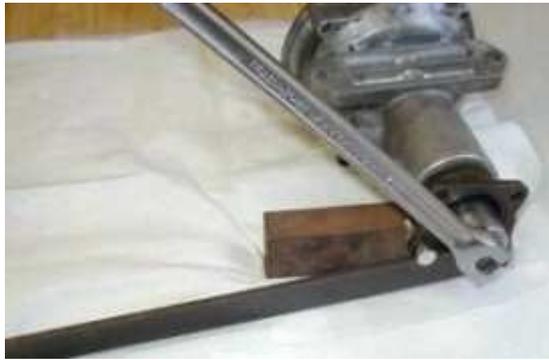
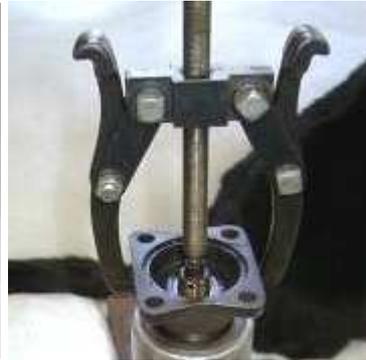
Rear Flange Removal: A "flange removal tool" made from a two foot length of 1/4 inch by 1 1/4 inch steel bar (a 1 inch bar will probably work as well) is used to hold the flange when removing the nut. A 3/8 inch hole is drilled close to the edge near the end for attachment to the rear flange. A second bolt is installed in the flange to rest against the edge of the tool to keep the flange from turning as shown in left photo below. This bar is also a "flange installation" tool. It can also be attached to the flywheel using one of the clutch pressure plate bolts to become a "flywheel removal or installation tool". The cotter pin was removed from the flange nut and then a breaker bar was used with the tool to loosen the nut.

A puller was used to remove the flange as shown in the right photo. The black object is one of the cats that live in the workshop. This is the dumb one; she is so dumb her fur should be blonde.

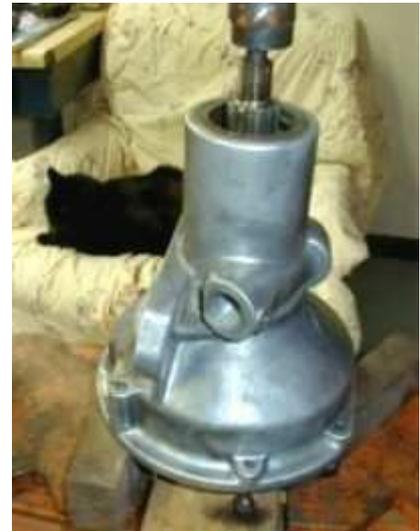
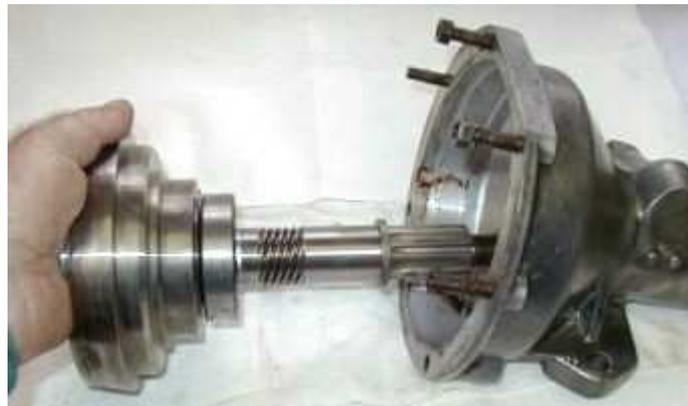
Removing the Annulus: The annulus was pressed out of the rear casting using the hydraulic press as shown on the right. The sides of the casting were blocked up off the press cross members. A scrap piece of 2X4 was placed under the casting to stop the annulus from slamming into the steel press cross member if it came loose with some velocity. This was a well behaved annulus that came out gently with minimum force applied. The annulus is shown in the photo below. The middle bearing must still be removed from the annulus shaft.

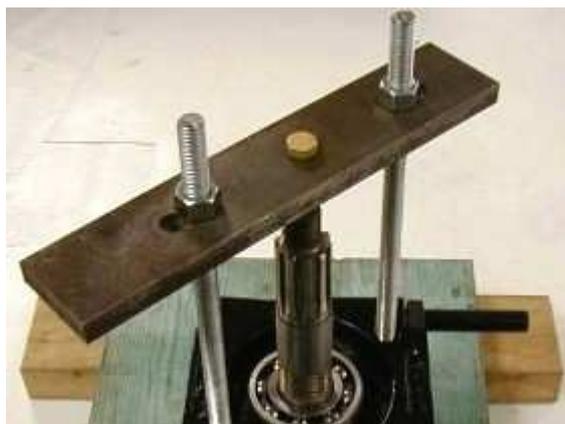
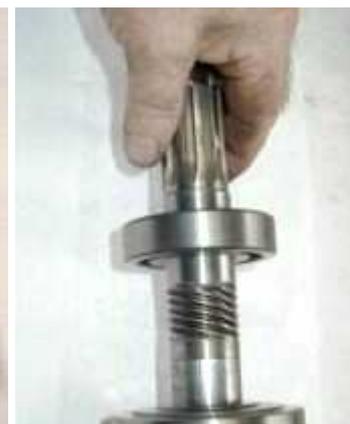
Middle Bearing removal: This bearing is also known as the annulus head bearing. A large bearing separator (available from Harbor Freight, ~\$20) was used to first push the bearing away from the shoulder on the annulus by tightening the two black bolts in the left photo below. Next, the bearing was pulled along the shaft by tightening the nuts on the threaded rods. The right photo shows the bearing nearly off the shaft. The press fit is only on the shiny section very near the shoulder.

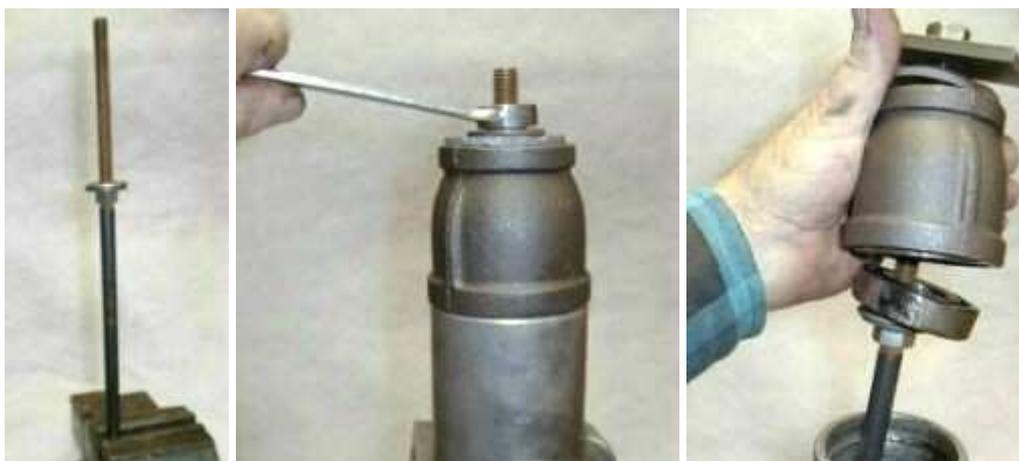
Rear Bearing & Seal Removal: A length of threaded rod, some washers and spacers were used to pull the rear bearing (aka annulus tail bearing) and seal from the rear casting. This is the same stuff used to press rear bearings and seals out of the gearbox extension of non OD gearboxes. The rod was secured in the vise as shown on the left. The rear casing and then a spacer and washer were slid over the rod and a nut threaded on and tightened. The lower washer on the rod pressed against the under side of the rear bearing. As the nut was tightened, the spacer pushed the casting down off the bearing. The freed bearing is shown on the right. The rear seal has been pushed up into the spacer; the bottom edge of the seal is visible.

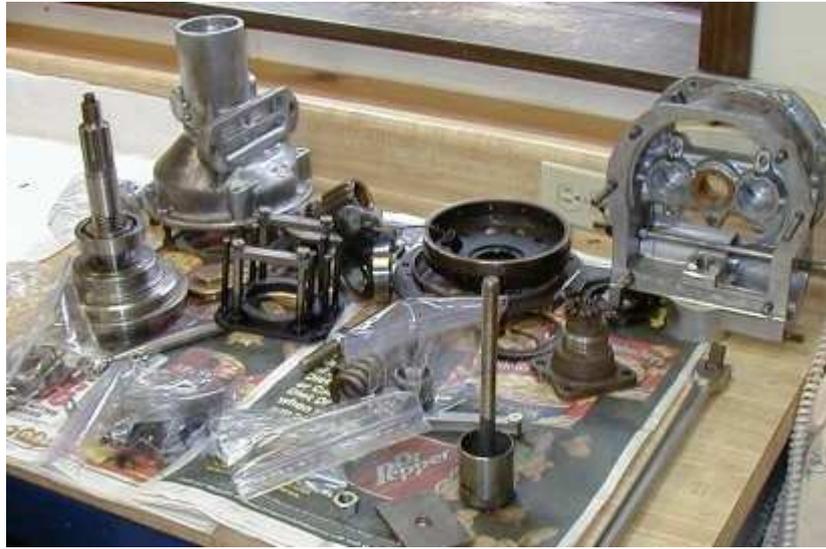
All the parts: The photo below shows all the parts extracted from the OD unit after they had been cleaned up and packed with associated components.
