Austin Healey Roadster Windshield Post Repair

Courtesy Michael Salter

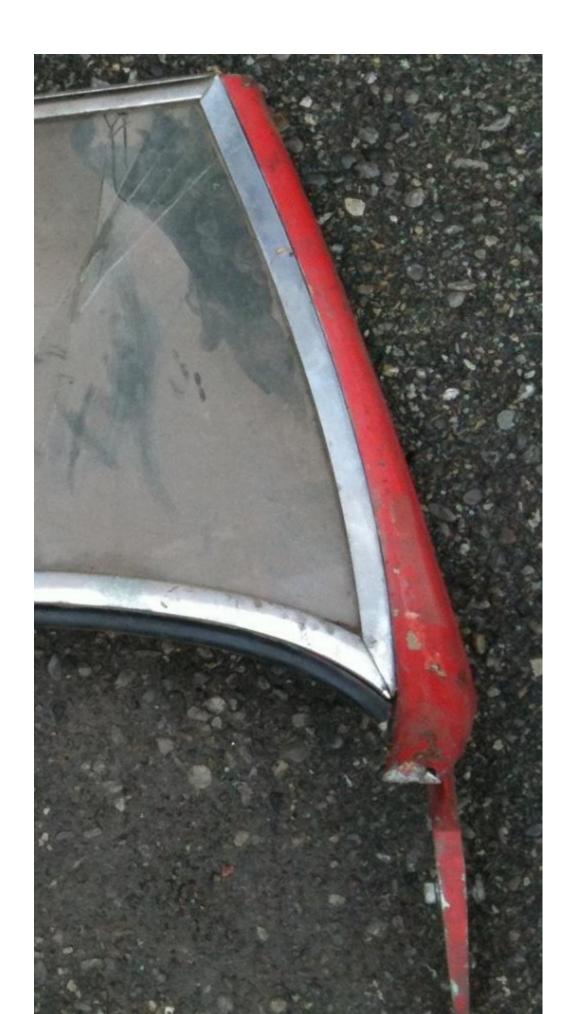
The windshield frame on the pre-1963 Healeys is secured to the windshield posts with four 10/24 chromed Phillips head steel screws.

The Red Part is the Post

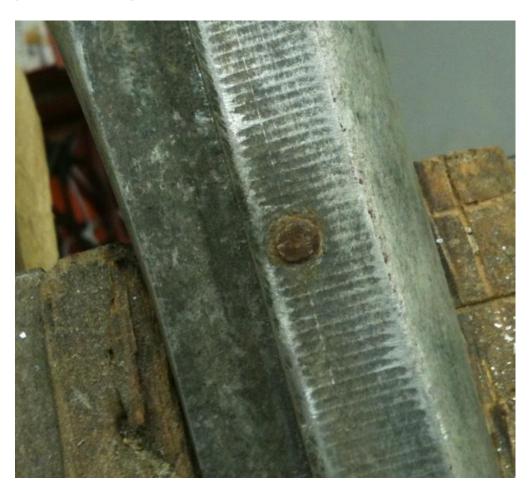
If the windshield has been fitted to a car that has been winter driven in areas where road salt is used it is very unlikely that you will be able to remove the screws without at least some of them breaking off. I have never had much luck removing steel threaded fasteners from aluminium when corrosion of this type has occurred. It seems that the aluminum forms aluminium oxide which swells into the space between the steel and the aluminum and jams the fastener completely. Heating usually works when you have a steel in steel situation but it is seldom successful when aluminium is involved. Try as you may the end result is usually something like this:

A Typical Broken Off Screw

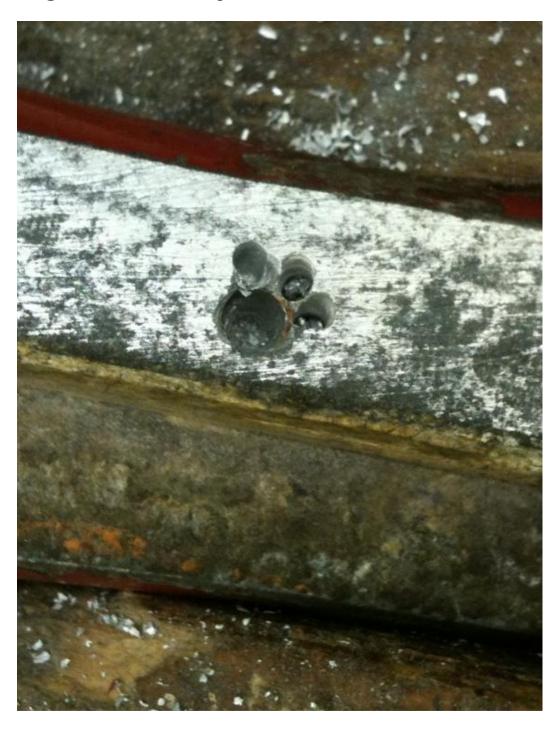
You Can Get About 8 Small Holes Around the Broken Off Screw

After many attempts I finally came up with what has proved to be a satisfactory if somewhat labour intensive method of saving the day!! this takes patience and a steady hand but, with windshield posts becoming harder and harder to find, it is worth the trouble. You start by drilling small (1/16" dia) holes around the entire perimeter of the broken off screw to a depth of about 5/8 ". Try to avoid drilling right through and definitely avoid breaking off drill bits as you do this.

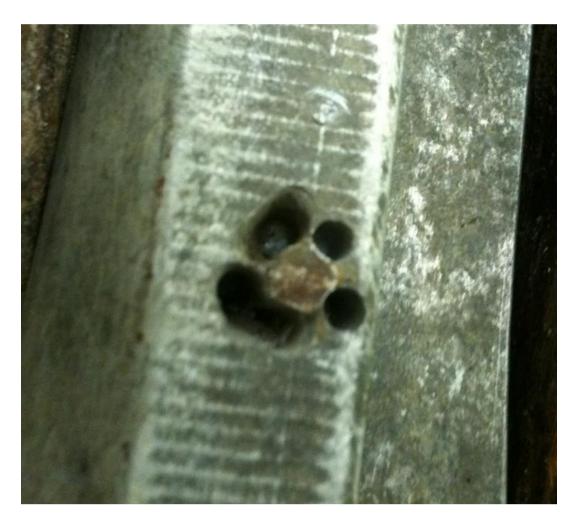
Enlarged Holes Will Start to Run Into Each Other

Once they are all drilled use a slightly larger bit to increase the size of the holes until they start to run into each other. Again proceed carefully and be careful not to break off any drill bits.

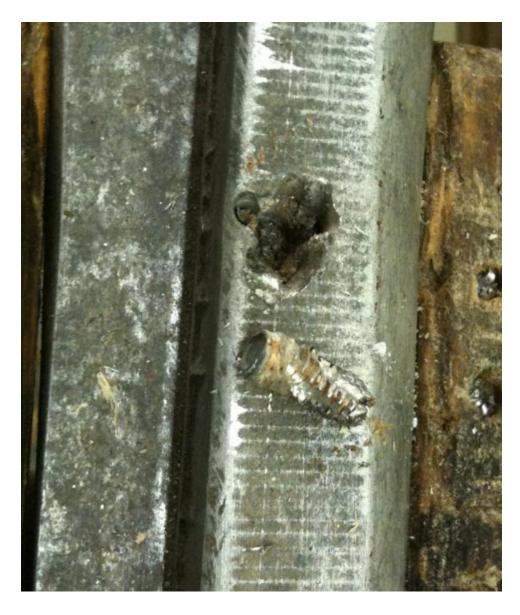
A Little Patience and The Broken Screw Can Be Removed
Once this is done you need to find a flanged 10/18 Rivnut.
These are usually used to install a threaded nut into sheet metal and are available at most good hardware stores.

Once this stage has been reached use a small pin punch to tap the broken off screw sideways back and forth until it becomes loose in the hole and can be lifted out with needle nose pliers.

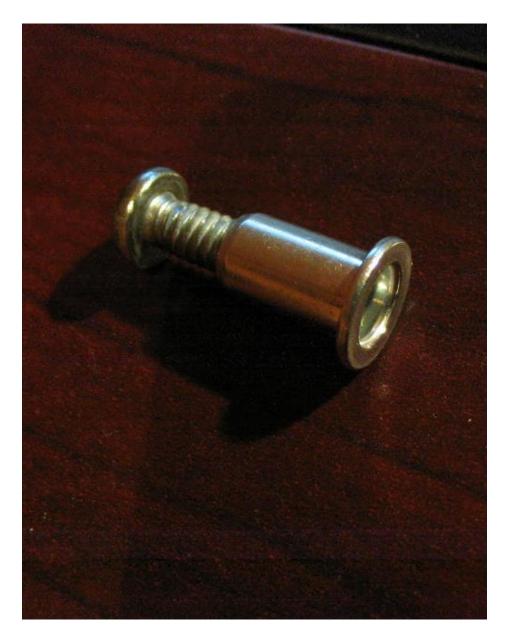
A Flanged 10/18 Rivnut. (This one as a 10/18 screw in it.)

The outside diameter of the flange on these is usually about 7/16". This is too big for our purposes so I usually mount one in my drill press on a piece of threaded bolt and with the drill press running run a file on the edge of the flange to decrease its diameter to almost nothing resulting in a flange of just under 5/16" outside diameter. At this stage I often

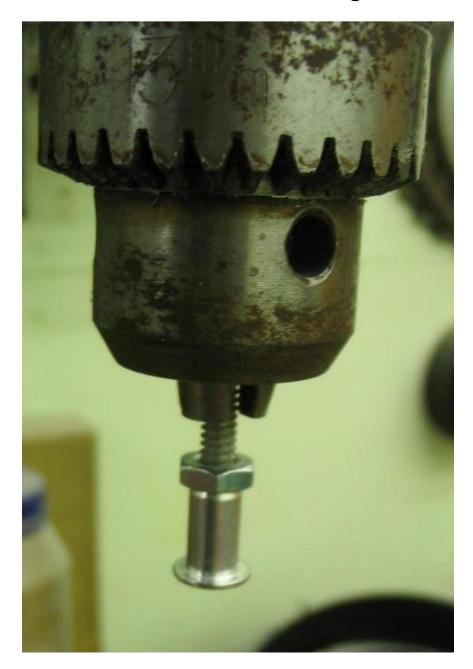
Rivnut Drill Ready for Filing Down

roughen up the outside of the Rivnut barrel to assist with adhesion of J B Weld used in the next stage.

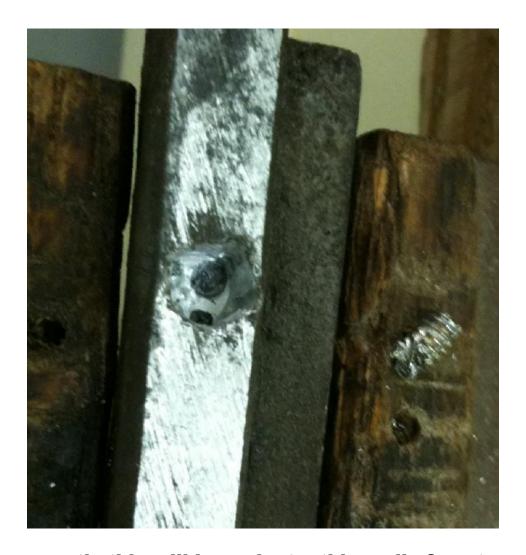
Once I'm happy with this I drill out the ragged hole in the windshield post to 5/16" diameter.

Done correctly this will leave just a thin wall of post on either side of the hole. Next slide the Rivnut, flange first, into the hole.

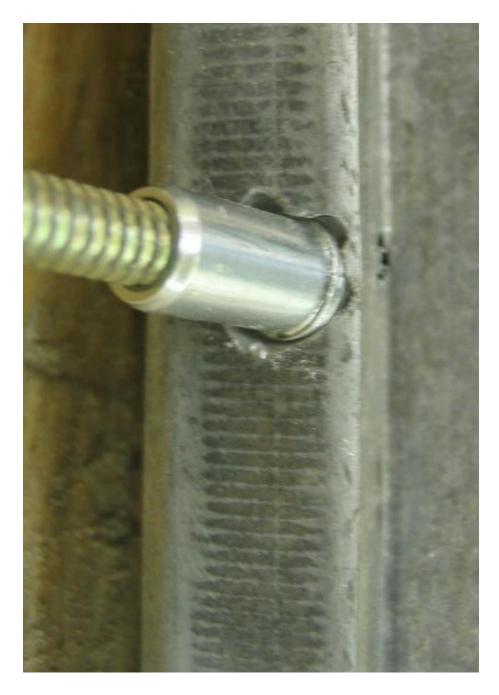
The Flange Has to be Small Enough To Fit Into The 5/16" Hole

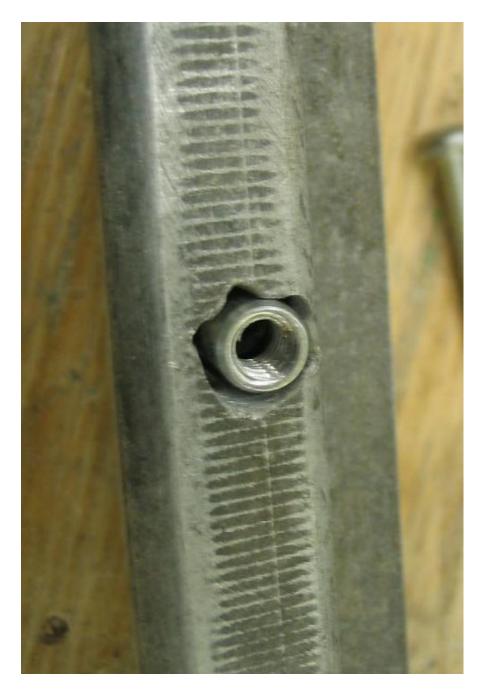
When The Hole is Deep Enough The Top of The Rivnut Will be Flush With The Post Surface

The hole has to be deep enough to entirely accommodate the modified Rivenut.
