I have recently had to remove the grille surround from my 3000 Mk II. This is a tedious job and only possible with the radiator, air deflectors and splash panels out; it's sensible to remove the fan at the same time...access is everything. With the grille out and posted off to be restored I had time and space to fettle everything in that area. The trafficator was centralized. The wiring loom and offshoots (headlights, side/indicator lights and horns) was correctly routed and clipped down. The whole area was cleaned up with Gunk. The grease nipples were removed, cleaned and cleared and all points greased up. The shock tower nuts were checked; these loosen themselves off and everyone should check them, at least annually. Oil levels in the steering box and idler were checked. Did you know that some people put STP Oil Treatment in their steering boxes?? This stiffens up the oil and stops that irritating seepage past the sealing olive where the wiring emerges for the horns and indicators. And, of course, I took the thermostat out and tested it.

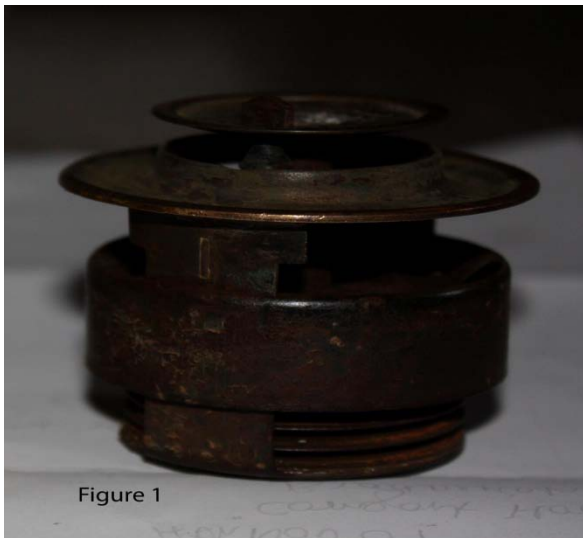
Figure 1

This is what I found, per figure 1. It is an AC Delco version of the Smiths Thermostat that would have been fitted by the factory back in the 60's. It is a model TF1, opening temperature 72° C. It is quite dead, immersion in boiling water yielding only the slightest movement. Note that it has died in the "open" position so that coolant will circulate through the radiator as soon as the engine is fired up. In fact, the thermostat might just as well not have been in the car. I have heard it said that our thermostats usually die in the "shut" position and I've seen that in other vehicles;

all I can do is report what I found.

at least to 3000 owners whose cars can be prone to overheating issues..... The thermostat has a "sleeve", the round skirt like thing above the bellows just visible in figure 1.

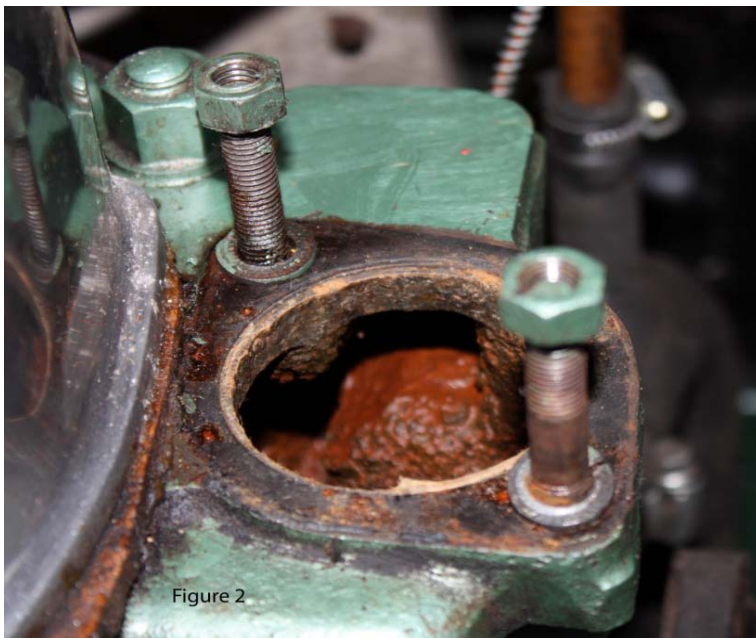
Figure 2

removed from the block. (Take off hose, remove two nuts and washers and prise judiciously upwards and off). The hole is visible in figure 2, though just barely. Look at the black area under the furthest section of the thermostat's seating position. That black area is the shadow where the bypass hole vanishes off into the block. Thus, it is plain that the bypass hole is quite large and that it is close enough to the thermostat's top plate for the sleeve to be able to rise up and block it off.

The sleeve's function is to progressively block off the bypass hole in the block as the engine heats up. When the bypass hole is open, the coolant can only go through the open thermostat and into the radiator via the top hose. This bypass hole can be found as soon as the so-called "outlet elbow" is

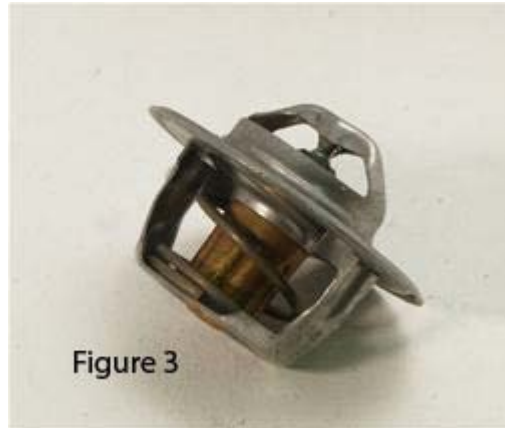
Figure 3 shows a modern thermostat. It has no sleeve. When the top is closed, coolant will flow through the bypass hole only. When the engine heats up sufficiently, the top will open and water will pass into the radiator. BUT, the bypass hole will still be accessible and a sizeable proportion of the coolant will flow through it and back to the hottest part of the engine. Thus that coolant will not go through the radiator and is, in effect, wasted. That is the key issue here, most important in cars prone to overheating.

There is also a modern equivalent, available, I believe from Moss Europe. It looks like figure 3 but with a sleeve and I'd suspect that someone, somewhere, is having sleeves tacked onto limited numbers of ordinary modern units. Their prices suggest that the sleeves are pure gold and that the work is done in the Rolex factory. One could probably do or have the job done oneself....take the sleeve of a dead old unit and tack it onto a new one?? Or, one could go down the Jaguar route. People suggested that Jags had bypass holes and their thermostats are still available. I did not go down that track as I was successful elsewhere.

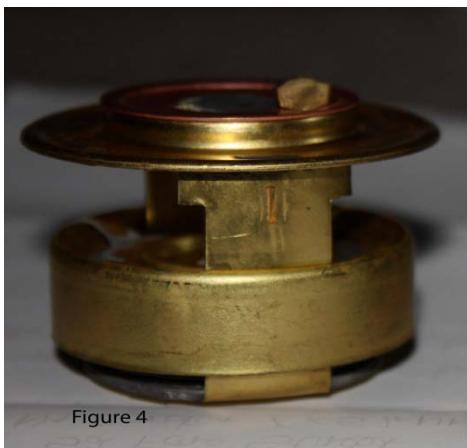
Figure 4 shows an unused and fully functional TF1 old style thermostat. It is cold so the top is closed and the sleeve is down which would make the coolant go through the bypass hole. The little flat six sided object at the thermostat's top right is a "jiggle pin". When the system is being refilled, this pin permits the upward passage of air, effectively bleeding the system...water goes in as one fills up the radiator and the displaced air comes right out. A modern thermostat, figure 3, has no jiggle pin and one needs to top up with water whilst running the engine up to operating temperature.

Figure 4 shows an unused and fully functional TF1 old style thermostat. It is cold so the top is closed and the sleeve is down which would make the coolant go through the bypass hole. The little flat six sided object at the thermostat's top right is a "jiggle pin". When the system is being refilled, this pin permits the upward

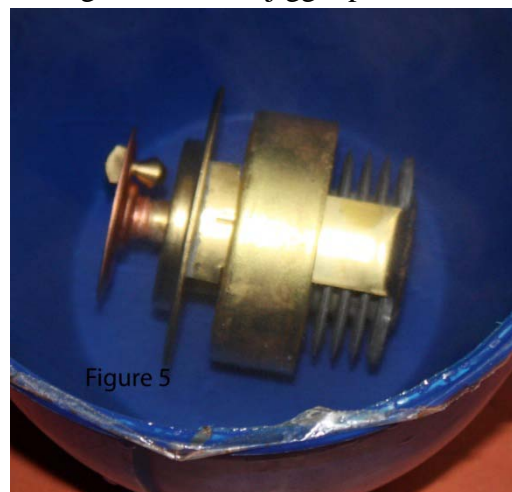
Figure 5 shows a TF1 in very hot water. The top is open, to the left, and the sleeve is up exposing the gas filled bellows; coolant cannot access the bypass hole and all of it passes into the radiator. The jiggle pin is shown to advantage at the top of the thermostat.
