Simon Lachlan
November '09

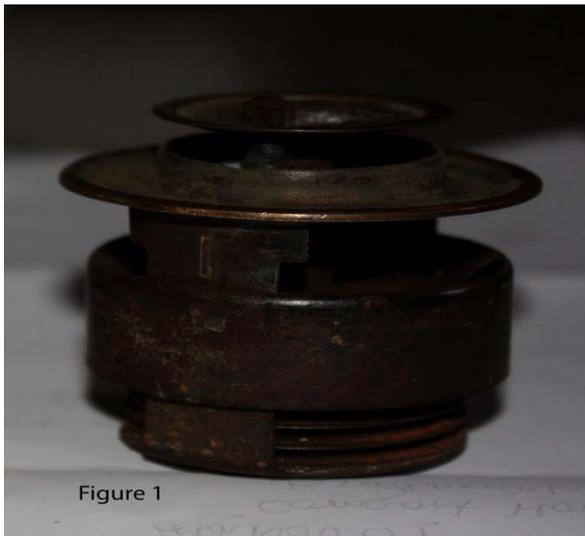
Figure 1

This is what I found, per figure 1. It is an AC Delco version of the Smiths Thermostat that would have been fitted by the factory back in the 60's. It is a model TF1, opening temperature 72° C. It is quite dead, immersion in boiling water yielding only the slightest movement. Note that it has died in the "open" position so that coolant will circulate through the radiator as soon as the engine is fired up. In fact, the thermostat might just as well not have been in the car. I have heard it said that our thermostats usually die in the "shut" position and I've seen that in other vehicles;

at least to 3000 owners whose cars can be prone to overheating issues..... The thermostat has a "sleeve", the round skirt like thing above the bellows just visible in figure 1.

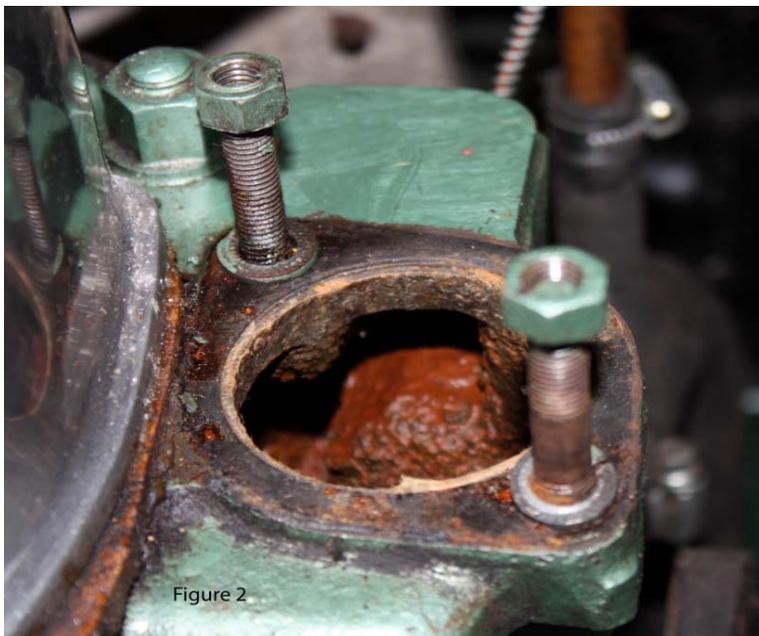
Figure 2

removed from the block. (Take off hose, remove two nuts and washers and prise judiciously upwards and off). The hole is visible in figure 2, though just barely. Look at the black area under the furthest section of the thermostat's seating position. That black area is the shadow where the bypass hole vanishes off into the block. Thus, it is plain that the bypass hole is quite large and that it is close enough to the thermostat's top plate for the sleeve to be able to rise up and block it off.

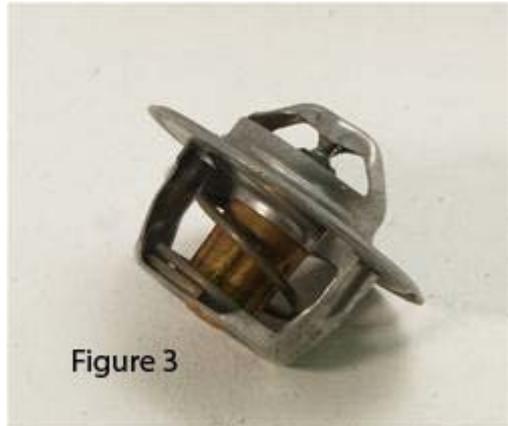
Figure 3 shows a modern thermostat. It has no sleeve. When the top is closed, coolant will flow through the bypass hole only. When the engine heats up sufficiently, the top will open and water will pass into the radiator. BUT, the bypass hole will still be accessible and a sizeable proportion of the coolant will flow through it and back to the hottest part of the engine. Thus that coolant will not go through the radiator and is, in effect, wasted. That is the key issue here, most important in cars prone to overheating.

passage of air, effectively bleeding the system...water goes in as one fills up the radiator and the displaced air comes right out. A modern thermostat, figure 3, has no jiggle pin and one needs to top up with water whilst running the engine up to operating temperature.

There is also a modern equivalent, available, I believe from Moss Europe. It looks like figure 3 but with a sleeve and I'd suspect that someone, somewhere, is having sleeves tacked onto limited numbers of ordinary modern units. Their prices suggest that the sleeves are pure gold and that the work is done in the Rolex factory. One could probably do or have the job done oneself...take the sleeve of a dead old unit and tack it onto a new one?? Or, one could go down the Jaguar route. People suggested that Jags had bypass holes and their thermostats are still available. I did not go down that track as I was successful elsewhere.

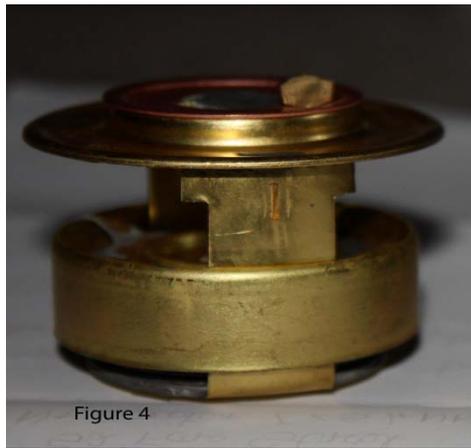
Figure 4 shows an unused and fully functional TF1 old style thermostat. It is cold so the top is closed and the sleeve is down which would make the coolant go through the bypass hole. The little flat six sided object at the thermostat's top right is a "jiggle pin". When the system is being refilled, this pin permits the upward

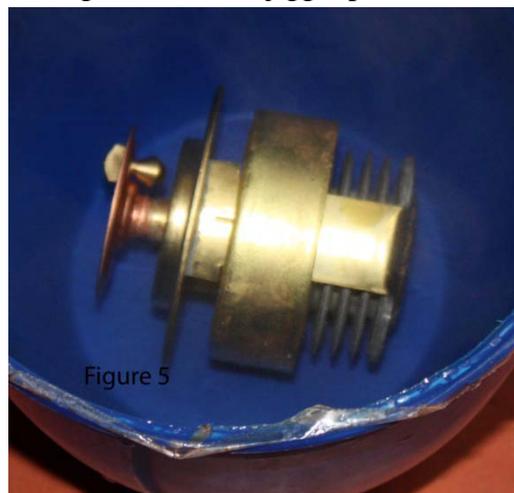
Figure 5 shows a TF1 in very hot water. The top is open, to the left, and the sleeve is up exposing the gas filled bellows; coolant cannot access the bypass hole and all of it passes into the radiator. The jiggle pin is shown to advantage at the top of the thermostat.
