A Type Overdrive, Part IV Final Assembly & Testing

By Nelson Riedel, nriedel@nextek.net

Initial 8-01, last revised 2-04-02

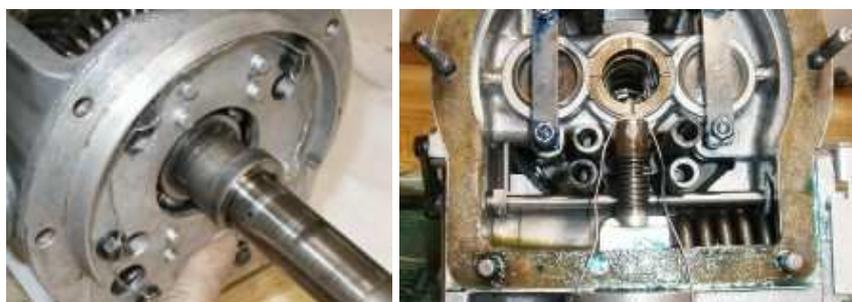
The dummy mainshaft was then rotated so that the spline was at the top and this position marked by putting a dab of Whiteout on the rear flange opposite the parting line at the top of the rear casting. The dummy main shaft was removed and a small amount of oil was poured into the main shaft hole.

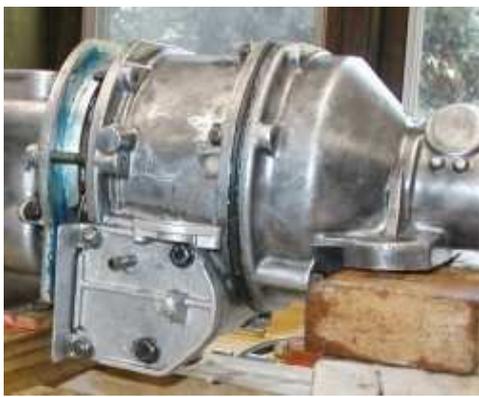
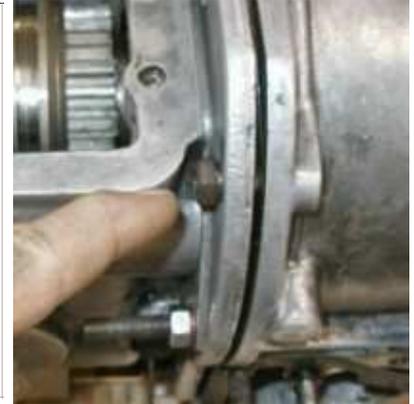
Mating OD to Gearbox: The OD was slid over the gearbox mainshaft and the back end was shored up with blocks as shown in the left photo below. The OD was then pushed toward the gearbox (or as the manuals say, offered up) while rotating the mainshaft back & forth till the splines on the mainshaft mated with the planet carrier and then the unidirectional clutch. Lock washers and nuts were put on the two long studs and used to draw the OD to the gearbox. The nuts were tightened alternately a couple turns each while rotating the mainshaft back & forth. When the mainshaft became hard to turn, both nuts were loosened until the shaft turned freely and then the back of the OD was wiggled --- the other studs seem to bind entering the adaptor plate and wiggling the OD freed them. A very minimum torque was used on these nuts. If the nuts are hard to turn, they should be backed off because something is hung up. Once the OD was closed within an inch or so, a screwdriver was used to push the springs forward and over the nipples on the adaptor plate (center photo below). The OD was then drawn further toward the gearbox until enough of the short studs were protruding so that lock washers and nuts can be screwed on. The top nuts must be screwed on before the OD is against the adaptor plate, there will be insufficient gap at that time to slip the nut over the end of the stud --- see right photo below. The wire holding the pump down was clipped and removed when there was about a 0.1 inch gap between the OD and the adaptor plate. The OD was then pulled to the gearbox by tightening the nuts on the two long studs. Once the OD was against the adaptor plate, the other four nuts were tightened. (Tightening the lower two nuts before the the OD is against the gearbox is one way to bend the adaptor plate.)

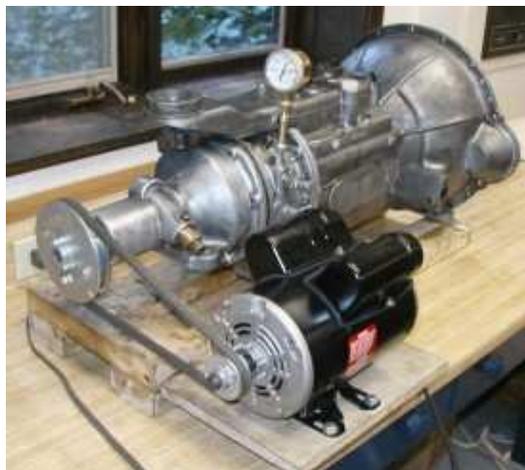
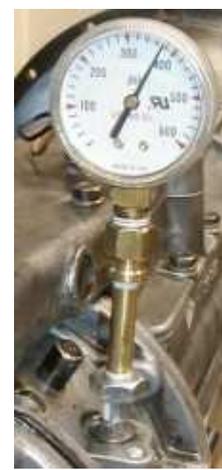
My setup is shown in the center photo below., An inexpensive 5 inch die cast pulley mated well with the OD output flange. I tried to get a 1 3/4 inch pulley for the motor but the smallest size the local stores had was 2 inch. I had a bunch of belts from some previous long forgotten project that were just the right length but too narrow for the pulleys. Used them anyway, worked fine and reduction was 2.7:1 so had ~ 1300 RPM. The board holding the motor is hinged where it attaches to the stand. This was intended to be sort of a clutch ---- lift the motor and let the belt slip to start. Turned out that is was not required since the motor had lots of starting torque, the load was light and the wrong width belt slipped a bit when starting. The motor can be removed when not in use by slipping out the hinge pins.

Ronnie had found a 0 to 800 psi gauge locally (in central Georgia) for less than \$10. After a few telephone calls I found that our welding supply store stocked a similar gauge for ~\$9. The gauge input is a 1/4 inch male pipe thread. (I understood that a liquid filled gauge would be better because it wouldn't vibrate as much; I planned to try to find one later.) The gauge screwed into the adaptor discussed earlier for injecting compressed air. **Caution, operate and release the operating valve using the lever or solenoid a half dozen times to relieve the pressure before removing the operating valve plug.**

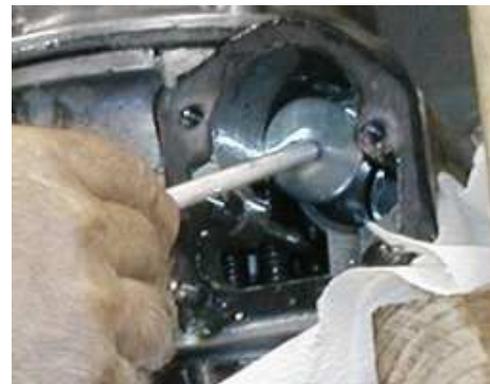
The pressure was at about 310 psi and needed to get to be 450psi, so needed an increase of 140psi. Decided to try two washers behind the spring. Turned the gearbox on the front to let oil drain out of the OD

(this is a test that needed to be run anyway to see if front seal leaked -- it didn't - yet). The cover plate was removed (nuts on studs first, then the bolts beside the spring, slackened together). **Caution, operate and release the operating valve using the lever or solenoid a half dozen times to relieve the pressure before removing the cover plate.** Then put in two washers (photo on right), put it back together and fired it up. Pressure went to about 360 --- about 25 psi increase per washer. The washers were 1/16 inch thick just like the one Ronnie used, but this is a different type accumulator and spring.

Next tried 6 washers and got a pressure of above 550 psi, an increase of over 240 psi, or a little over 40 psi per washer.

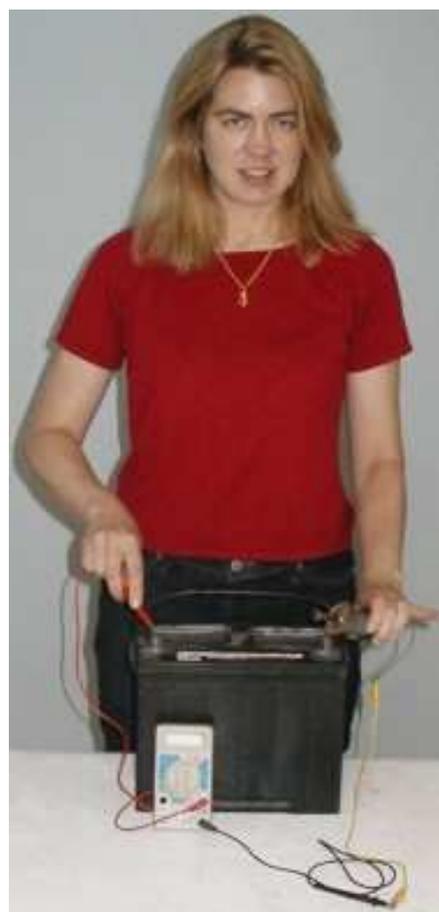
The engineer set the multimeter to the 20 ampere current range and connected the negative (black) probe to the solenoid lead using the yellow clip lead. The positive (red) probe was held against positive battery terminal and the solenoid case was touched against the negative battery terminal. The first test was made with the plunger removed. We read 16 amperes on one and 17 amperes on a second solenoid. Next, she measured the current with a plunger in the solenoid. When the current was applied this time, the plunger snapped into the solenoid and the current read about one ampere, just as it should. She explained that with the plunger in the solenoid, the initial current is about 17 amperes until the plunger reaches the back of the recess and operates a switch to remove the high current pull-in coil and leave only the low current holding coil in the circuit. She must have checked out the schematic at the end of Part I.

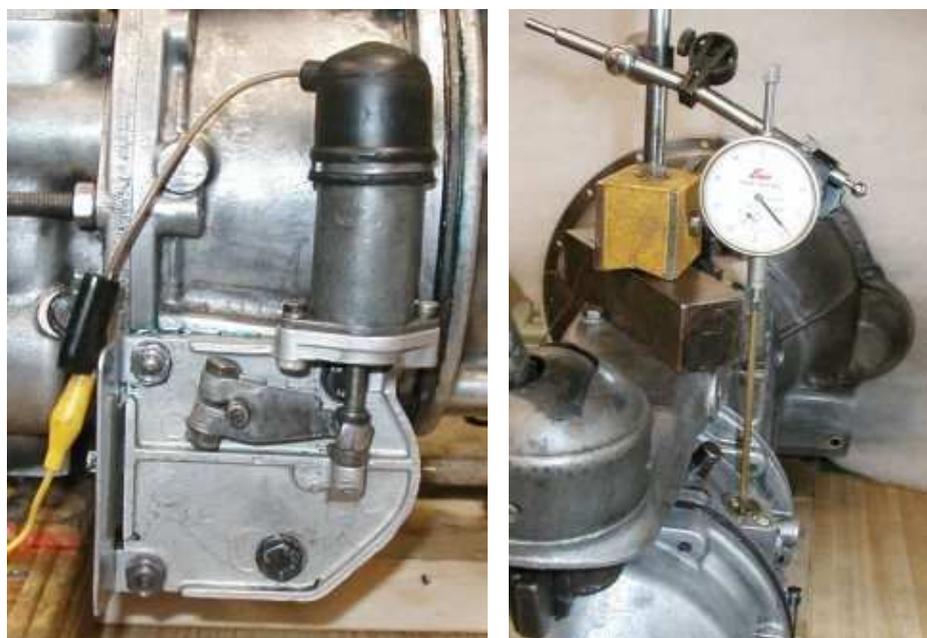
Adjusting the Operating Valve: The manuals talk about putting a 3/16 drill through the hole in the lever on the outside of the case below the operating valve and in a matching hole in the main casting. This is supposed to position the operating valve open the correct amount. The solenoid is then operated, the actuating lever pushed down against the bottom lip of the plunger and the pinch bolt then tightened. This may have worked when new, but not on these old worn units. In most cases I've seen, the valve is still closed in the position with the drill in the holes.

It was decided to use a dial indicator to adjust the valve as shown in the right photo below. The plug and spring were removed and a length of 5/32 inch OD - 1/8 inch ID brass tube (hobby store) was placed over the end of the plunger and the combination then placed between the ball and the dial indicator. The solenoid was not operated without something over the ball --- didn't want to be dodging steel balls --- the solenoid is a very effective ball launcher (bit of experience speaking here). While messing around the lever was turned too far and the end of operating valve spindle (the long thin shaft) dropped past the lever to the bottom of case --- used that bent wire again to retrieve it.

The lift adjustment is made as follows:

1. Loosen pinch bolt
2. Position the plunger with brass rod in the center of the ball and record the dial indicator reading.
3. Push the solenoid plunger up as far as it will go and then operate the solenoid (don't operate the solenoid with valve released --- shock is not good for the indicator).
