100 TECHNICAL CD-ROM

INTRODUCTION

This CD is a compilation of articles I have found, been given or written, which are specifically for 100's, or are of a general nature that may be of interest to 100 owners. Every owner whether they are concourse, runner or modifier types should be able to find something of interest, there are 460 pages so have a lot of reading ahead of you.

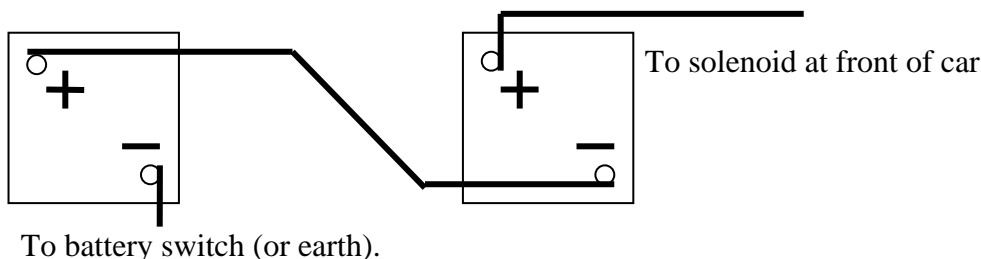
First disconnect the batteries and if your car is Positive Earth (alternators are negative earth) turn them around and reconnect as shown below. Leave one lead disconnected until the rest of the electrical work is finished.

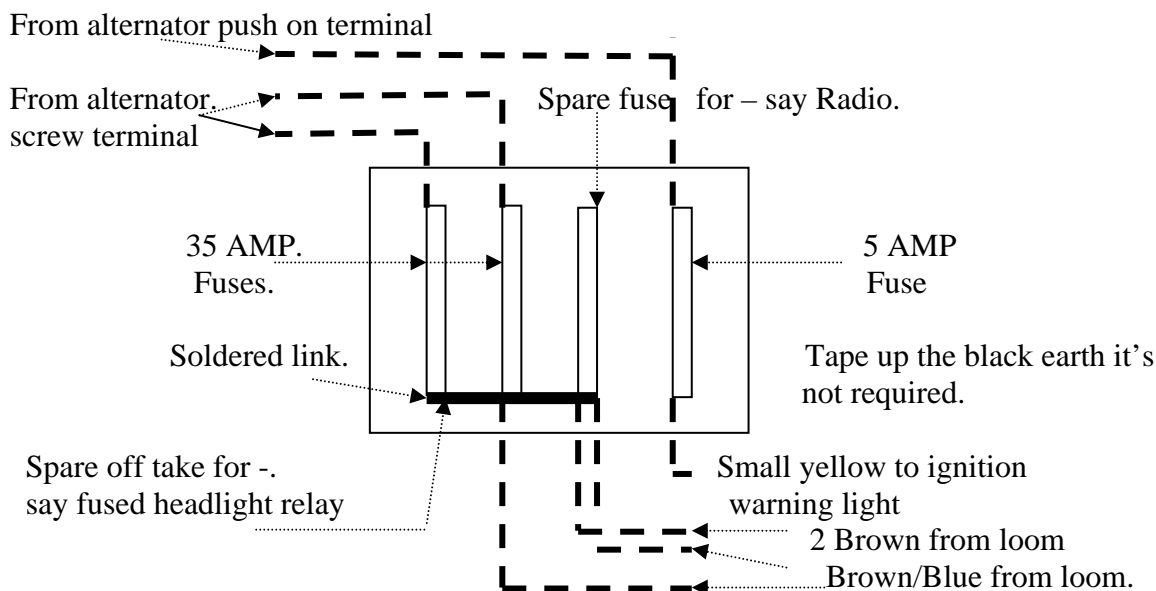
Disconnect and remove the Voltage Regulator. Mount a 4 (or more) terminal junction or fuse box in it's place and wire up as below. First solder a link of copper or wire across the underside of the 3 left hand lower connections, if it has push on connections use piggyback connectors and solder across these. You can use the existing generator wires, but as alternators charge from 35 up to 85 AMPS against the generators 22. It is best to replace the original with two 20 AMP ones from the screw terminal on the alternator and a 5 AMP one from the push on terminal (tape up both ends of the old ones).

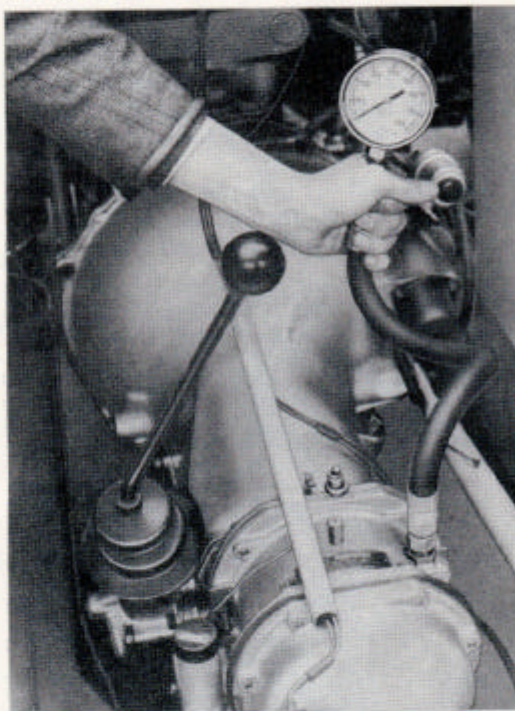
STR 1570

Successful operation of the overdrive unit, as fitted to the Austin-Healey 100, depends to a large extent on maintenance of oil pressure and it is essential that this pressure be checked if any repairs have been carried out or the oil emptied from the gearbox and overdrive unit.

The adaptor, 7H 5899 mentioned is no longer required, as it is now part of 18G 251.

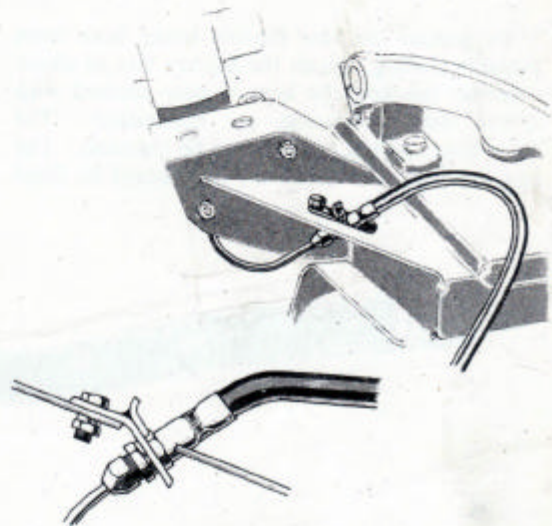
STR 1685

Replacement chassis frames will be supplied without the bracket which must be ordered separately.

New arrangement.

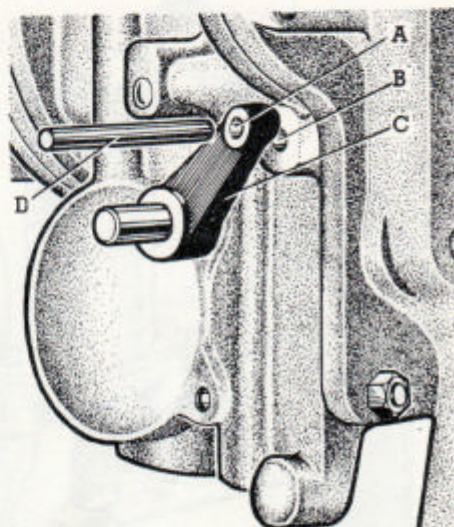
Fig. 1

1. Insert a $\frac{1}{8}$ " pin (D) through the hole (A) in the setting lever (C) into the setting hole (B) on the right hand of the casing. The operating valve in the unit is now held open. Fig. 1.
2. If the solenoid bracket is of the closed type (Fig. 2) remove the cover plate.
3. Loosen the solenoid lever clamping bolt (A). Figs. 2 and 3.
4. Break the snap connector on the solenoid lead and connect through an ammeter to the battery negative, thus energising the solenoid.
5. Check that the current used is about 1.0 amperes. A current of 18-20 amperes indicates that the operating coil is not being open circuited when the plunger is fully home, and that the solenoid is faulty, and must be replaced.

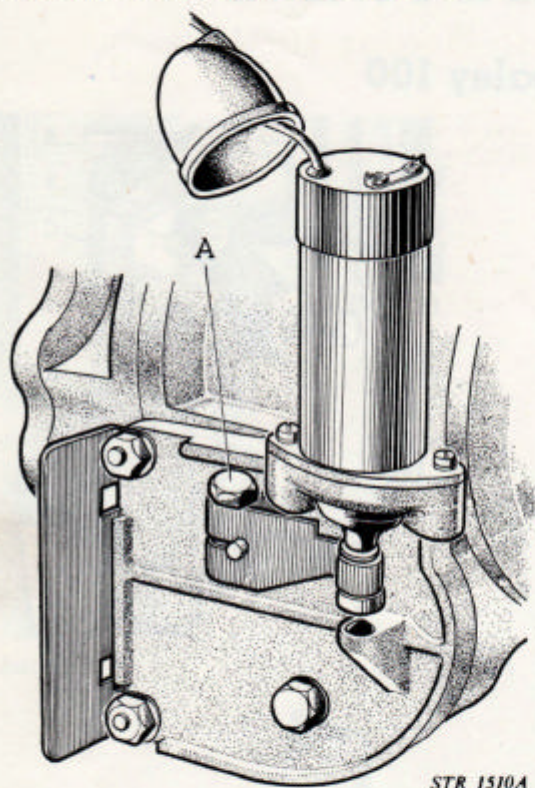
6. Hold the solenoid lever down against the plunger collar.
7. Retighten the lever clamping bolt, taking care that there is no end play in the cross shaft.
8. Remove the locating pin from the right hand side of the gearbox.
9. Operate the solenoid several times to check the setting and ensure that the current is about 1.0 amperes. If the current is 18–20 amperes, as was previously 1.0 amperes in operation 5, it will be necessary to reset the solenoid lever again.

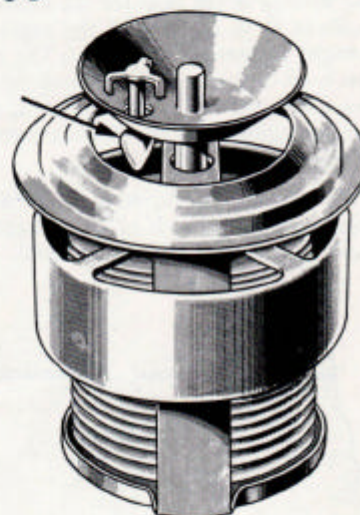
NR 1655

A new thermostat incorporating a 'jiggle-pin' in the vent hole—see illustration, has been introduced. The purpose of the 'jiggle-pin' is to prevent the vent hole from becoming blocked with rust or dirt, and to ensure rapid warming up from cold. When the engine is stopped the pin hangs down under its own weight leaving the vent hole open to ensure that an air lock does not occur when the engine is refilled with water after draining. When the engine is running the pressure of water from the pump forces the pin to rise and seal the vent hole, thus completely closing the waterway until such time as the engine is warm and the thermostat opens.

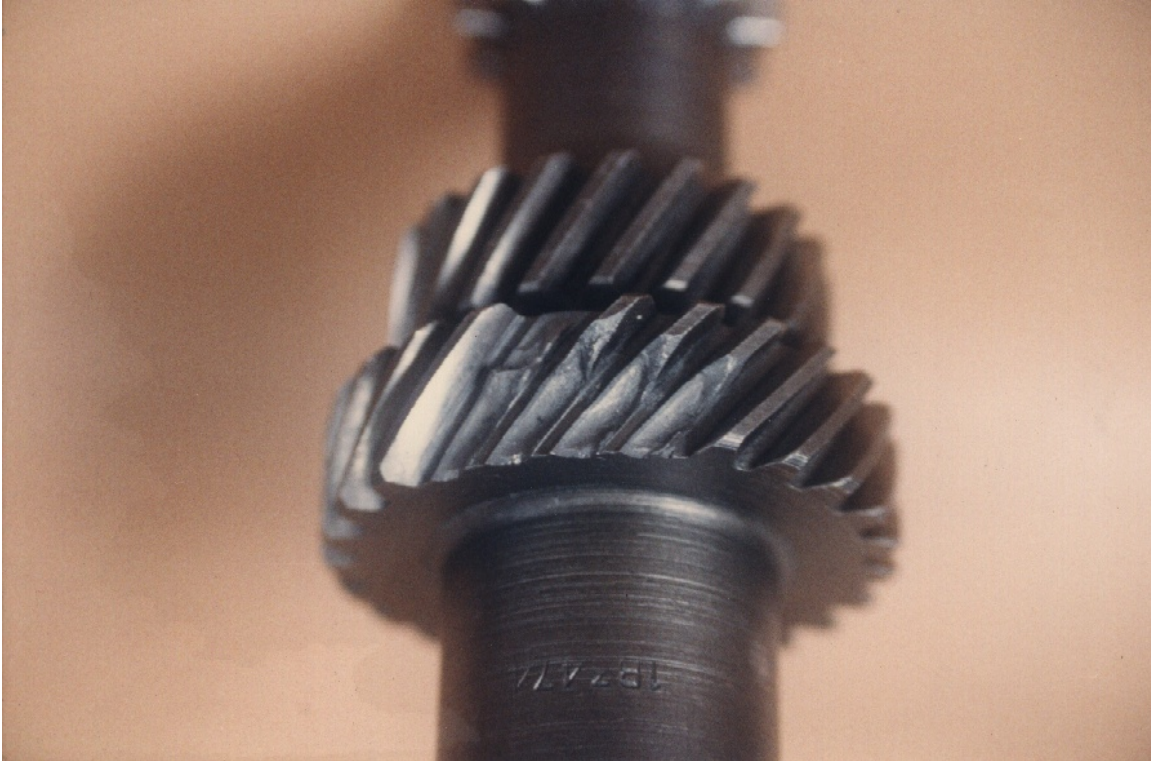
In March 1988 just 6 months after I bought the Healey the gearbox cluster 2nd gear lost one tooth and part of three others.

Club spares had an A70 gearbox, so with a rebuild using the best parts (as the original box had A70 gears) and new bearings we were back on the road fairly quickly.

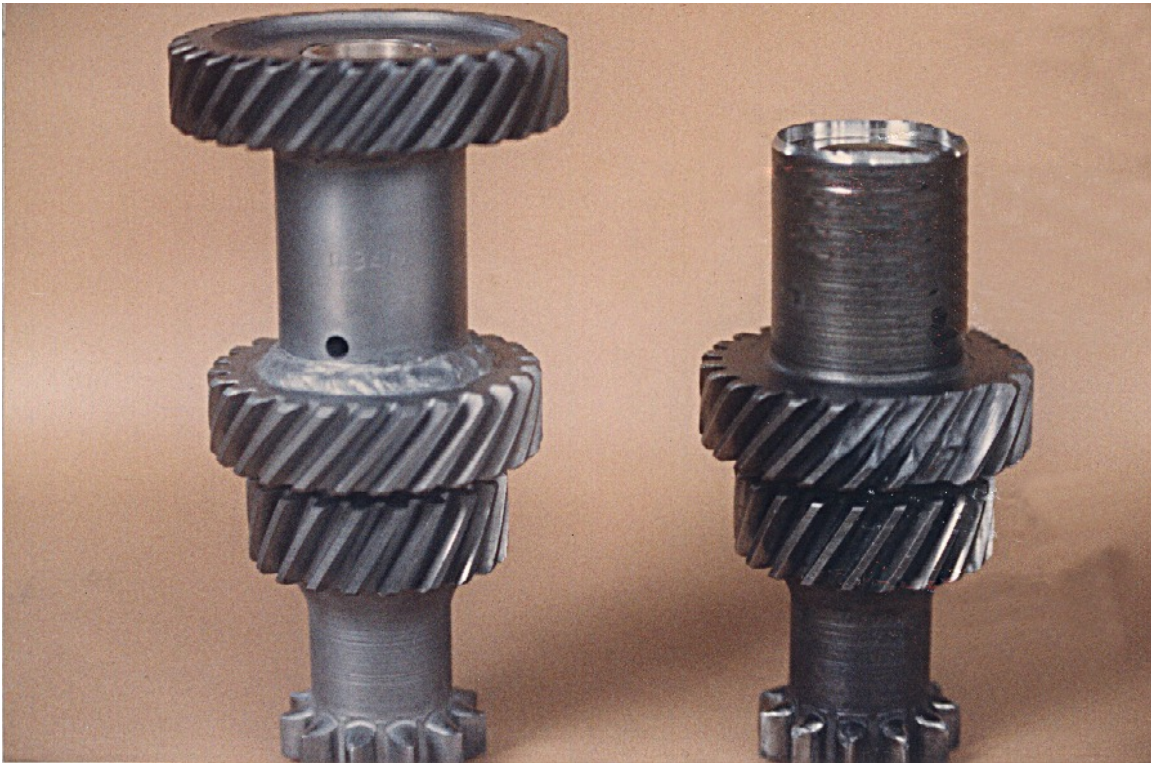
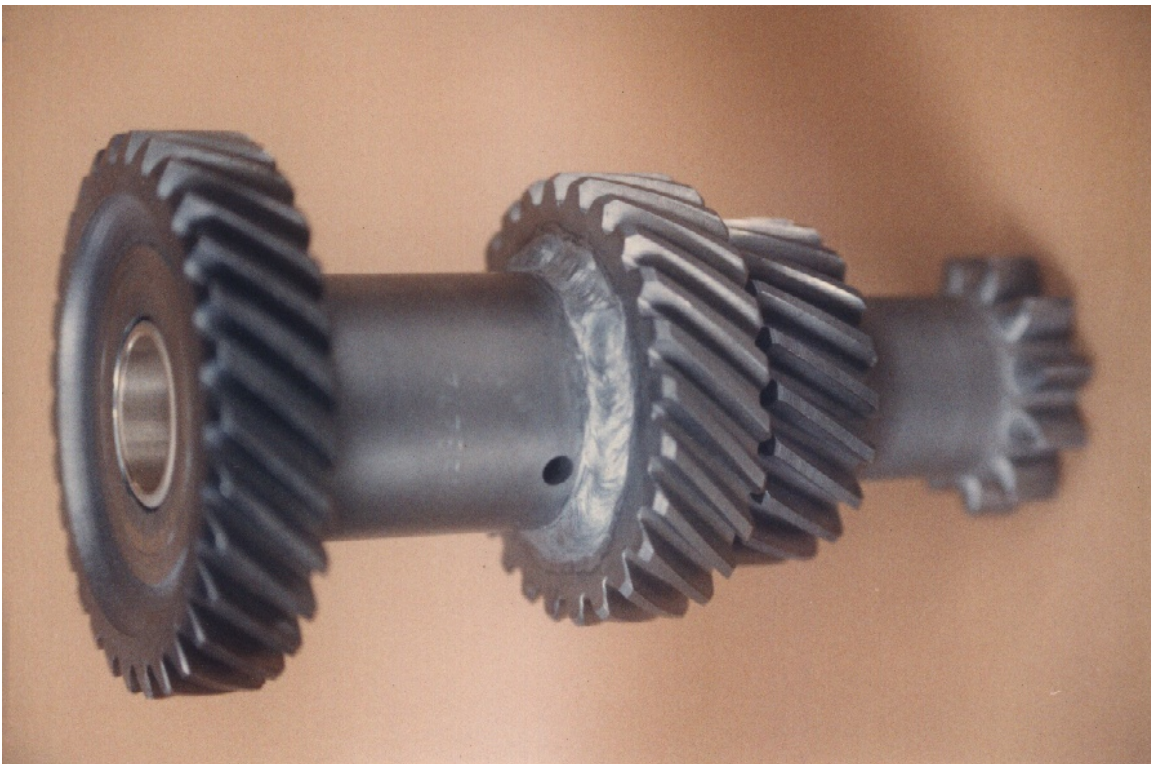
The repaired cluster and the remains of the donor.

The repair has now done 62,984 miles, so hopefully it will go for many more. I must admit I try not to stress 2nd gear with high revs at full throttle.

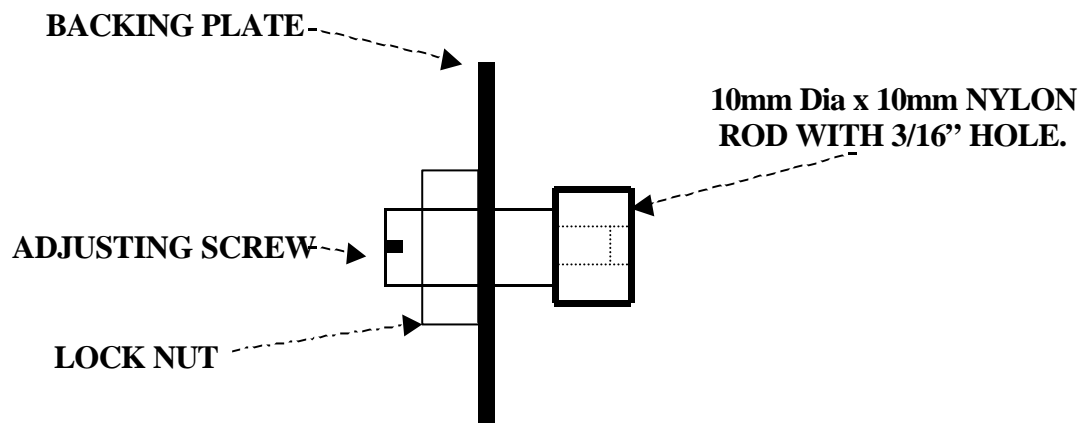
Further to Barry Campbell's Technical Report on Brake Shoe Steady Posts in last months Flat Chat, I have been wearing Nylon End Caps on my Steady Posts successfully for many years (a la Rover 90). The cap is a 10mm length of 10mm dia Nylon rod with a 3/16 inch dia hole down through its middle. It fits over the end of the post, in place of the felt bush, the brake shoe web bears against it and the adjustment is done the same as before. This gives quieter operation (as most felt bushes are long gone), less friction and virtually no wear to the shoe or post. Most shoes are worn where they bear against the post so nothing is to be gained by not taking the hole right through the cap.

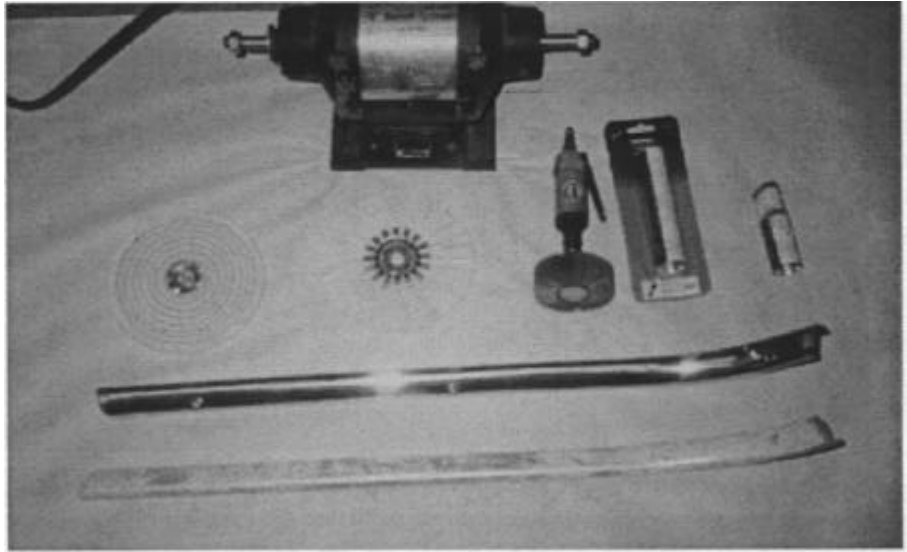
If you have an unrestored roadster, the aluminum cockpit surround has gotten scratched and bruised over the years. I bet you would like it to be bright and shiny again. I asked my local chrome shop what they would charge to remove the scratches and polish the surface of the surround. \$10 per foot says he! I started measuring and came up with \$120-130 for the job. That seemed like a lot of money to me. I figured if my chrome shop guy could do the job, so could I. It's really not that hard. You'll need some equipment, however. The first picture shows what you'll need; a **bench grinder** (Eastwood recommends a motor speed of 3400-3600 RPM) with the guards removed, **buffing pads**, one **closely woven** and one **loosely woven**, a **die grinder** or **drill motor**, **120 grit flapper wheel** (or a powered hand sander) and a stick of **Tripoli** compound for rough polishing and a stick of **White Rouge** compound for finish polishing. All of the required items can be obtained at Sears or Home Depot. If you already have a bench grinder and sander, the rest of the items can be purchased for less than \$20. You'd still save money over having a shop perform the work even if you had to buy all the equipment, including the grinder and sander. Shown in the bottom portion of the picture is a before and after shot of a piece of aluminum door trim. The trim can be brought back to a "chrome like" sheen,

What follows is a step-by-step procedure to make aluminum shine like new. Be sure to wear eye protection during these operations. The picture shows the surface being prepared for polishing. All the coating is being removed and all surface scratches are ground smooth. The finer the grit sand paper, the less polishing that will be required.

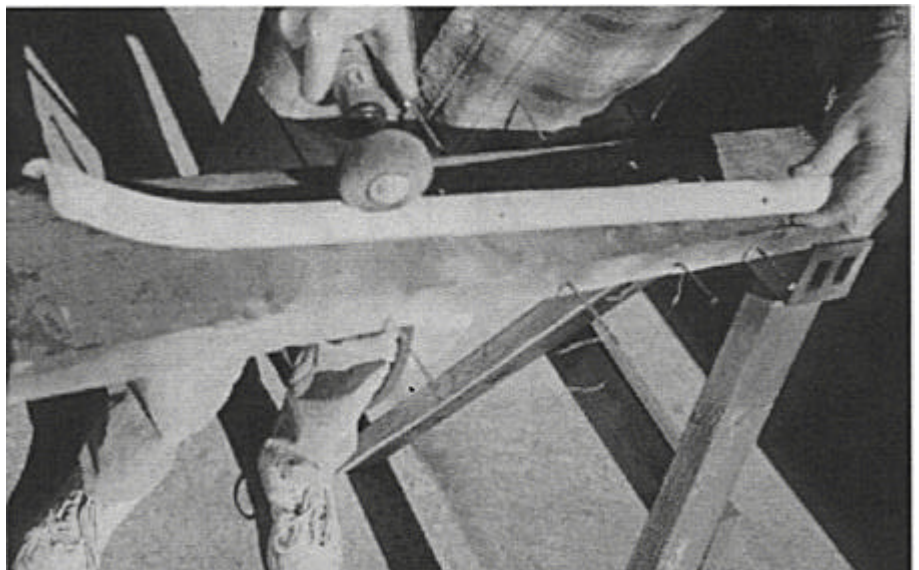
Once the surface scratches are removed, we begin the polishing process. The buffing pad used on the left side of the converted grinder has the **closely wound buff**. This pad will be used to **rough polish** the aluminum part. I used 2 pads on the left side to give more surface area to work the piece being polished. Load the buff with **Tripoli** while the grinder is running. Just press the stick against the surface of the buff until a small amount is transferred from the stick to the pad.

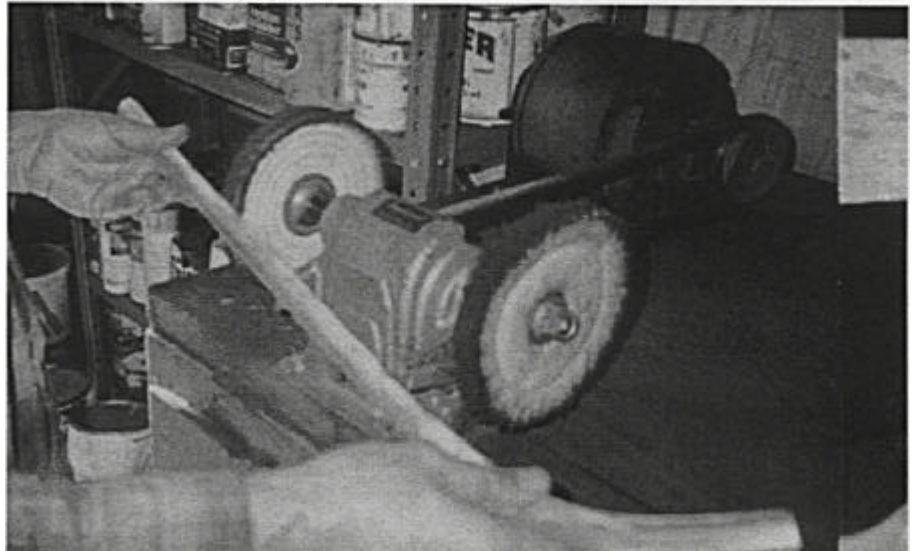
On the right side of the grinder is mounted the **loosely wound buff**. Using the same procedure as before, load the buff with White Rouge. This buff will remove any fine scratches remaining from the rough polish. Eastwood suggests moving the piece you're buffing with the direction of wheel rotation before final inspection. Remove any residue from the part with a soft cloth to expose the shiny surface. With a little practice you'll save yourself some money and learn a new skill.

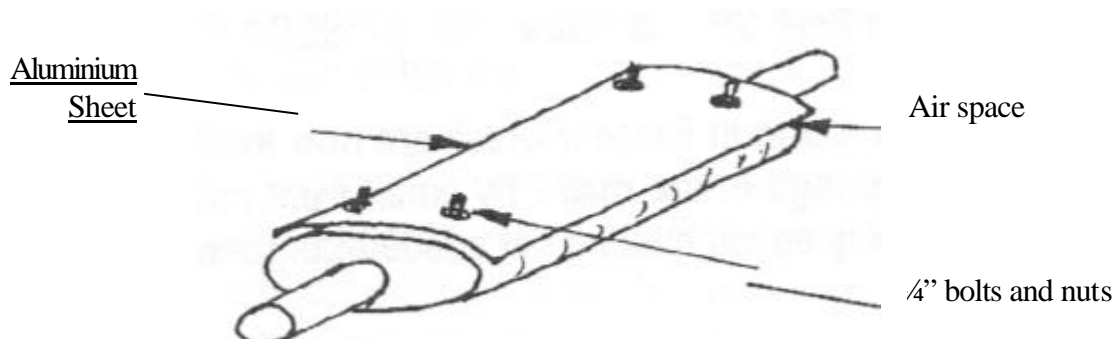
- 5) An additional shield can be fitted above the muffler, by welding four 1/4" bolts to the muffler and bolting on a curved sheet of aluminium, as shown in the sketch.

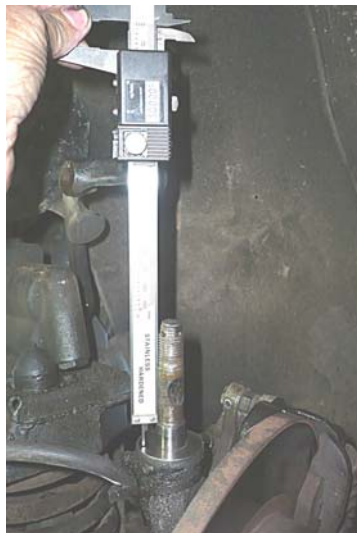
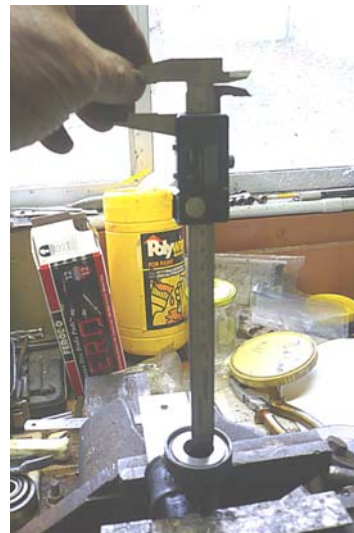
Measure the distance from the step on the king pin to the top of the stub axle and subtract the distance from the step inside the trunnion to the roller bearing fitted inside the trunnion to get the end float.

Install the thrust with sufficient shims to leave 2 thou end float, replace the trunnion and tighten the top nut. Check the end float by using a long screwdriver under the stub axle and over the wishbone to lift it and note the movement. Measure this end float, with the stub axle lifted up, between the bottom of the stub axle and the bottom of the king pin with Feeler Gauges and adjust the number of shims if necessary to get the required 2 thou end float.

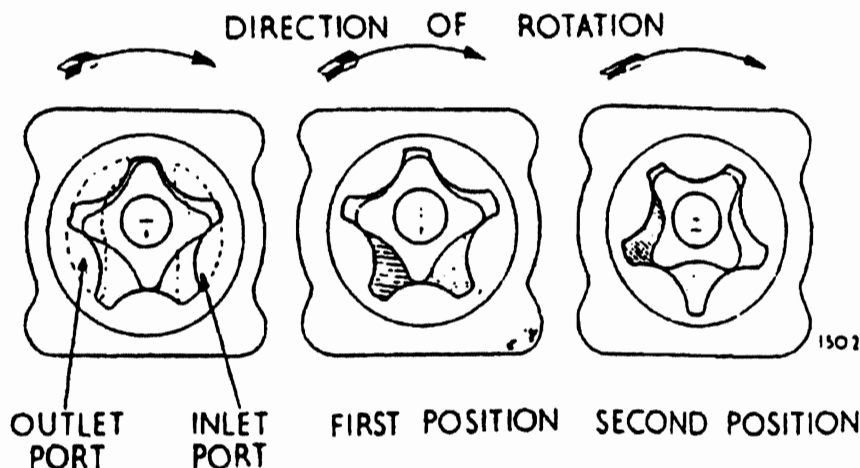
Figure 1: An eccentric rotor type oil pump has one lobe less than the number of internal segments in the outer rotor.

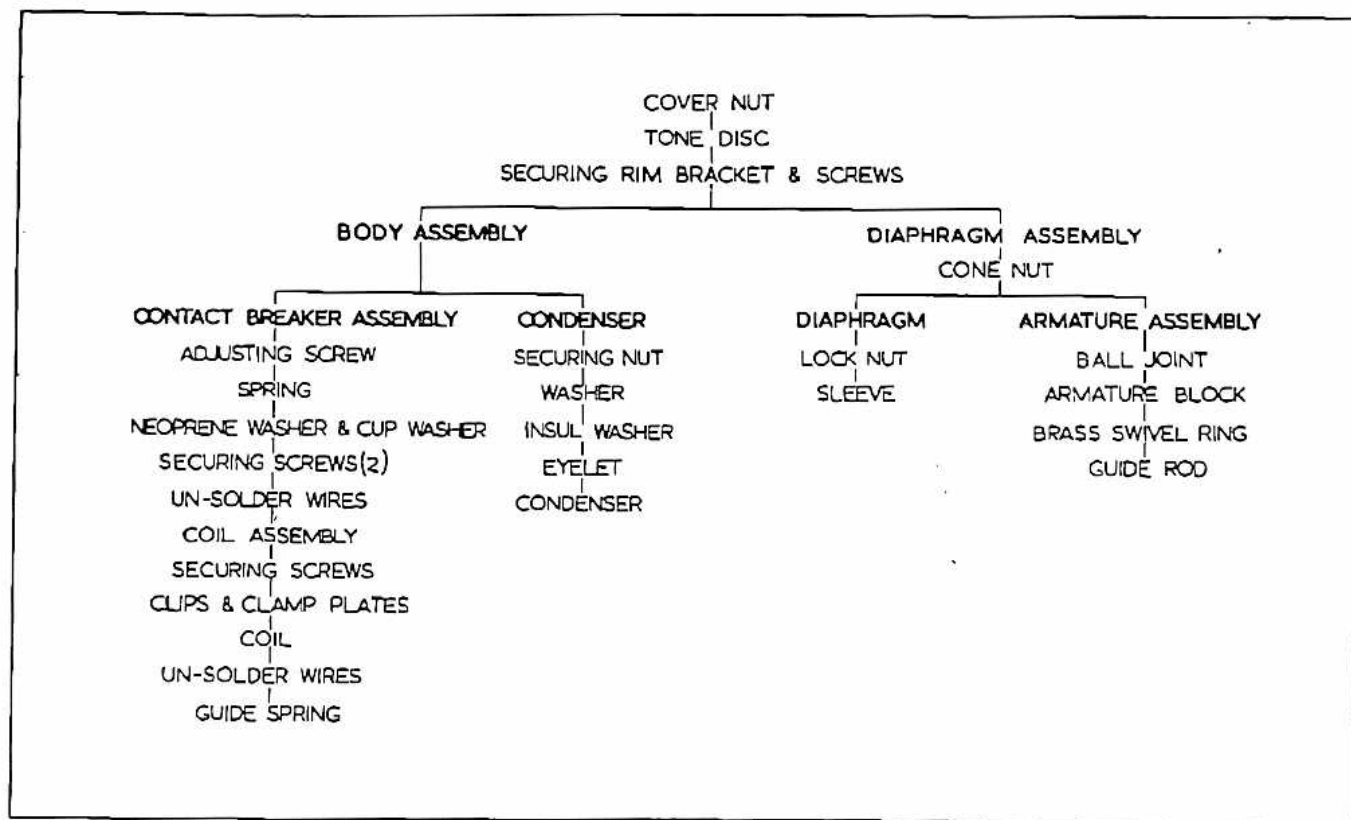
Fig. 4.

Do not bend the guide spring more than is necessary, or the spring steel may be damaged.

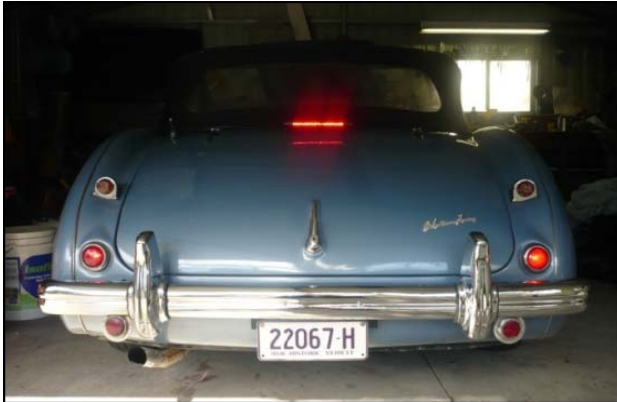
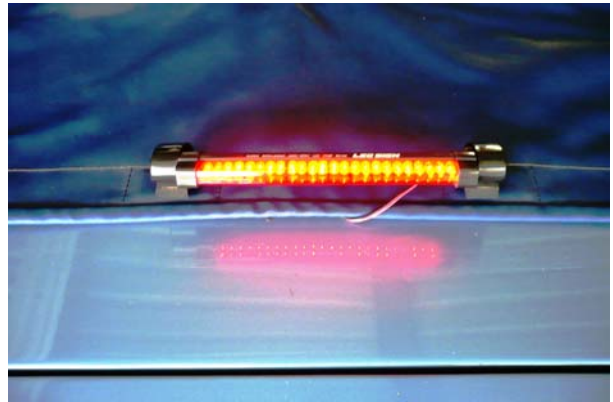
On the Tonneau Cover I have replaced the two pieces of aluminium sewn into the rear that clip into the retainers on the shroud, with a piece of steel bar 20wide x 3thick x 570long. The magnets attach firmly to this.

The magnets attach firmly to the existing steel bar at the back of the hood.

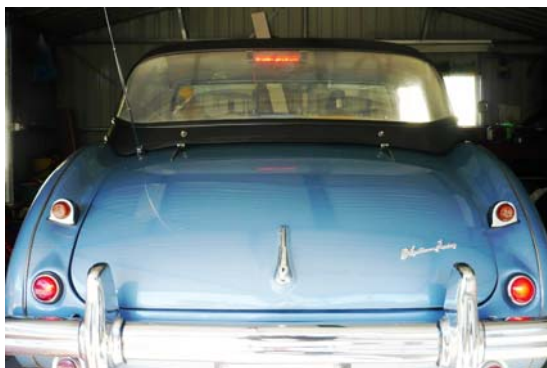
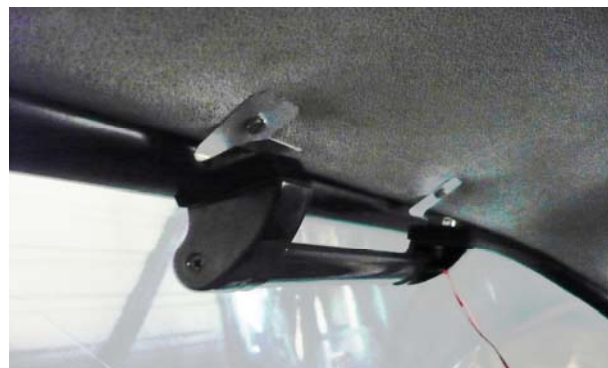
In the hard top two small steel brackets screwed into the wood surround of the back window which is fiber glassed into the shell hold the light firmly.

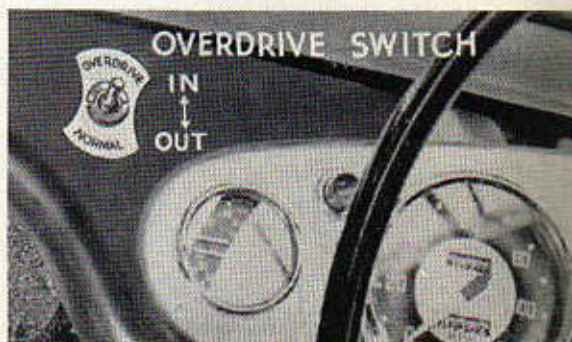
Manual Switch.

The overdrive operates in 2nd and top gears and is brought into operation automatically at approximately 40 m.p.h. (64 k.p.h.) by an electrical centrifugal governor and solenoid. On deceleration the overdrive remains in engagement but at speeds below 30 m.p.h. (48 k.p.h.) automatically disengages when the throttle is opened for acceleration. A further switch operated by the gear lever prevents engagement of the overdrive when either 1st gear or reverse is required.

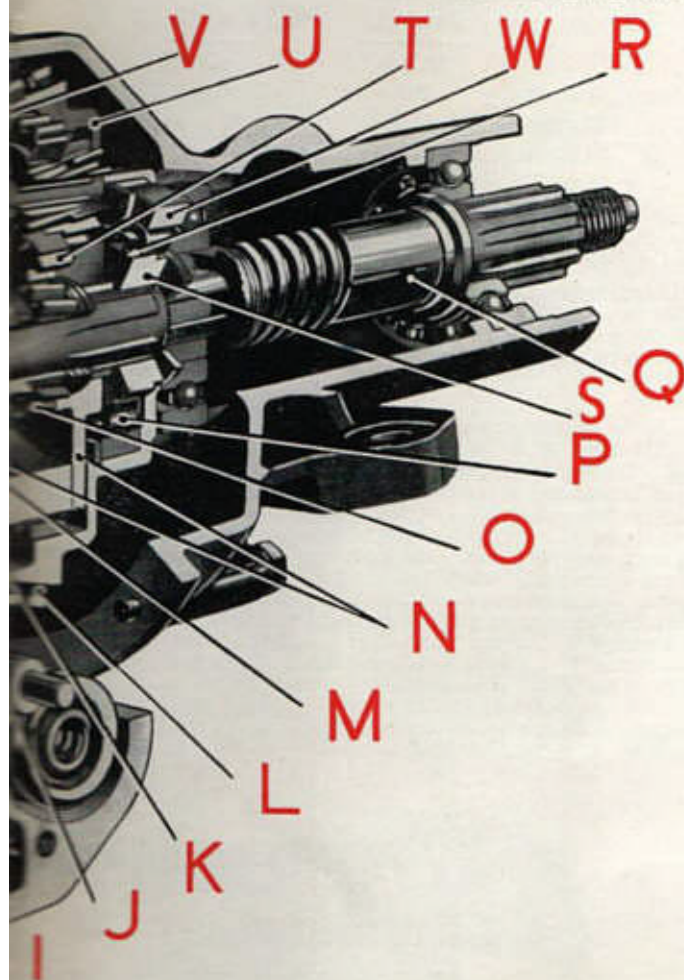
On completion of its forward movement, the outer lining (J) of the cone clutch (K) contacts the brake ring (I). Pistons (B) exert pressure not only sufficient to overcome springs (V) but also to bring clutch (K) together with sunwheel (O) to rest. Note that clutch (K.J.I.) being oil immersed comes to rest perfectly smoothly without shock.

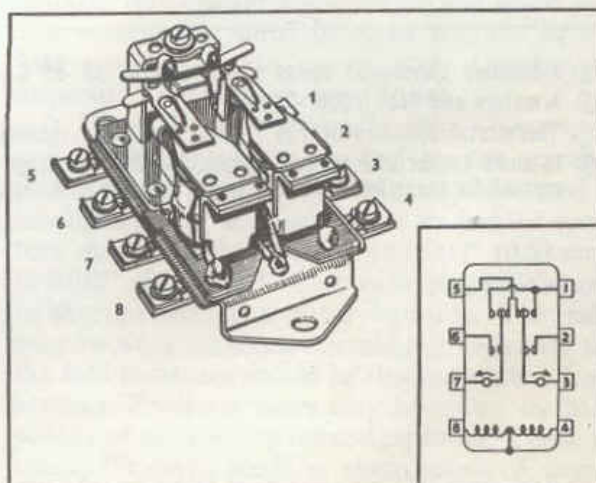
Lucas brake override relay and the wiring diagram.

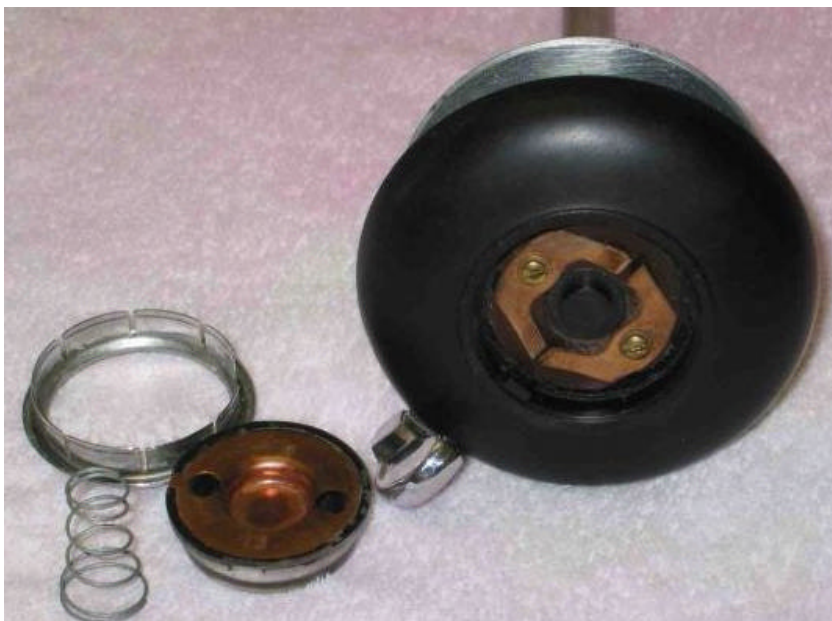
Once the horn button is loosened, the horn spring will be revealed. Its small diameter end faces to the bakelite head. The laminated blades of the horn switch secured by two brass screws also become evident.

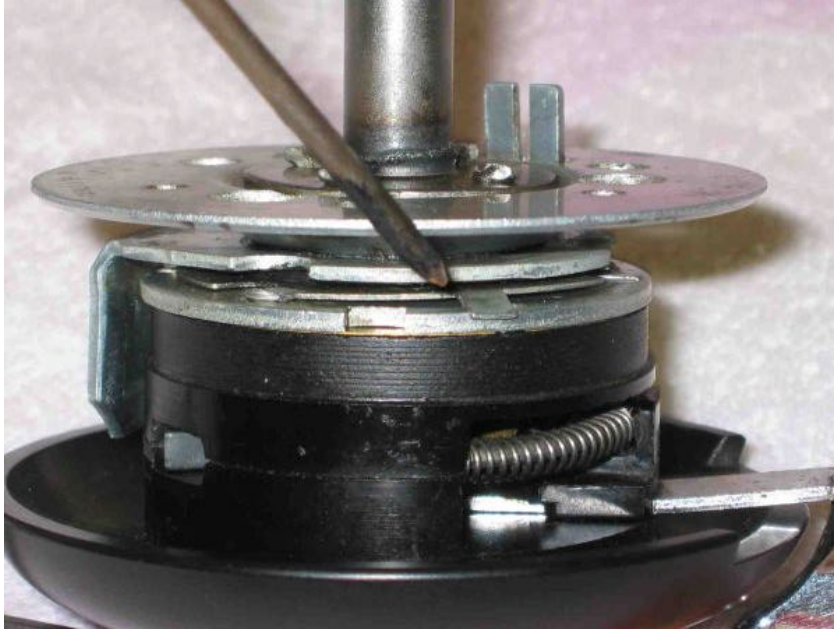
Examine the entire assembly. On the back of the unit, viewed from the side, a small tab bent down into a slot can be observed.

The tab can be pushed up so that it slides on the flat plate and the unit can be rotated slowly. Doing so provides access through 3 holes in the base mount plate to 3 slotted screws.

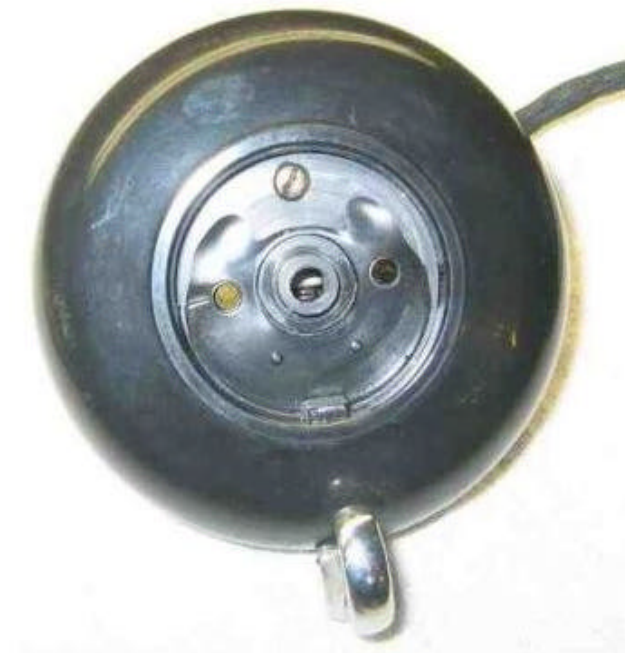
The turn signal lever is attached with one screw to the back of the bakelite mounting plate. Underneath it is a curved wire with a spring on each side of the lever.
