Austin Healey 3000 Mk III BJ8 Overdrive Hydraulics

by Mark Schneider, Austin Healey Club of Oregon

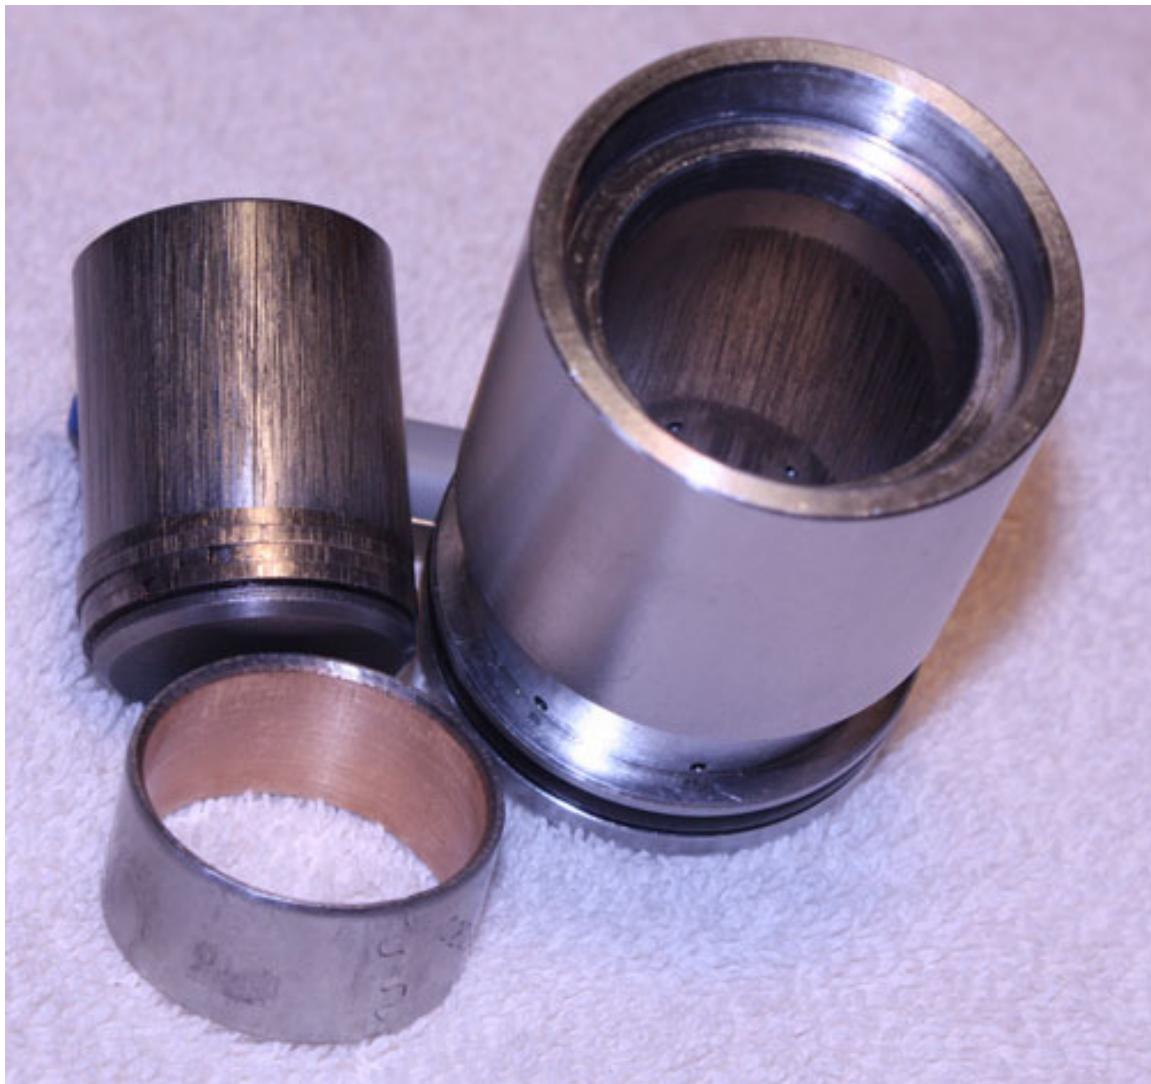
An important component in the hydraulic system is the accumulator piston and its housing (Figure 1). The piston and housing in the photograph were removed from my Laycock de Normanville overdrive hydraulic accumulator housing, piston with rings, and metal ring compression tool. The housing and piston show scoring from approximately 120,000 miles of use.

I have owned the car for 39 years and in all those years the overdrive has never failed. It has always has engaged and disengaged smartly when the OD switch was thrown or when I depressed the accelerator to pass a slower Ferrari or Jag. However, close inspection of these critical overdrive components during a recent tear down and rebuild of the driveline components revealed significant damage. In Figure 1 the scoring of the inner housing bore and similar damage done to the piston are obvious. Although I have routinely changed the oil and was careful to avoid introducing contaminants the accumulator items were badly worn. It was clear that new units were required.

Figure 1. My BJ8 overdrive after 118,400 faithful miles.

Note that the piston seen in Figure 1 has a series of metal rings located in a groove near the bottom of the piston. The piston and rings were purchased from Moss Motors as separate pieces and require assembly. There are a total of 6 cast iron rings. These rings are brittle and can break easily. Therefore the installation of the rings requires some care and finesse. The ring set consists of two wide rings which are installed on the piston first and line the bottom of the groove. These are followed by four narrower rings that rest on top of the two inner rings. The next step requires great care and patience, that is, inserting the ringed piston in the near zero tolerance of the accumulator

When my gearbox/OD project arrived at this juncture I conducted a little research. I read the workshop manual and studied the overdrive material on John Sims' excellent website, www.healey6.com. Unfortunately, there was no description of a technique for the installation of the ringed piston into the accumulator housing. However, some automatic transmissions contain similar piston/housing components and face a like challenge during a rebuild. A visit to a transmission shop produced the small piece of tubing seem in the lower left corner of Figure 1.

The metal ring in the figure has an ID of 28.65 mm, slightly larger than the 28.45 mm bore of the housing. I used this ring to compress the piston rings and then to insert the piston and rings into the accumulator housing. The following process works well and minimizes stressing the fragile rings. First, I chamfered the inner and outer edges of one end of the metal ring. Then I inserted the piston into the ring until the first ring touched the chamfer. Using two long needles I compressed the first ring until the gap in the ring was closed, then I applied a small amount of finger pressure to the bottom of the piston causing the first ring to slide into the ring. I repeated this ring compression three more times and left a small portion of the piston bottom protruding from the metal ring. The protruding piston bottom served to center the package directly over the center line of the housing bore and provided a visual clue to the alignment of the piston relative the housing. Finally, pressure was applied to the piston as it slipped from the ring and into the housing without any of the rings being allowed to re-open and interfere with a smooth insertion.
