Control Head (Trafficator) Rebuild for an Adjustable Wheel July, 2005

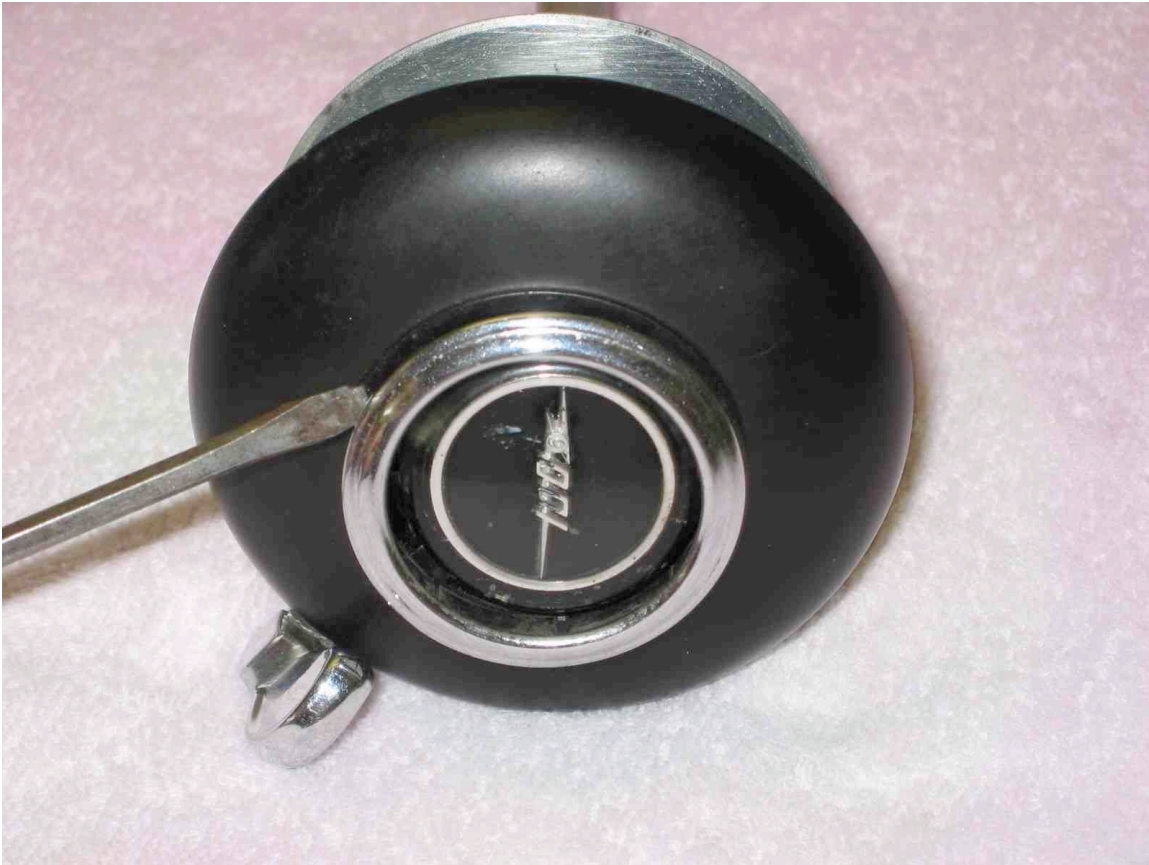
Image 1

First, carefully pry the horn button trim ring away from the bakelite head being careful not to scratch it.

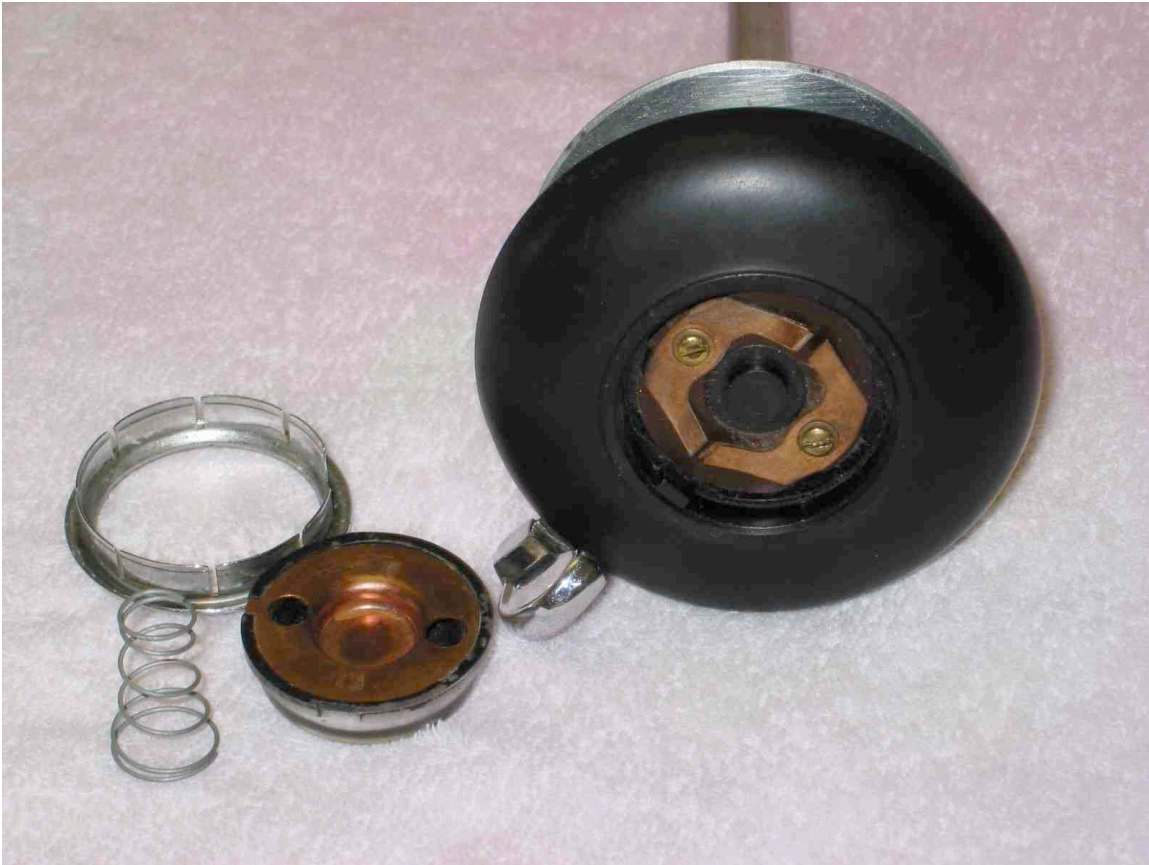
Image 2

Once the horn button is loosened, the horn spring will be revealed. Its small diameter end faces to the bakelite head. The laminated blades of the horn switch secured by two brass screws also become evident.

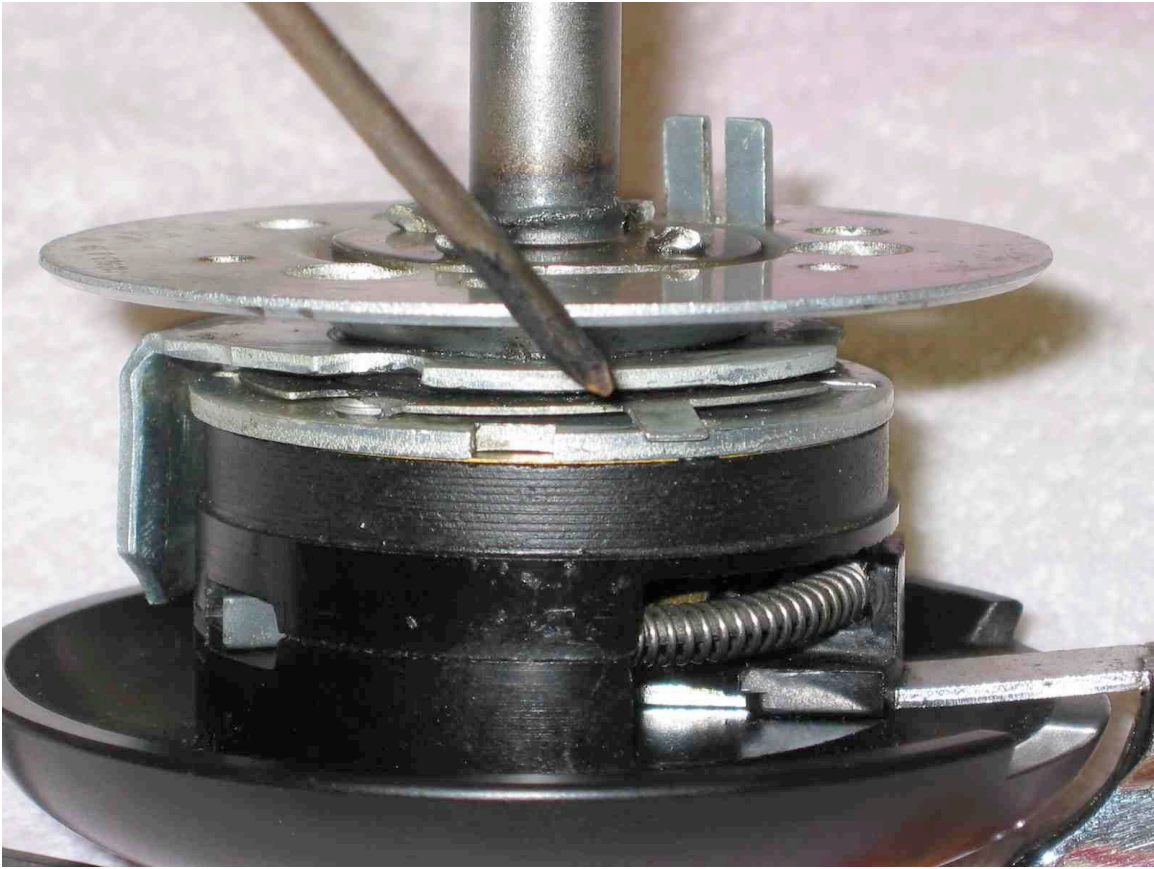
Image 3

Examine the entire assembly. On the back of the unit, viewed from the side, a small tab bent down into a slot can be observed.

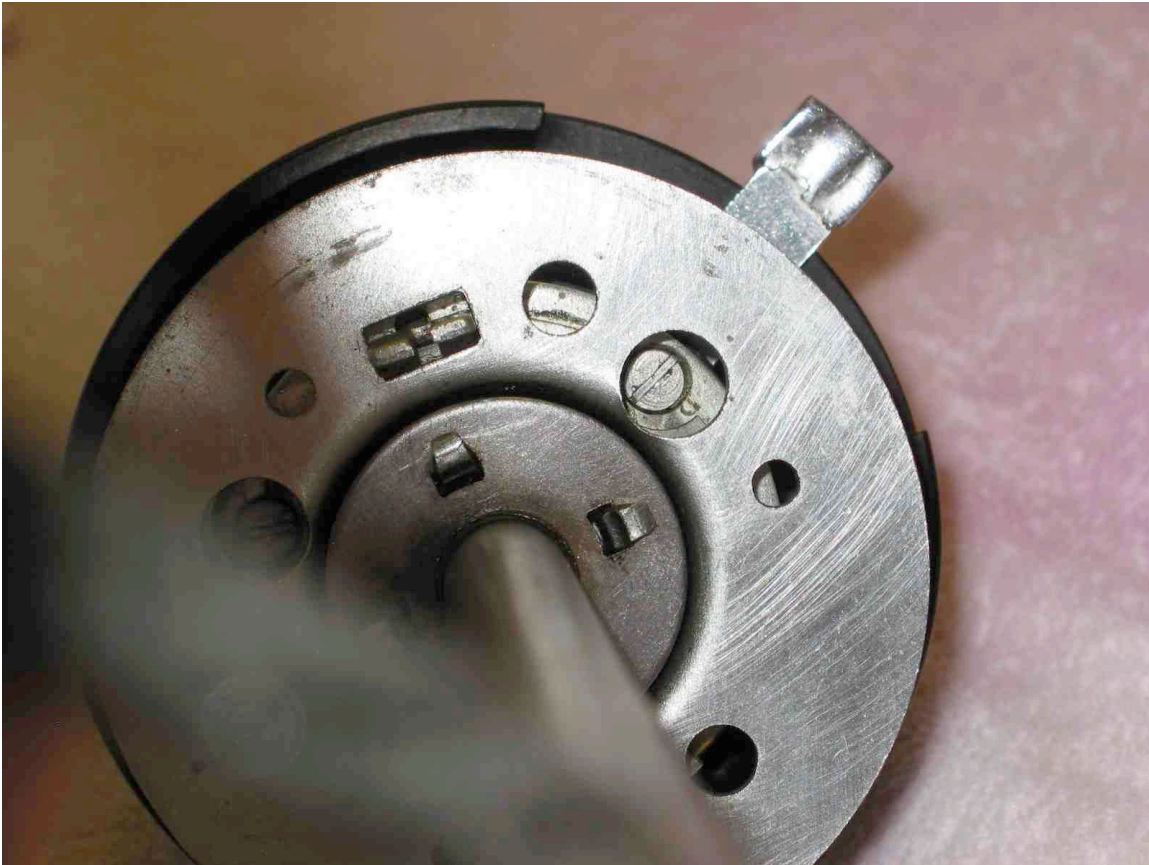
Image 4

The tab can be pushed up so that it slides on the flat plate and the unit can be rotated slowly. Doing so provides access through 3 holes in the base mount plate to 3 slotted screws.

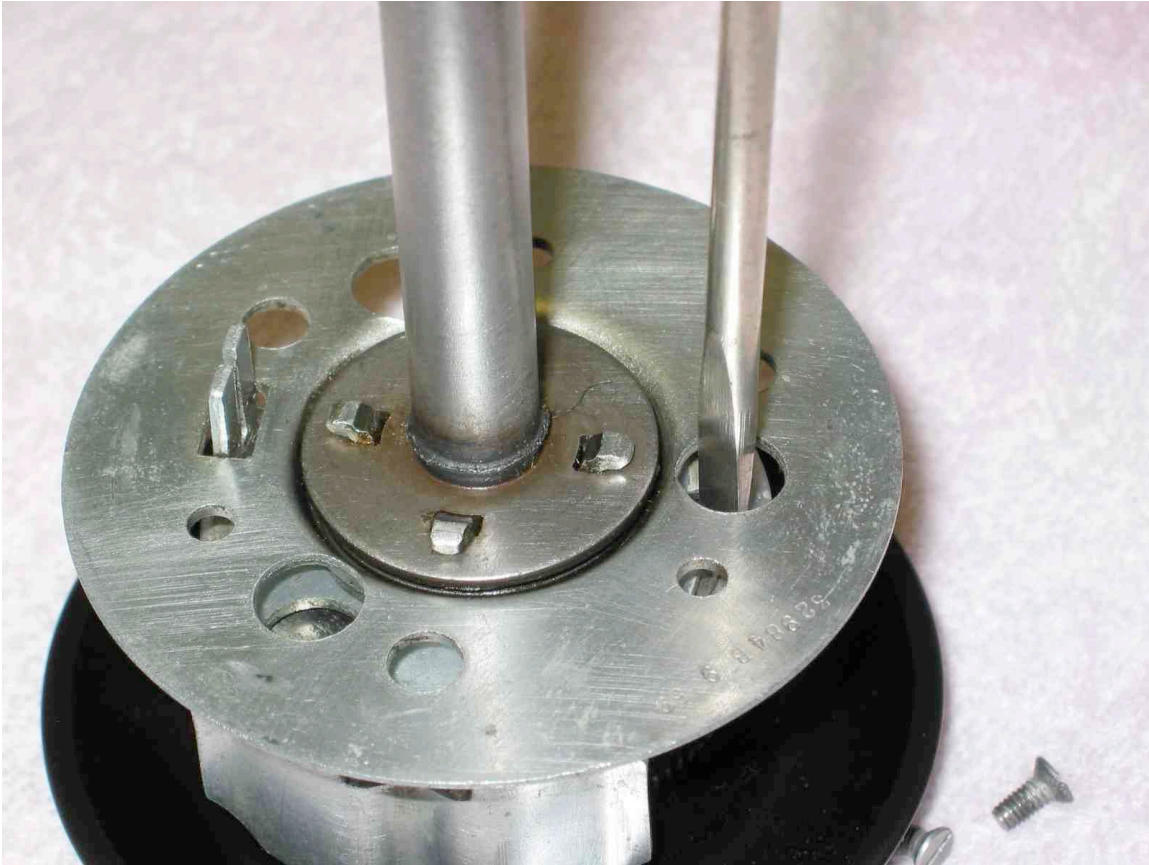
Image 5

Before removing the three screws, make a note or reference mark of how the two halves of the unit secured by the three screws goes together. Then remove the screws. The correct orientation of the turn signal lever is straight up, but if the two halves are oriented incorrectly, the turn signal lever will be either pointed down, or off to the side.

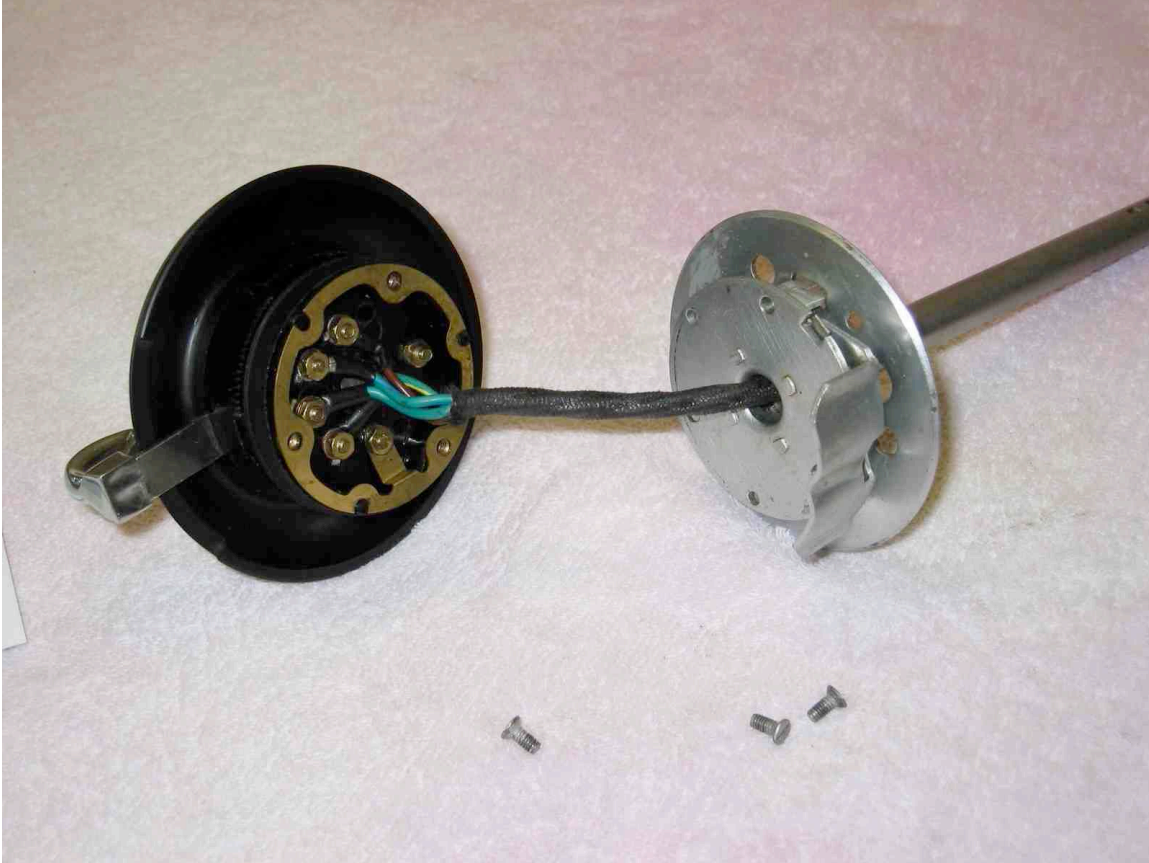
Image 6

The stator tube, base plate, locating plate, the base mount plate and assorted washers and spring can then be separated from the bakelite mounting plate and head. This assembled unit does not need to be disassembled. It can be pulled off the wires and set aside for assembly later.

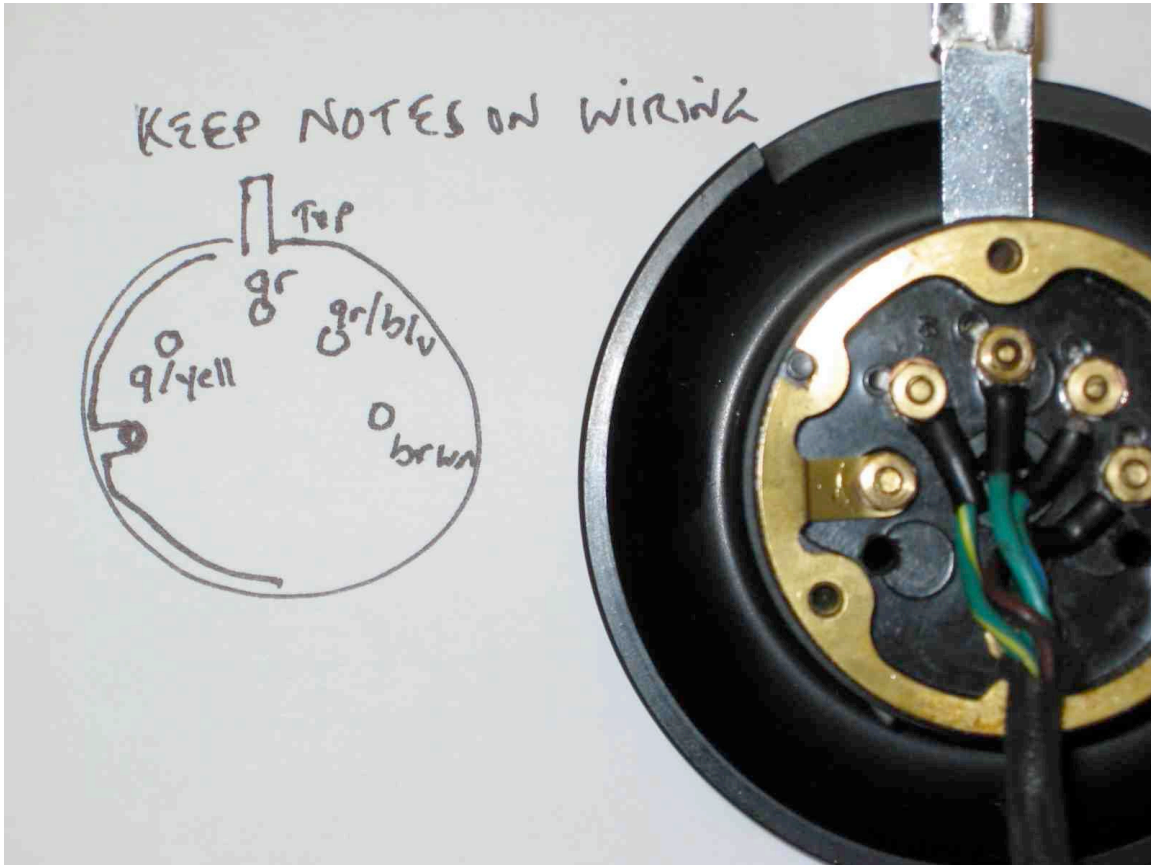
Image 7

Examine the back of the mounting plate. There are six nuts visible. Three are for the turn signal switch, two are for the horn (one goes through the brass ground ring) and the one without an attached wire is to hold the head and the mounting plate together (It is barely visible in the photo under the wiring sheath). Make a drawing to illustrate the color code and where each of the wires should reconnect to its proper fitting.

A. The screw on the right in the photo is accessed under the horn button. Hold it with a screw driver and loosen the nut holding the wire, remove the nut, change the wire, refit and tighten the nut.

B. The nut second from the right is held in place by a hex head screw recessed in the bakelite mounting plate. The turn signal lever must be moved so that it is aligned behind the screw/nut. It will hold the screw in place permitting removal of the nut and old wire, change the wire and refit and tighten the nut. **Do not let the turn signal lever slip while doing this procedure or you will likely be disassembling the complete unit!**

C. Reposition the turn signal lever to the center position and repeat B. above for the screw/nut located third from the right.

D. Move the turn signal lever behind the screw/nut located fourth from the right and repeat B. above.

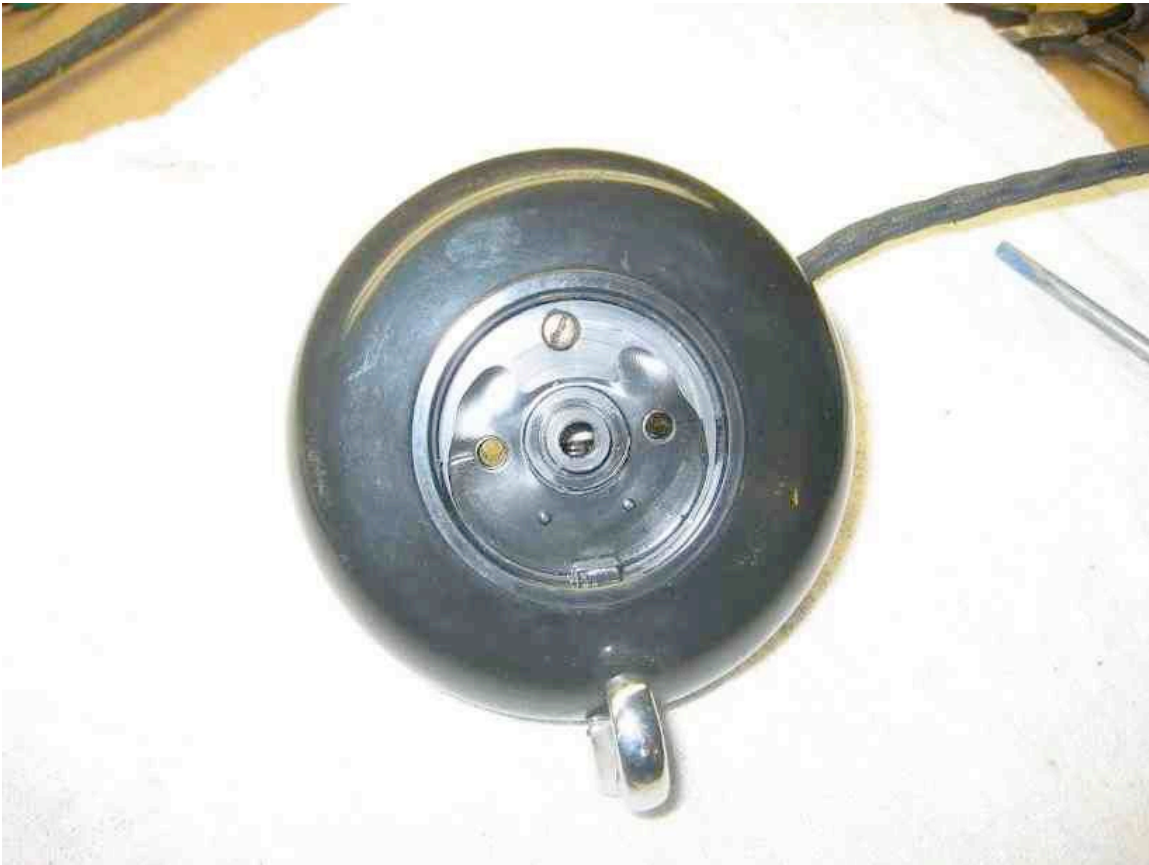
Image 8

Remove the two screws holding the laminated blades of the horn switch under the horn button. The horn switch will lift out. The third screw can then be removed and the bakelite head can then be separated from the mounting plate.

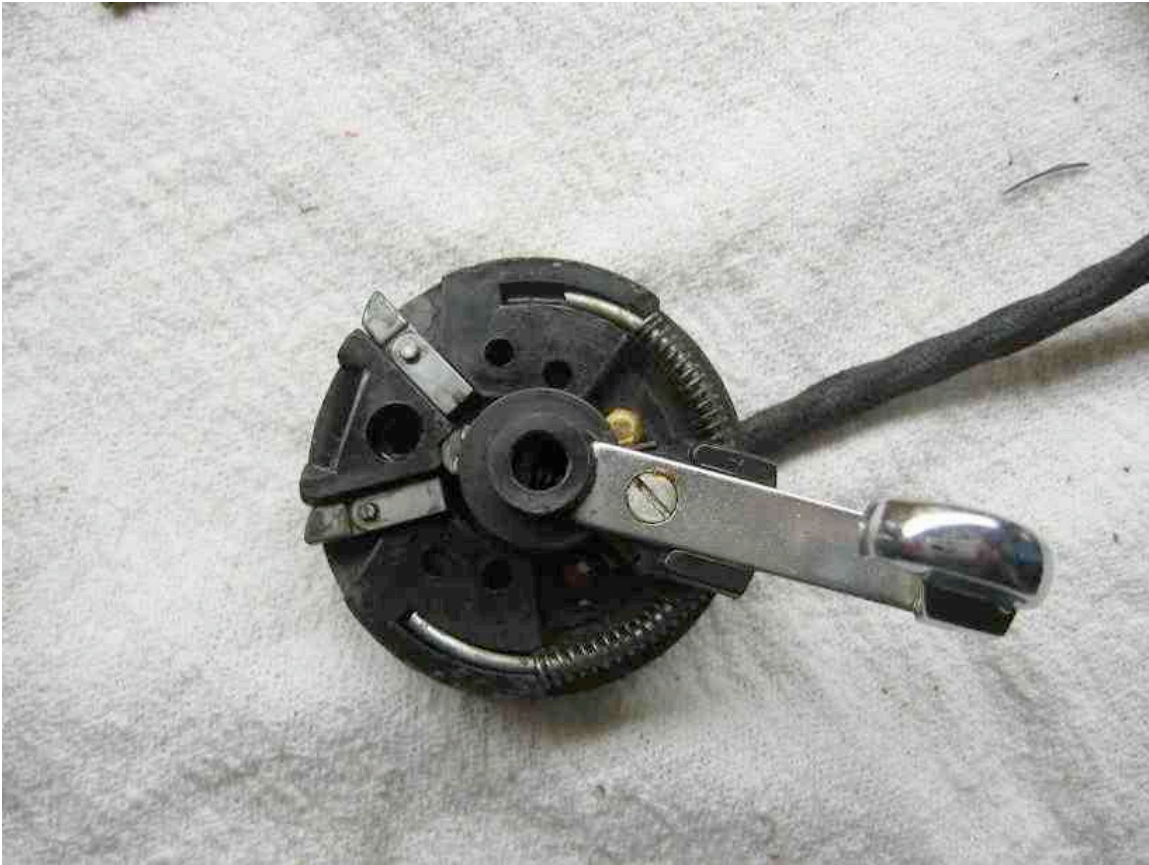
Image 9

The turn signal lever is attached with one screw to the back of the bakelite mounting plate. Underneath it is a curved wire with a spring on each side of the lever.

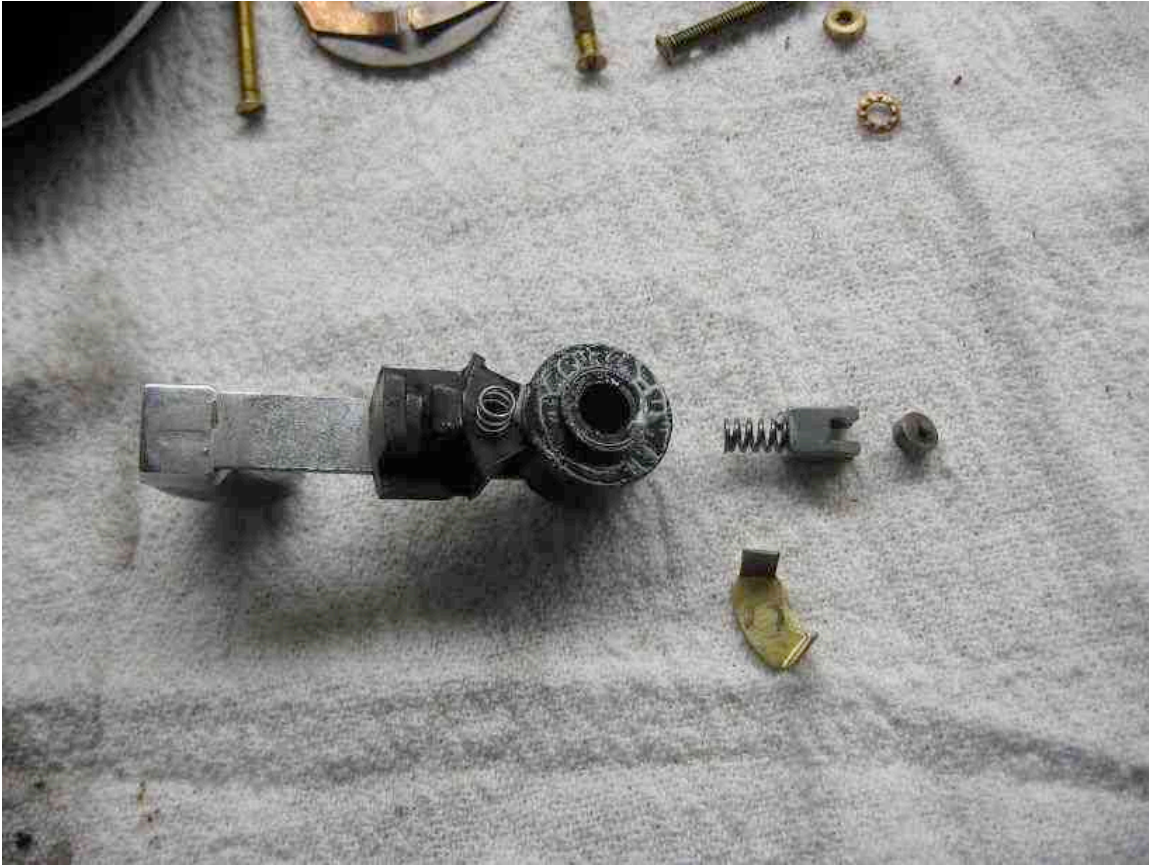
Image 11

There is another little spring and ball at the bottom of the turn signal lever.

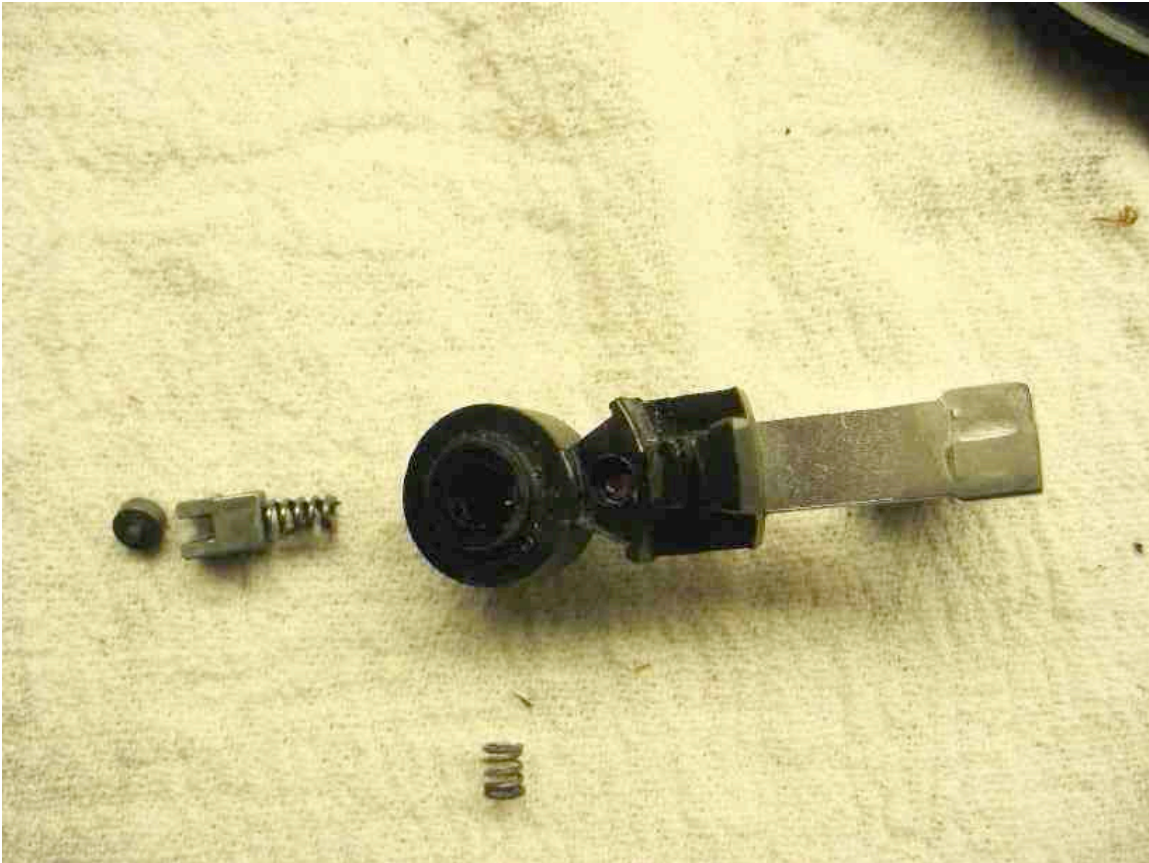
Image 12

If you carefully remove the single screw to separate the lever from the assembly, the springs and small parts should stay in place. Note how they should be reassembled, then take apart, clean and lubricate with a little lithium grease.

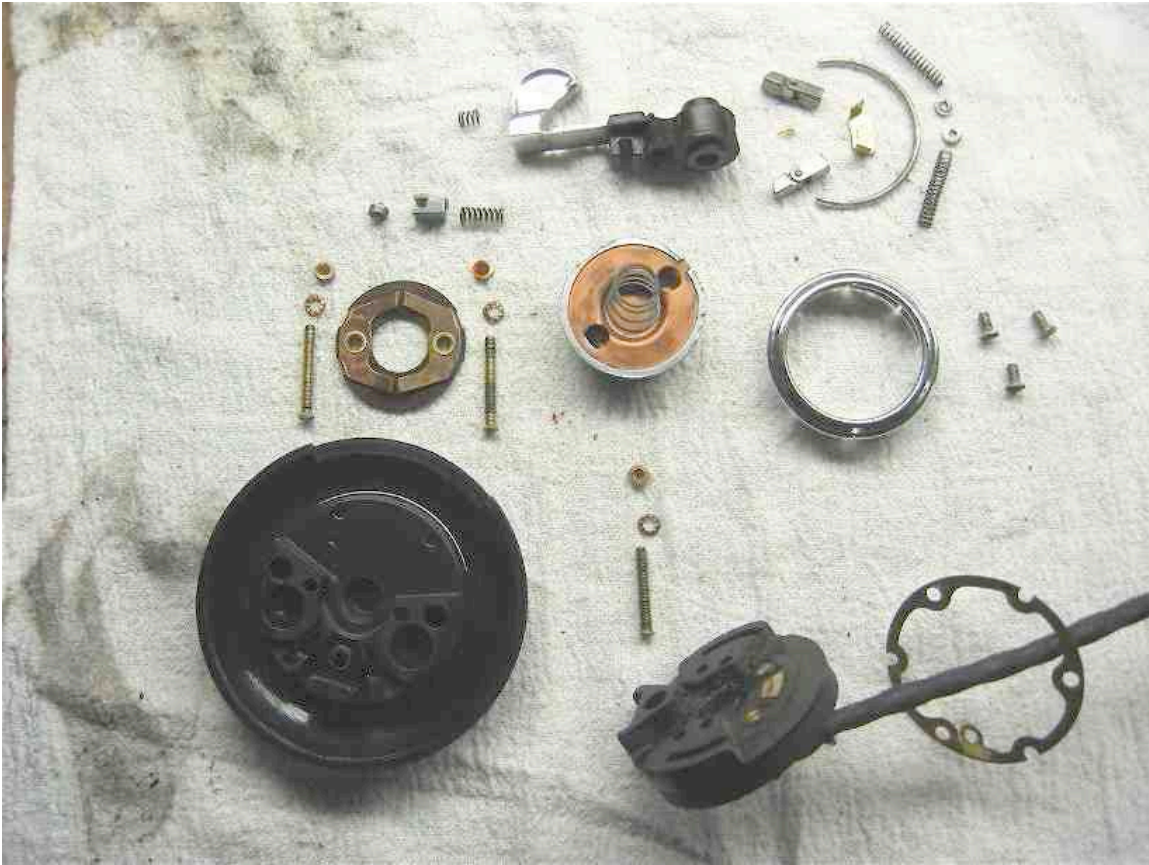
Image 13

If you experience an explosion of parts, don't be alarmed. It will all go back together! All components are identified in the photo below:

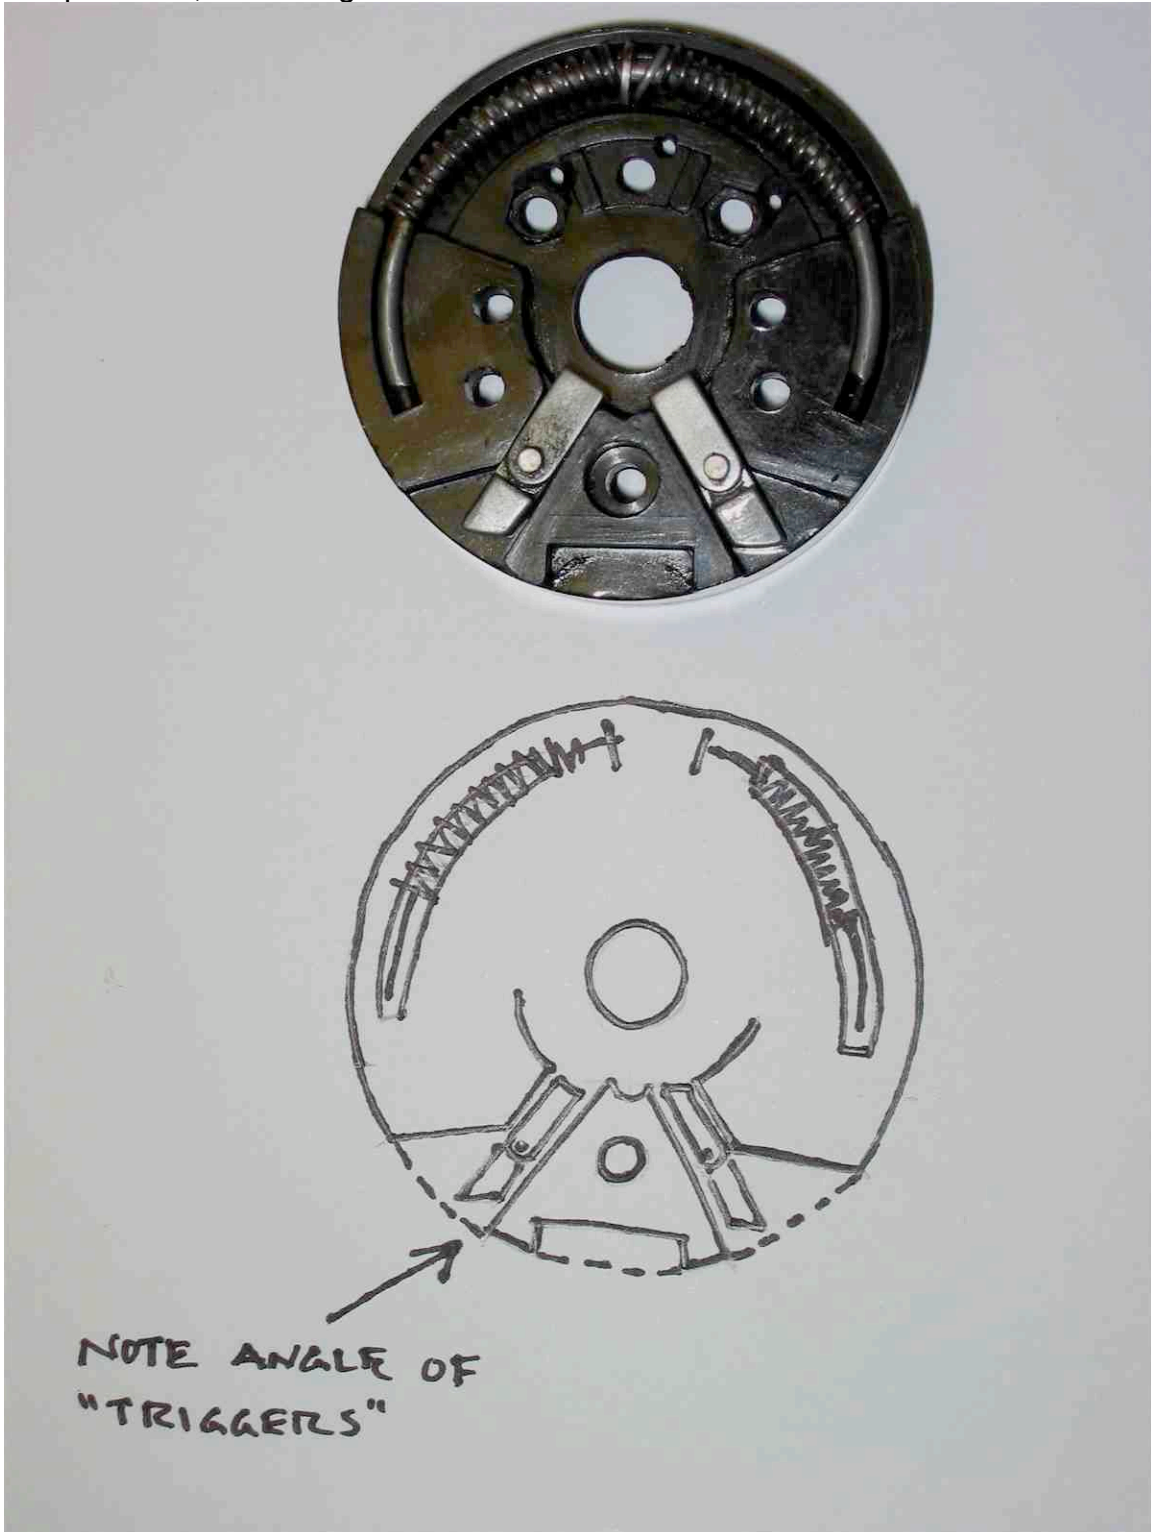
The proper positioning of the two hinges or "triggers" is important. They have angles on the end that fit opposite each other. They need to be placed as seen in the image and drawing for the canceling switch to work. Before reassembly of the complete unit, now is a good time to refinish the bakelite if it is needed.

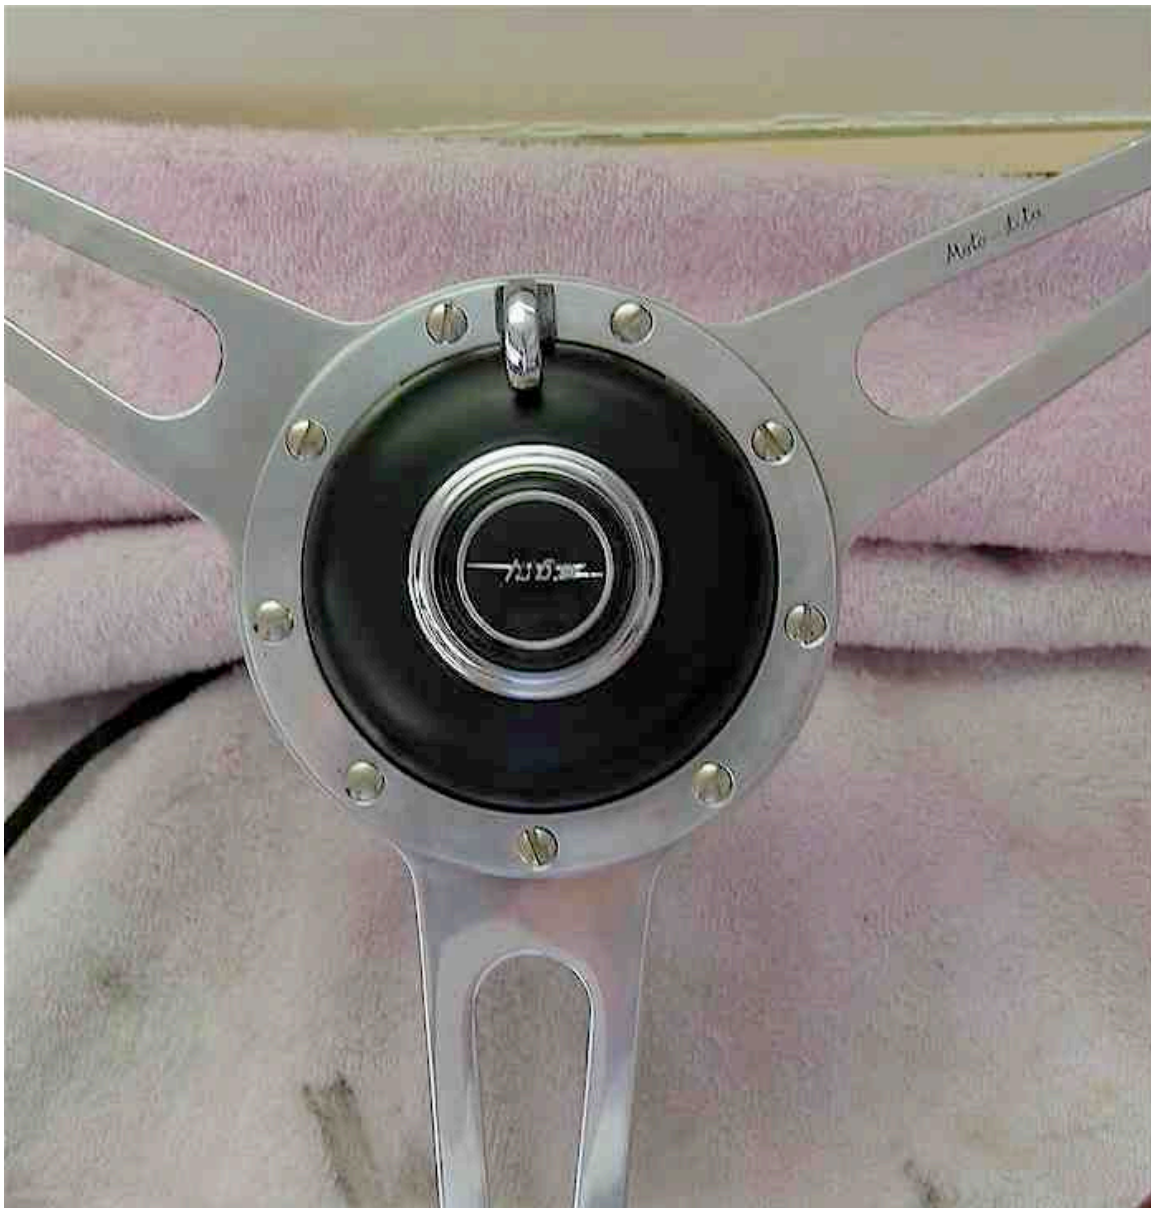
Image 14

I have lost the source of these instructions or I would give attribution, but clean the head well and wipe with a liquid cleaner like the type used before spray painting metal. Then apply black India ink. I used two coats letting the first coat dry for about an hour before applying the second. Then use black paste shoe polish rubbed in well. Polish. Reapply paste and polish again. Finally, apply a coat of carnuba wax for protection and final shine. Be very careful to not drop the bakelite head! I recommend doing all the polishing over a carpeted floor in case the head is dropped. This should result in a control head that looks brand new.

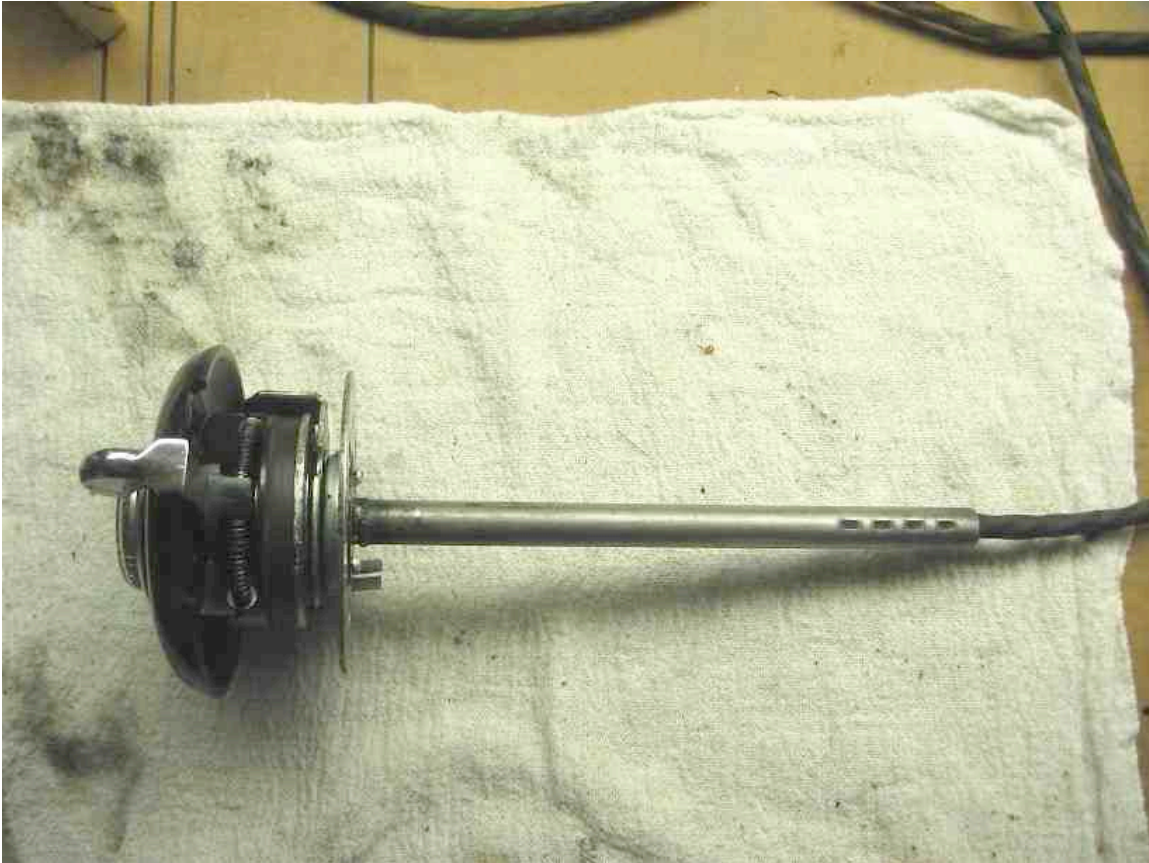
Image 15

Carefully place the head and the mounting plate together pushing the spring at the end of the turn signal lever into the mounting plate. Holding the two pieces together install and tighten the single screw and nut at the bottom of the unit. This screw/nut will securely hold the two pieces together while the horn switch screws and nuts are inserted and tightened.

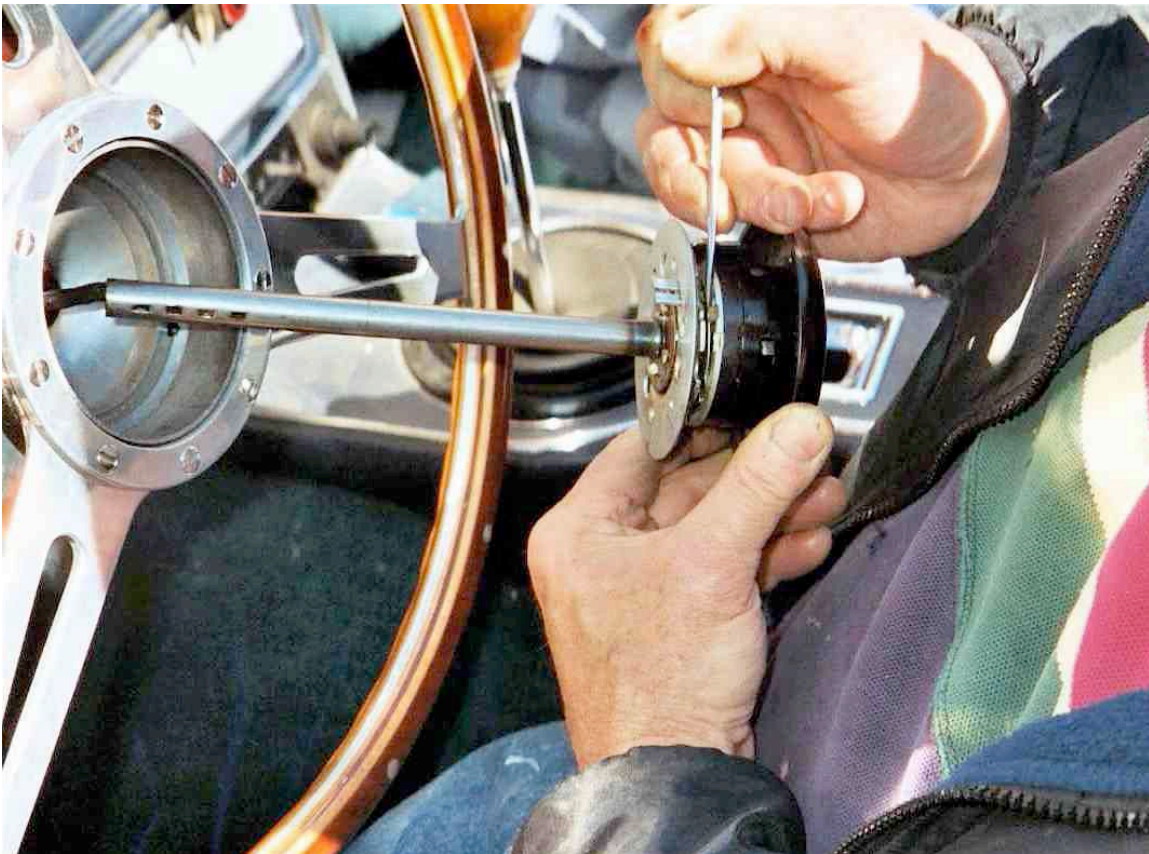
Image 16

Push up and rotate the retaining tab as seen in Image #3 and below.

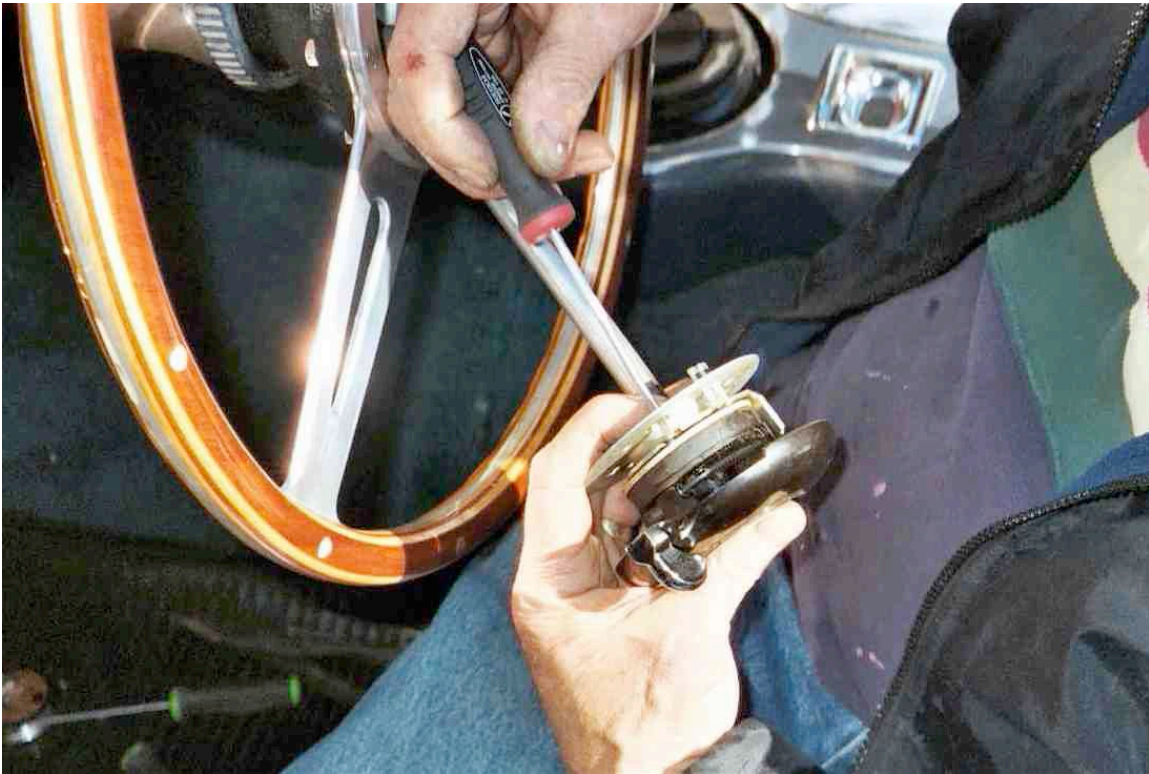
Image 17

Remove the three screws securing the mounting to the backing plate.

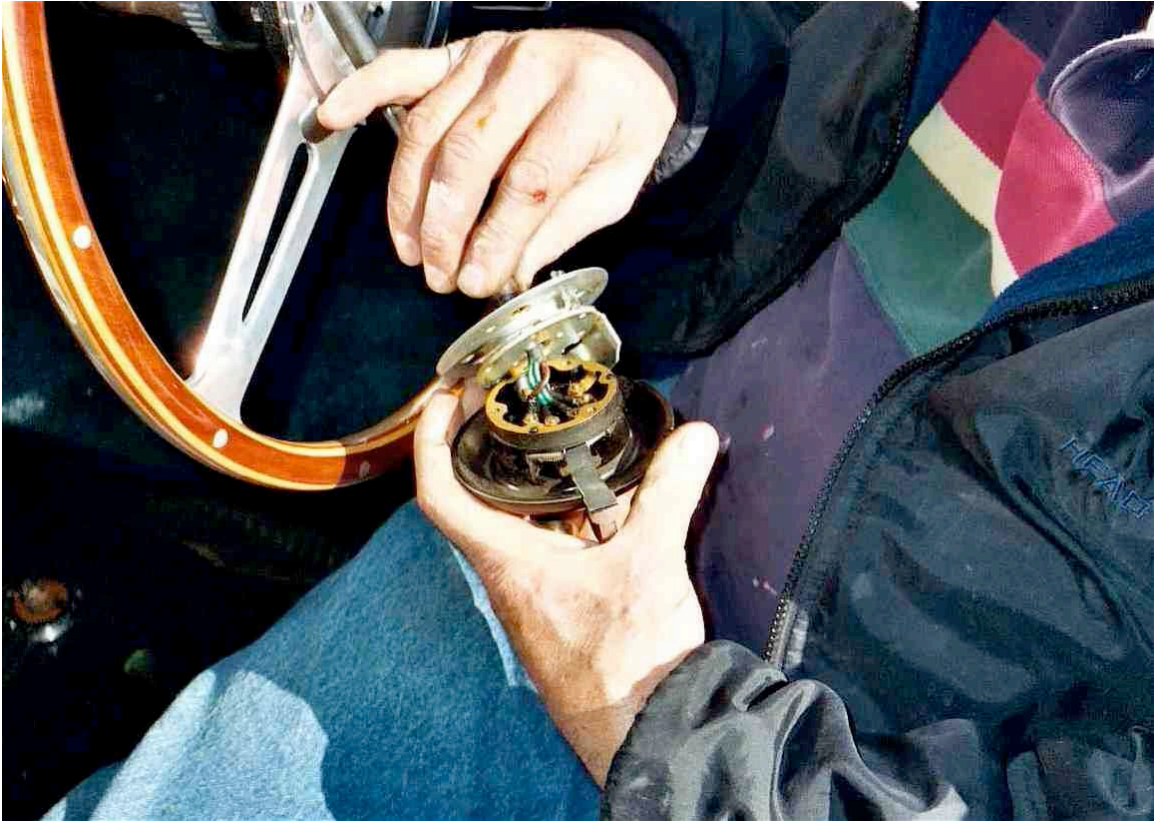
Image 18

Then separate the backing plate:

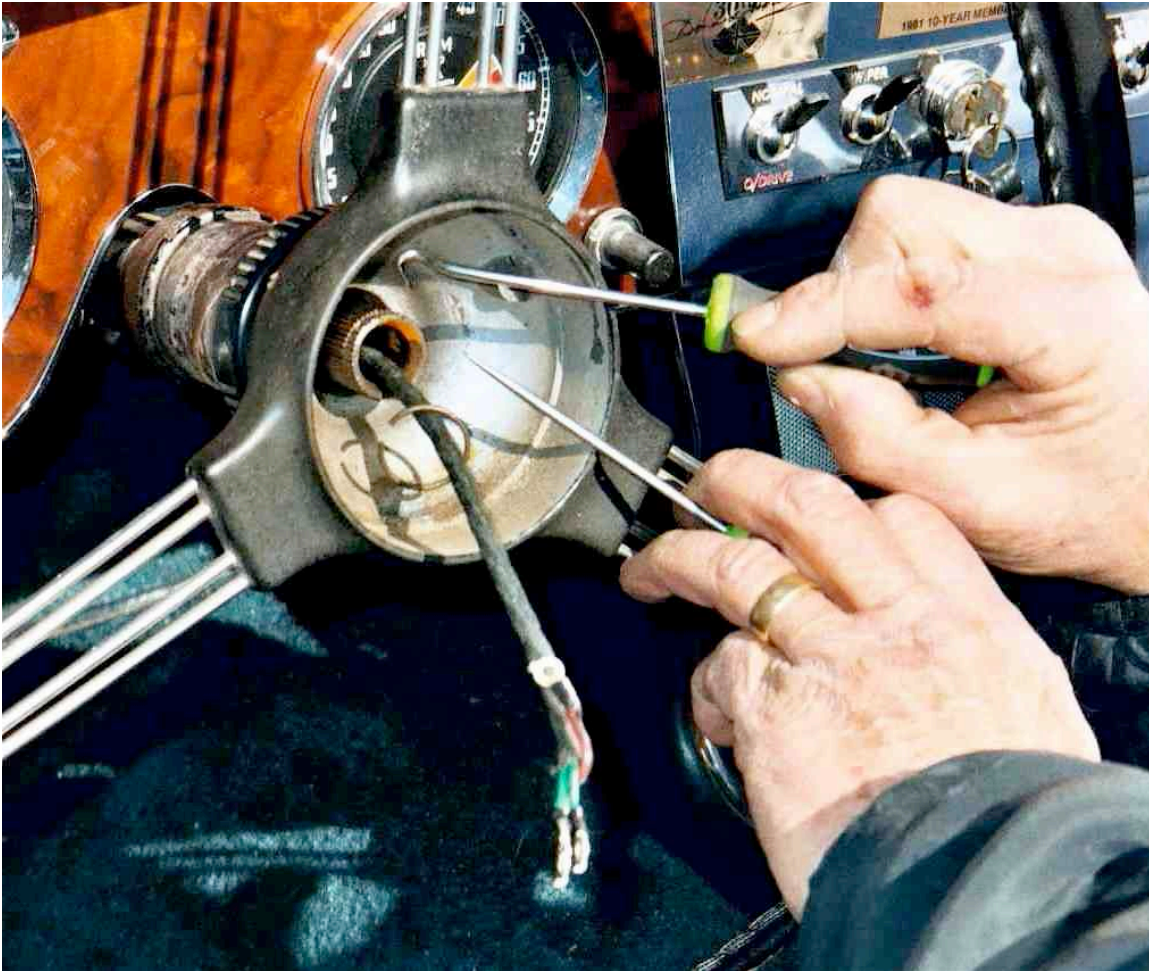
Image 19

With the control head unit free of the wiring one can then replace the steering wheel if that was the (an) objective by removing the circlip and sliding the wheel off the shaft.
