No. A / 381

OVERDRIVE THROTTLE SWITCH  
CORRECT SETTING

AUSTIN-HEALEY 100-SIX (BN6)  
AUSTIN-HEALEY 3000 (BN7: BT7)

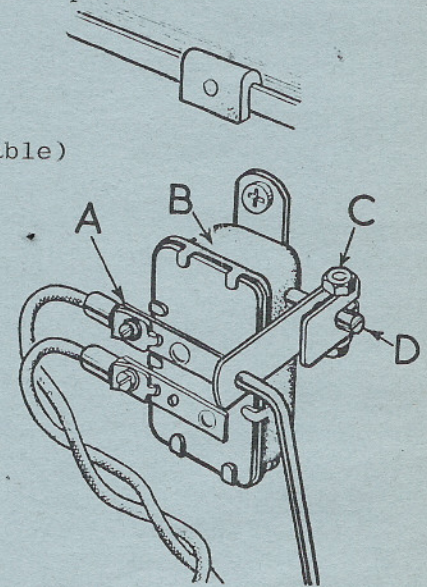
Take a feed from the top terminal 'A' on the rotary throttle switch 'B' through a low consumption test lamp (a 12-volt 2.2-watt dash panel bulb is suitable) to a convenient earthing point.

With the gear lever in 3rd or top position, the ignition switch ON, and the overdrive switch ON, the bulb should light. Switch overdrive OFF; the bulb should still be alight with the throttle closed.

Progressively open the throttle until the light goes out, which should occur at 1/5th throttle opening. At this position it should be possible to pass a 3/16" (5 mm) diameter bar beneath the throttle stop.

If the setting is incorrect, slacken the throttle switch lever clamping bolt 'C' and adjust the switch by turning the shaft 'D', which has a slotted end to take a screwdriver.

Harshness when coming out of overdrive due to a particular driving technique can be reduced by delaying the operation of the throttle switch to a slightly wider throttle opening.
