Subject: BN7 side screen hardware finish

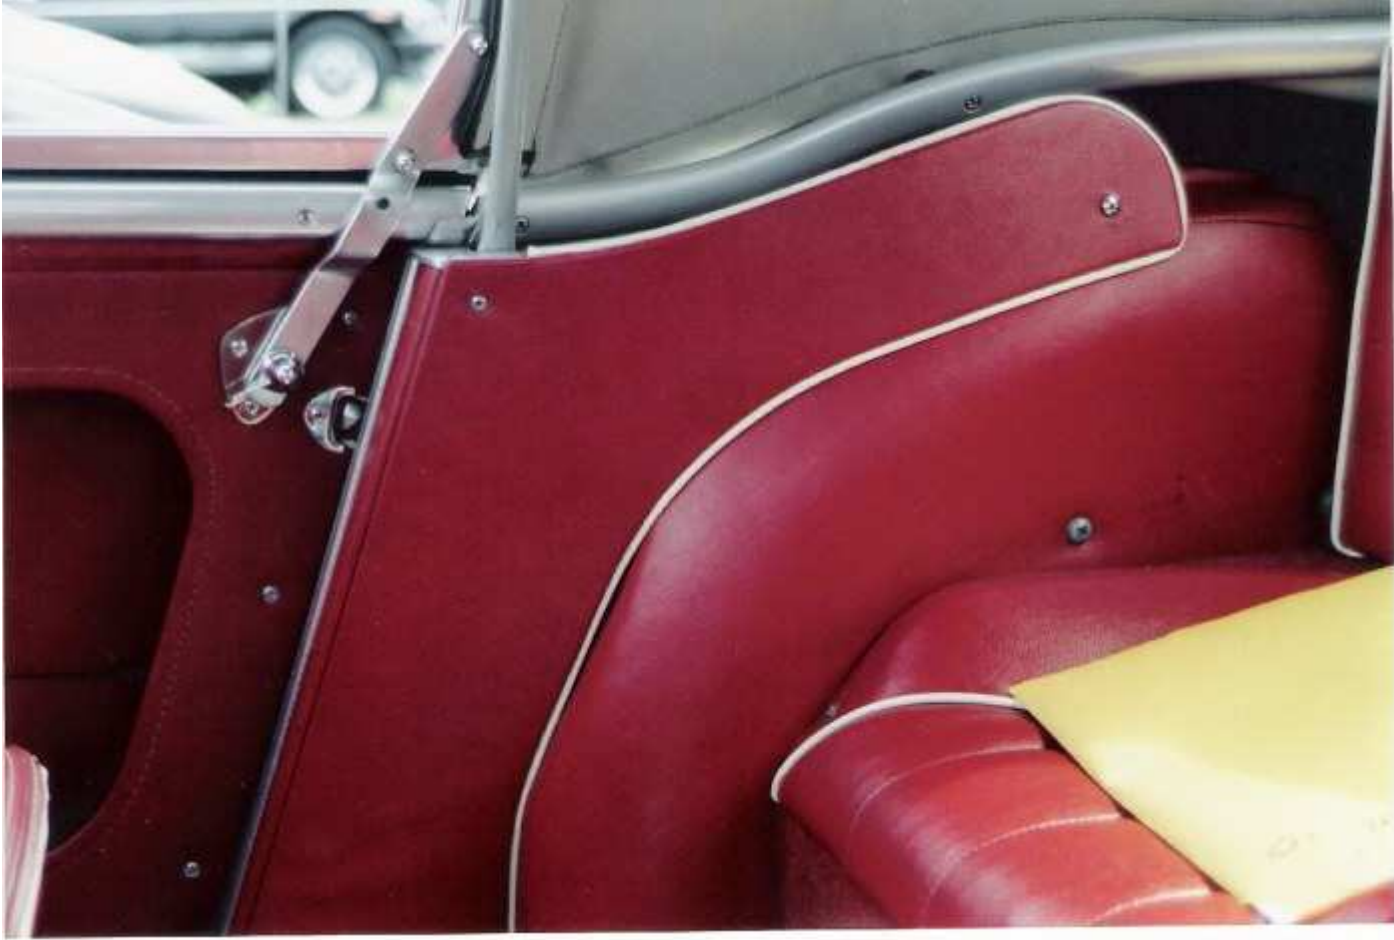
The finish on these steel brackets for your BN7 is a smooth satin silver finish, which ends up looking quite like polished anodized aluminum. They were not painted. The repros I've seen do not have the original finish and appear to me to be too bright, like zinc.

I'm enclosing a picture of a later style pair as fitted to a 100/Six but they are the same for your car. You can see the smooth satin finish I'm trying to describe.
